CITY OF PITTSBORO, INDIANA

SIDEWALK INVENTORY

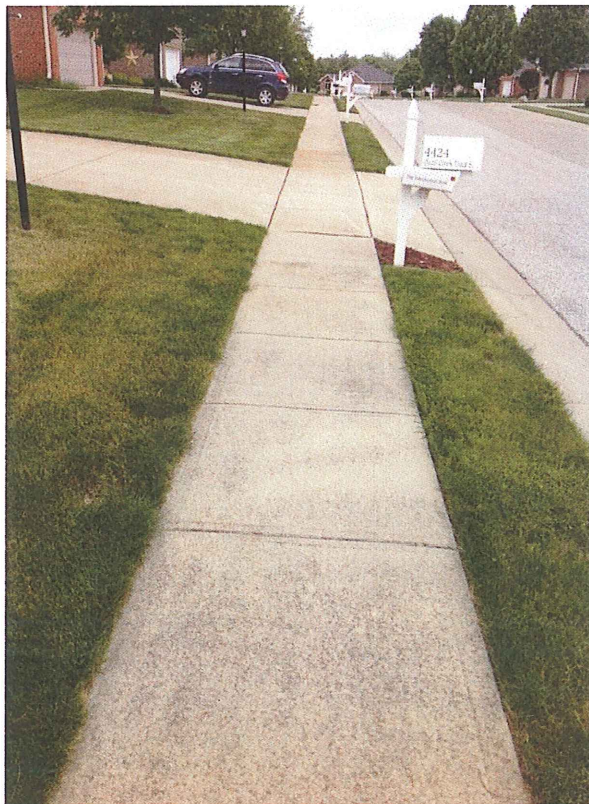
Sidewalk Cross Slope	less than 2%
Sidewalk Running Slope	0.9
Sidewalk Width Without Curb Feet	4
Sidewalk Width Without Curb Inch	0
Comments	3 raised panels 3/4".

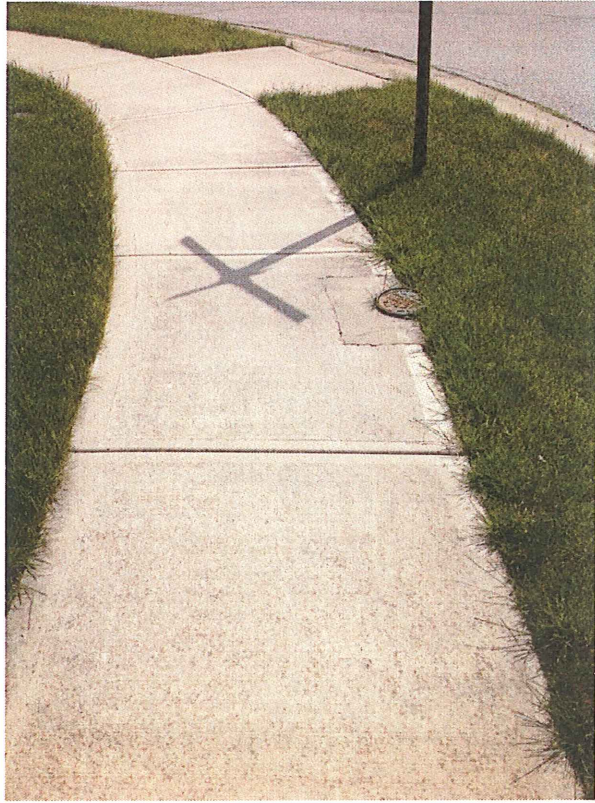
Sidewalk Cross Slope	less than 2%
Sidewalk Running Slope	0.4
Sidewalk Width Without Curb Feet	4
Sidewalk Width Without Curb Inch	0
Comments	Valve box up 3/4"

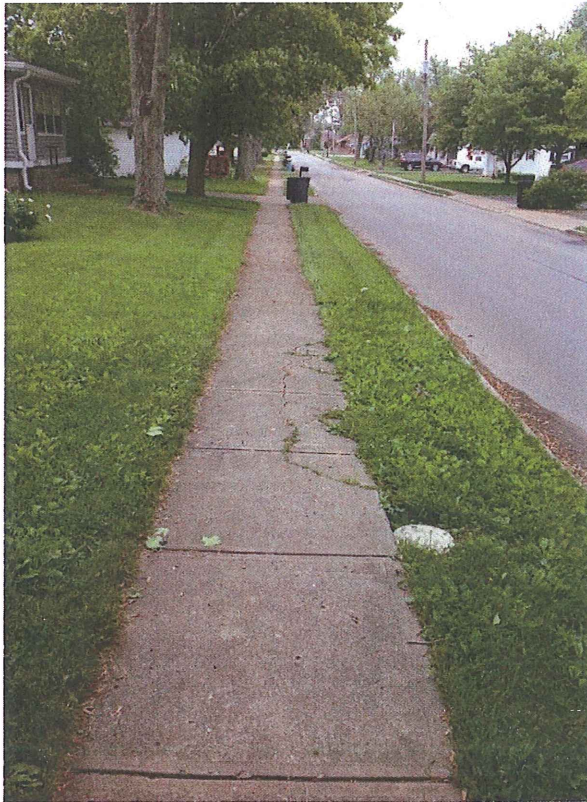
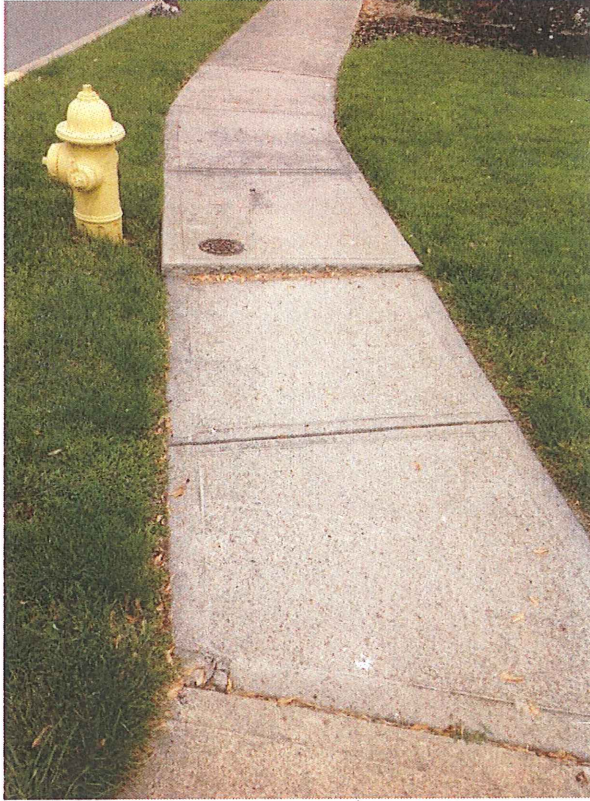
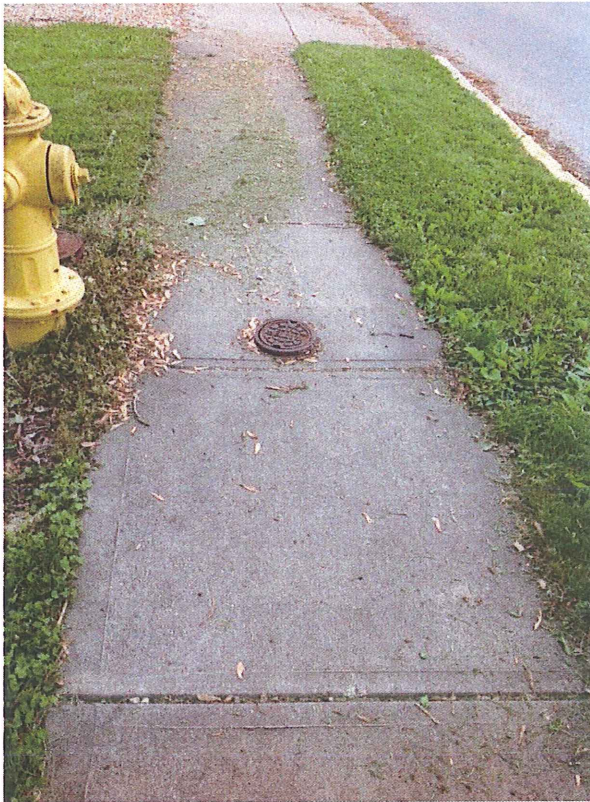
Poplar to Wall

Sidewalk Obstructions	Yes
Sidewalk Cross Slope	less than 2%
Sidewalk Running Slope	2.4
Sidewalk Width Without Curb Feet	4
Sidewalk Width Without Curb Inch	0
Comments	2" raised panel at hydrant. 30' of cracked panels. Water valve up 1"

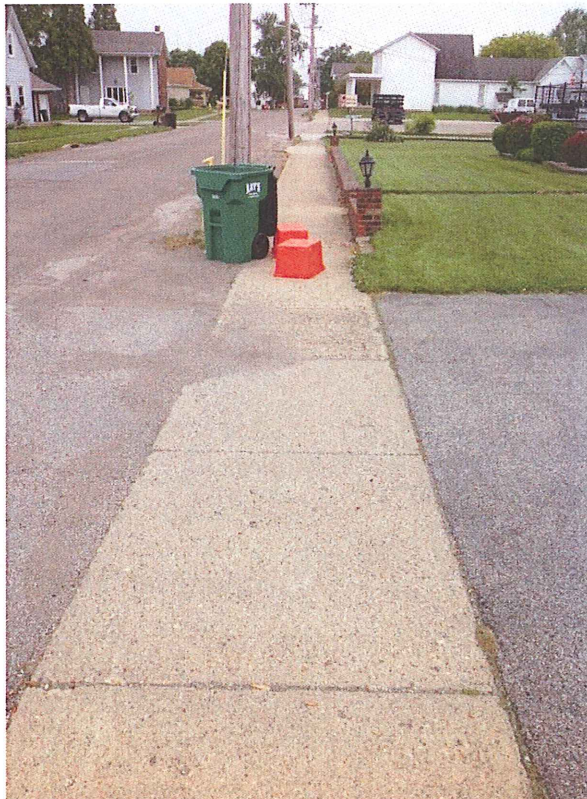
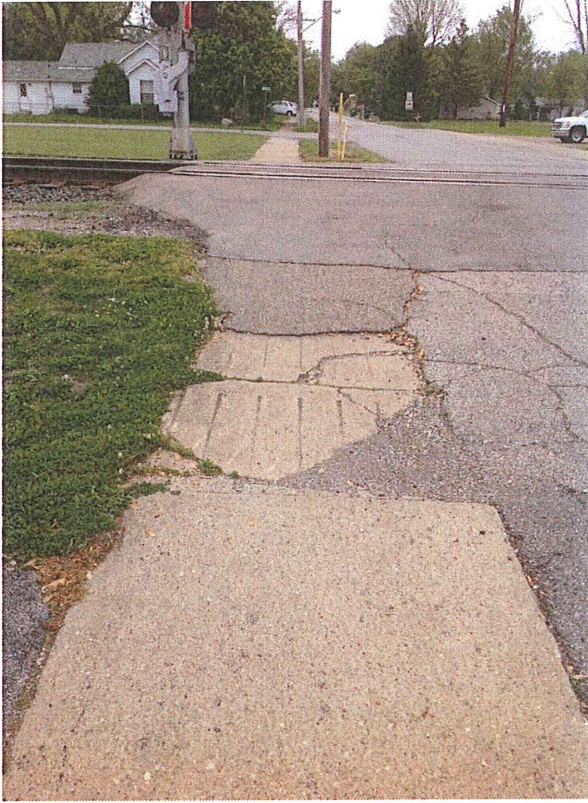
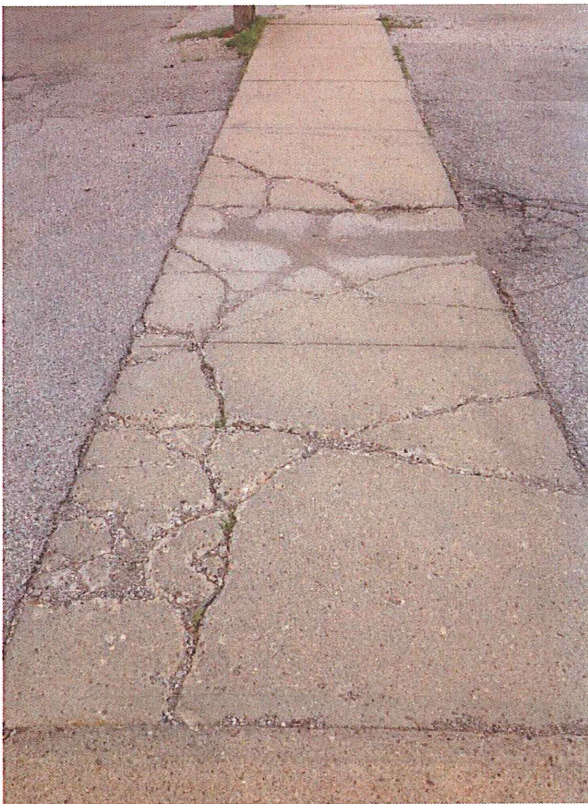
Sidewalk Cross Slope	less than 2%
Sidewalk Running Slope	1.7
Sidewalk Accessibility Obstacles	Yes
Sidewalk Width Without Curb Inch	0
Comments	Running slope at RR 6%. Badly cracked areas

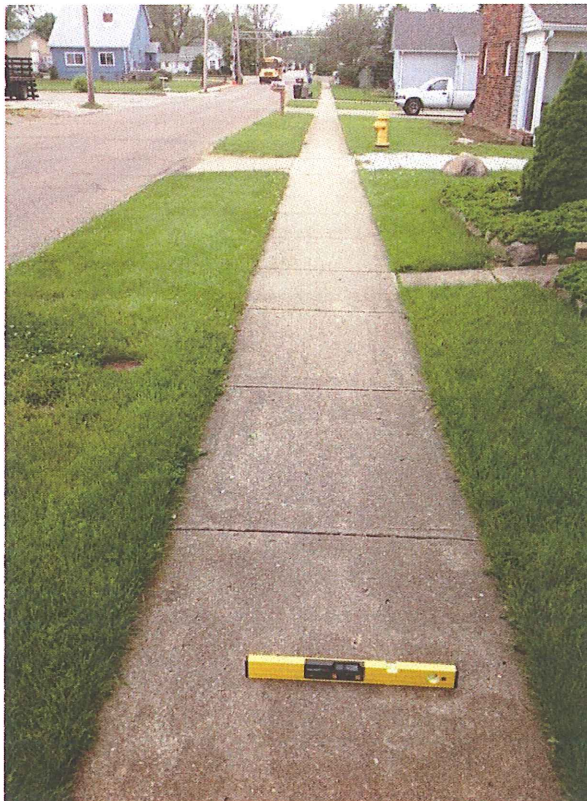
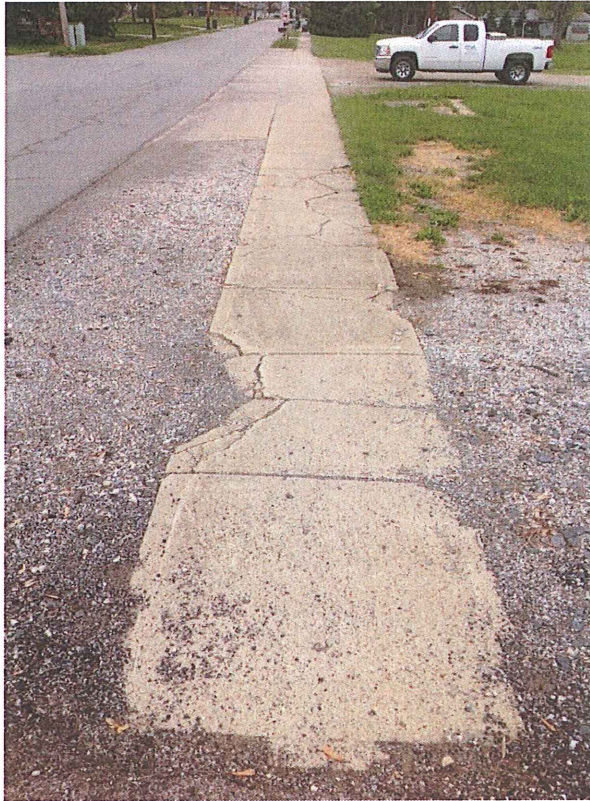
Lodge to Scott

Sidewalk Cross Slope	less than 2%
Sidewalk Running Slope	0.8
Sidewalk Width Without Curb Inch	0
Comments	Cracked and uneven areas

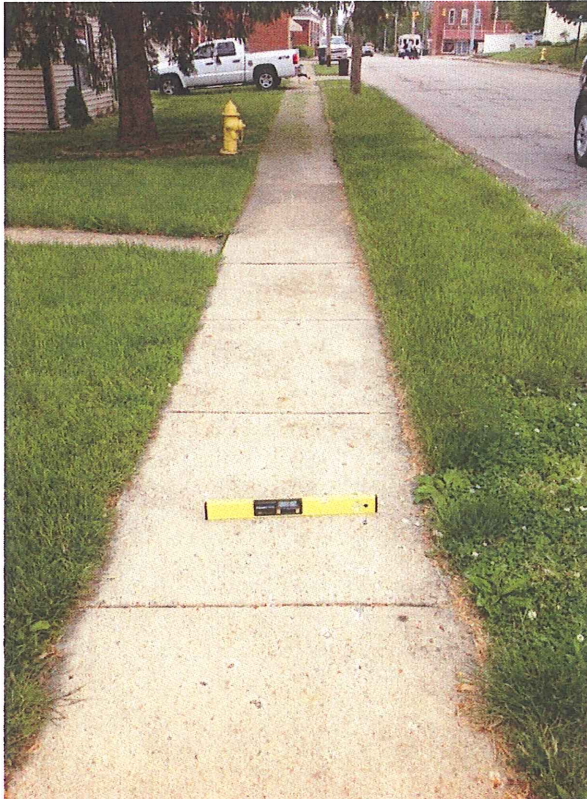
Lodge to church

Sidewalk Cross Slope	less than 2%
Sidewalk Running Slope	0.4
Sidewalk Width Without Curb Feet	4
Sidewalk Width Without Curb Inch	0
Comments	Badly cracked areas and curb up 6" above walk

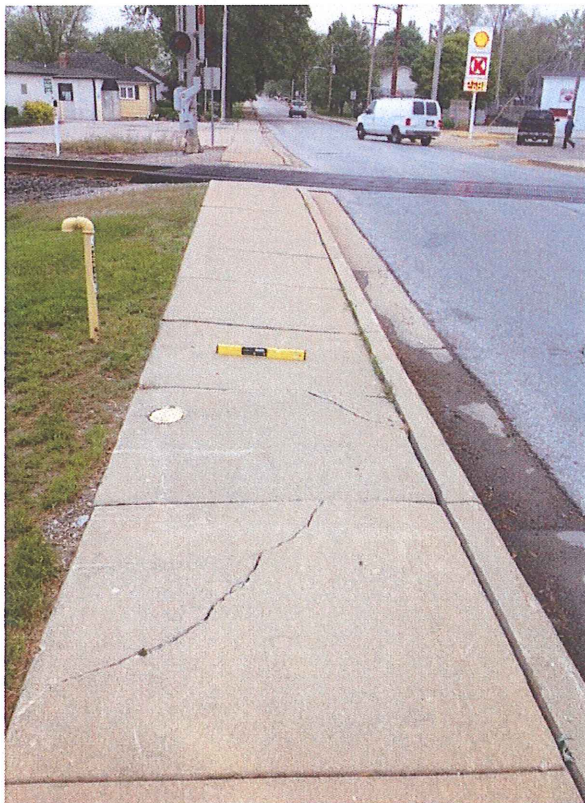
Sidewalk Cross Slope	greater than 3%
Sidewalk Running Slope	1.4
Sidewalk Vertical Discontinuities	Yes
Sidewalk Width Without Curb Feet	5
Sidewalk Width Without Curb Inch	0
Comments	1" trip hazard at tracks. Both sides of street

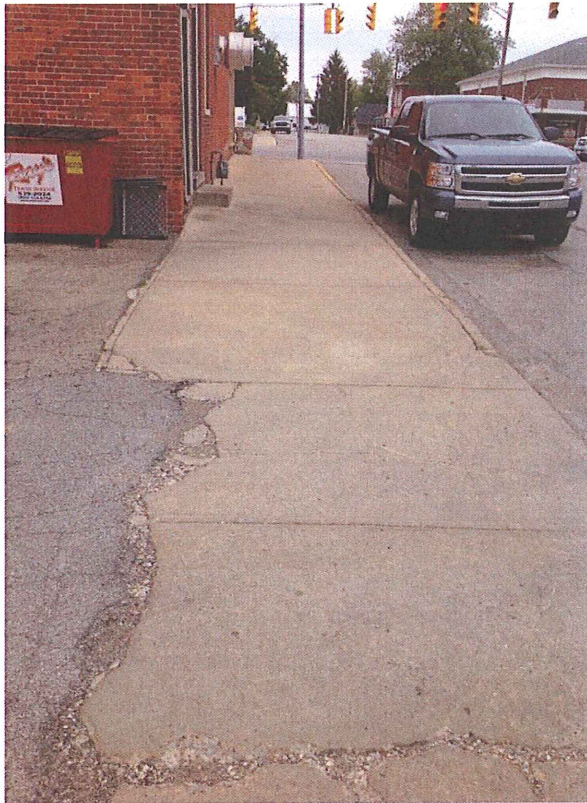
Sidewalk Cross Slope	greater than 3%
Sidewalk Running Slope	1.3
Sidewalk Width Without Curb Inch	0
Comments	Half of block is < 2%. Badly cracked in areas

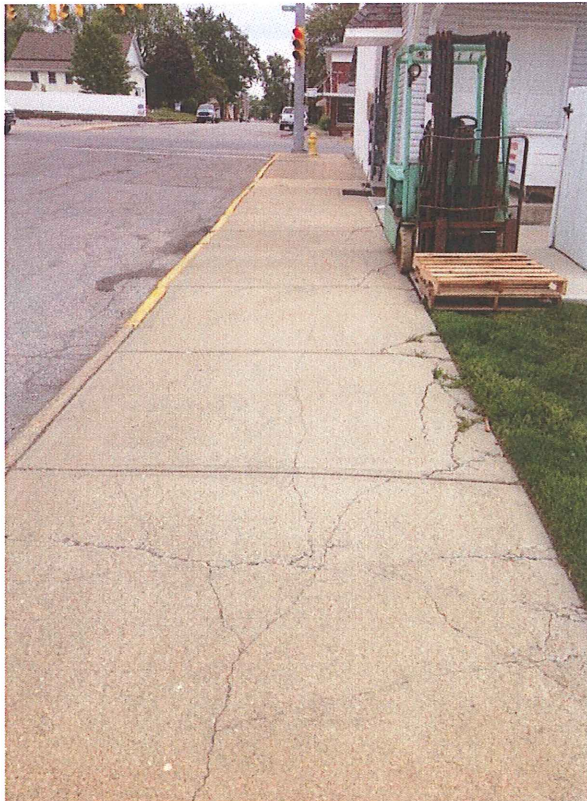
Sidewalk Cross Slope	less than 2%
Sidewalk Running Slope	1.4
Sidewalk Width Without Curb Feet	7
Sidewalk Width Without Curb Inch	6
Comments	Few cracked areas

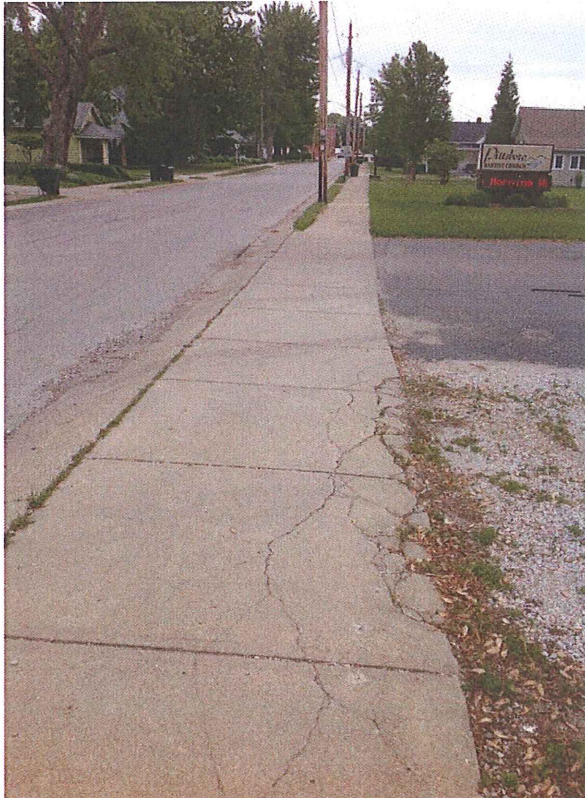
Woodridge to Olsen st

Sidewalk Cross Slope	less than 2%
Sidewalk Running Slope	0.8
Sidewalk Passing Space	Yes
Sidewalk Vertical Discontinuities	Yes
Sidewalk Width Without Curb Feet	4
Sidewalk Width Without Curb Inch	0
Comments	< 100' cracked and 2-3% x slope. Width 4 to 5'. 2 raised panels 3/4"

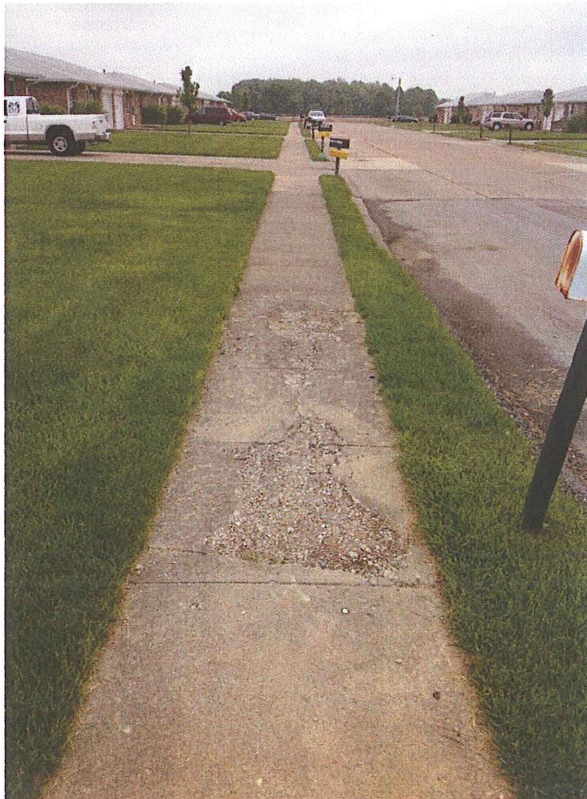
South of Noyes

Sidewalk Cross Slope	less than 2%
Sidewalk Running Slope	0.3
Sidewalk Width Without Curb Feet	4
Sidewalk Width Without Curb Inch	0
Comments	40' spalled. Rest of block good condition

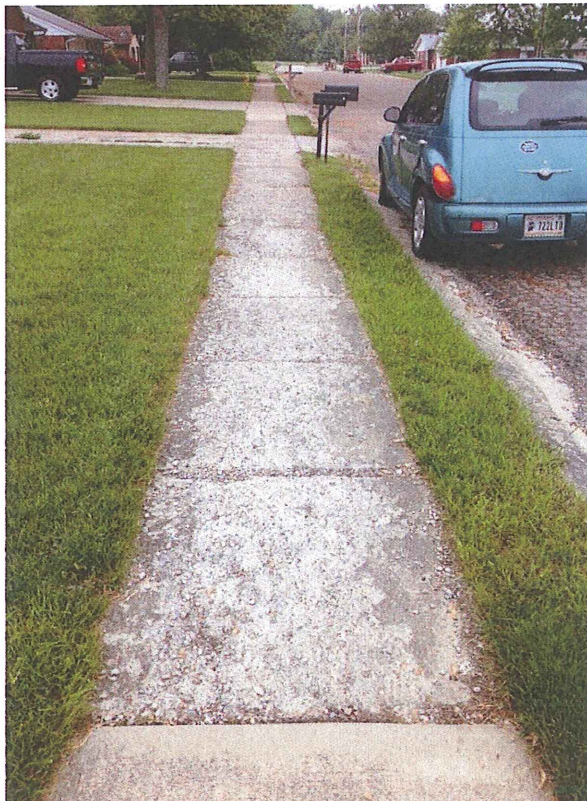
South of Noyes

Sidewalk Cross Slope	less than 2%
Sidewalk Running Slope	0.2
Sidewalk Width Without Curb Feet	4
Sidewalk Width Without Curb Inch	0
Comments	80' spalled badly

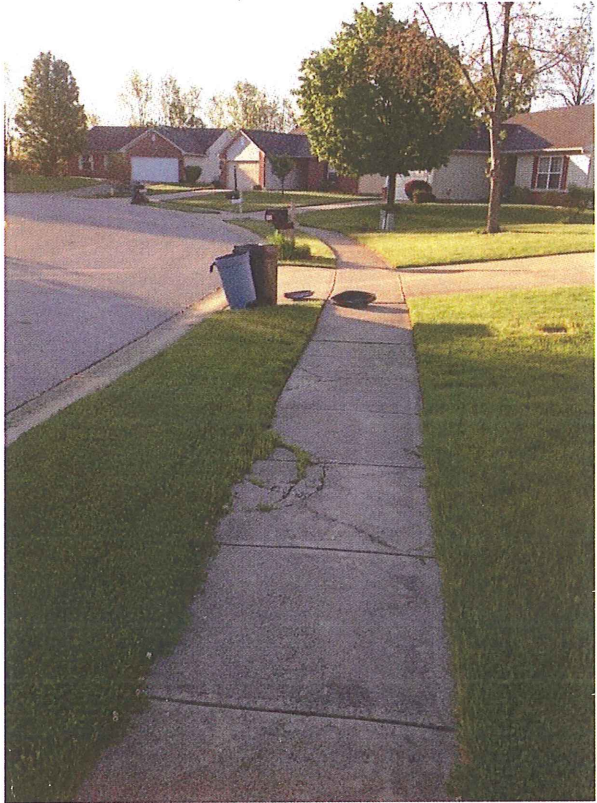
Sidewalk Obstructions	No
Sidewalk Status	Active
Sidewalk Cross Slope	greater than 3%
Sidewalk Running Slope	0.5
Sidewalk Passing Space	No
Sidewalk Surface Discontinuities	No
Sidewalk Vertical Discontinuities	No
Sidewalk Accessibility Obstacles	No
Paving Obstructions (greater than 1/2")	No
Sidewalk Width Without Curb Feet	4
Sidewalk Width Without Curb Inch	0
Comments	5 cracked panels Both sides of street
