CITY OF PITTSBORO, INDIANA

CURB RAMP INVENTORY

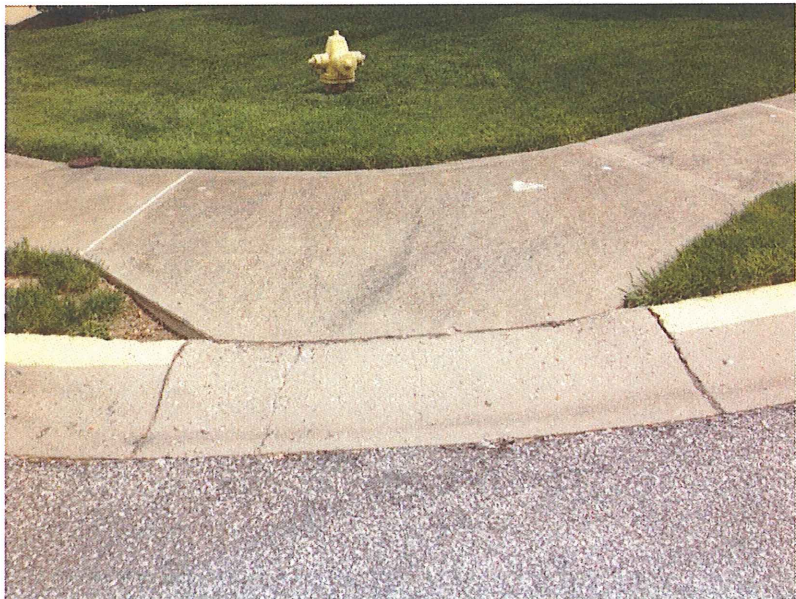
Photo of Curb

Quail Creek Tr. and Quail Creek Tr. South , SE

Landing	No
Curb Ramp Width Feet	5
Running Slope	3.3
Cross Slope	2

Truncated Domes	No
Comments	Asphalt lip 1" at gutter

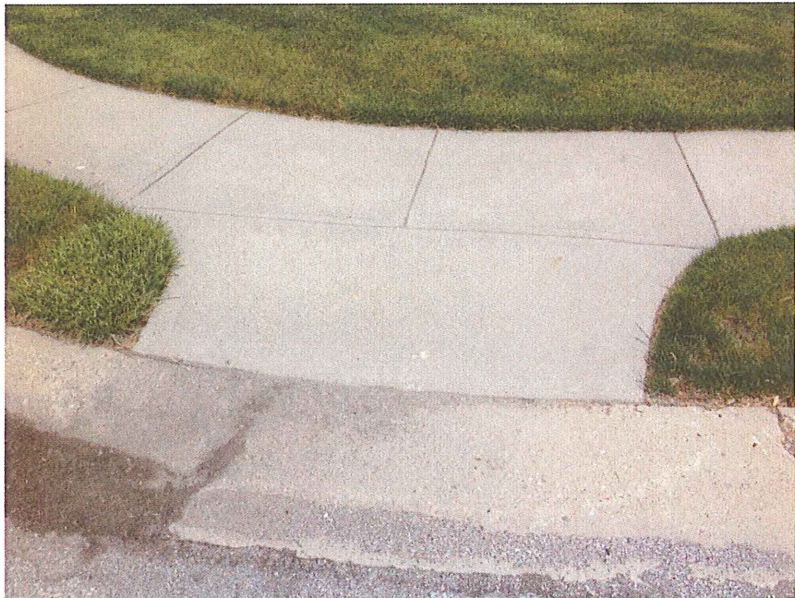
Quail Creek Tr. and Quail Creek Tr. South , NE

Landing	Yes
Curb Ramp Width Feet	5
Running Slope	7
Cross Slope	0.9

Truncated Domes	No
Comments	1" lip at rolled curb

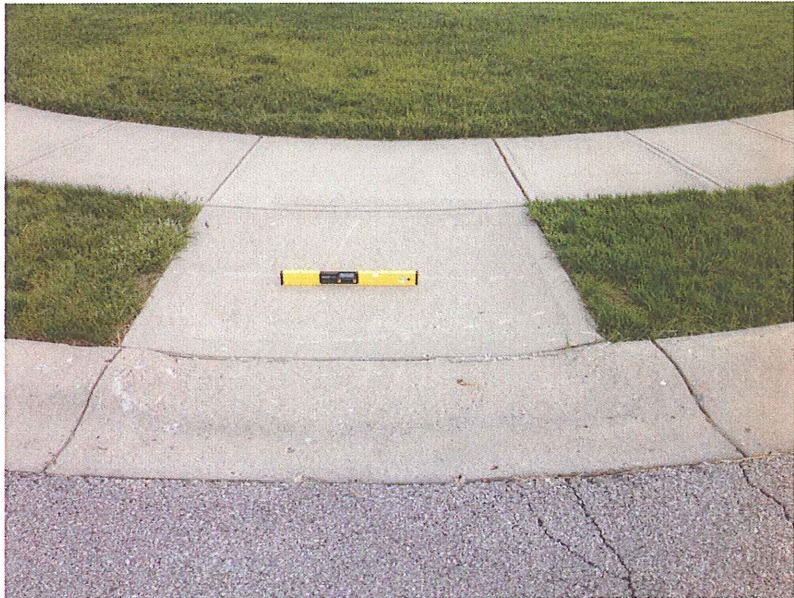
Quail Creek Tr. and Quail Creek Tr. North, SE

Landing	Yes
Curb Ramp Width Feet	6
Running Slope	5.2
Cross Slope	0.4

Truncated Domes	No
Comments	2" rolled curb

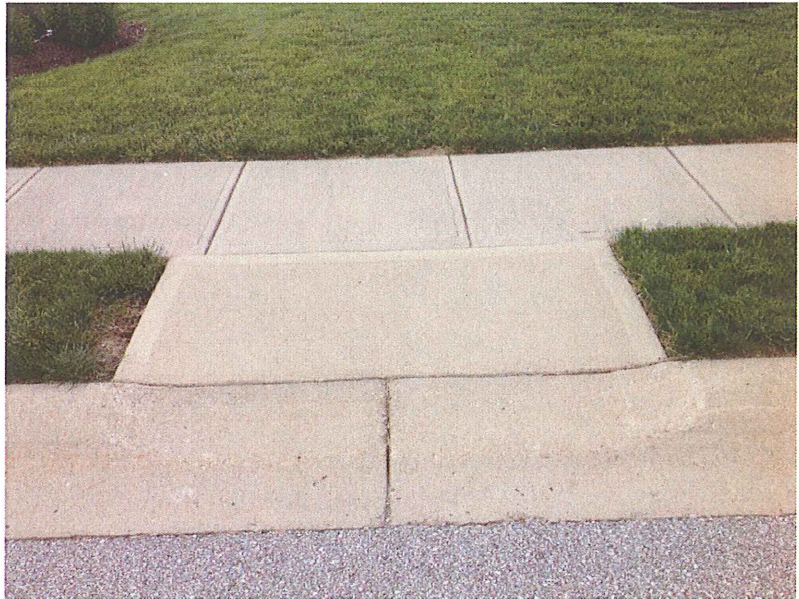
Photo of Curb

Quail Creek Tr. and Quail Creek Tr. North , SW

Landing	Yes
Curb Ramp Width Feet	6
Curb Ramp Width Inch	6
Running Slope	6.4
Cross Slope	0.2

Truncated Domes	No
Comments	2" rolled curb

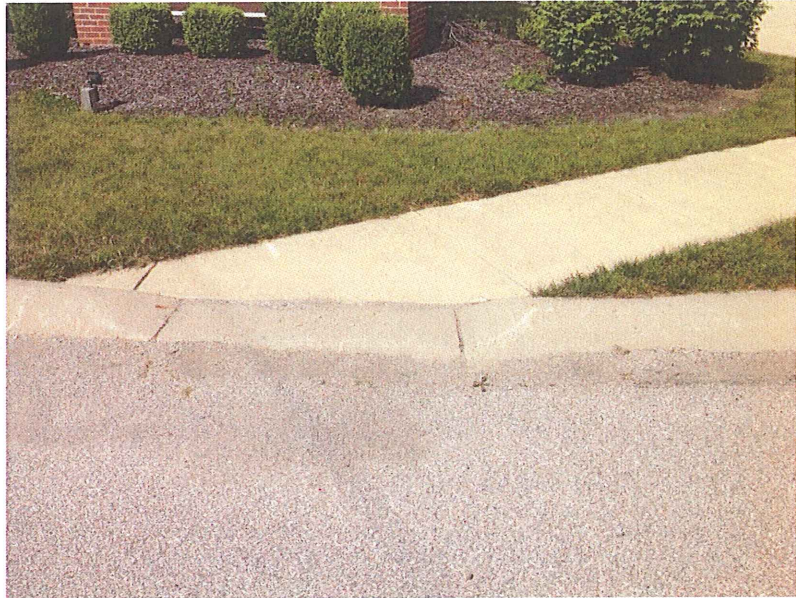
Photo of Curb

Penny In. And 401 East, NE

Curb Ramp Width Feet	4
Running Slope	3.2
Cross Slope	4.6

Truncated Domes	No
Comments	No ramps on any other corners

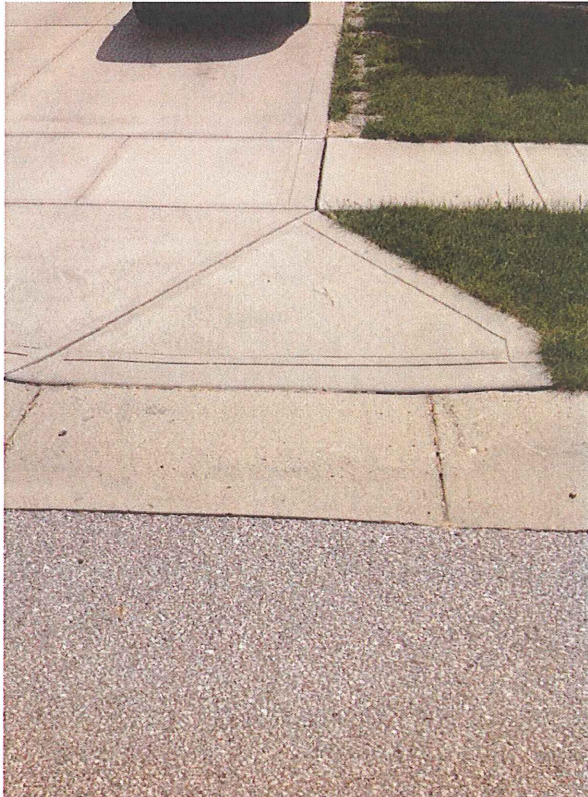
Penny Lane and Blue Jay way, S

Landing	No
Curb Ramp Width Feet	4
Running Slope	7.8
Cross Slope	1.2

Truncated Domes	No
Comments	Combined in driveway

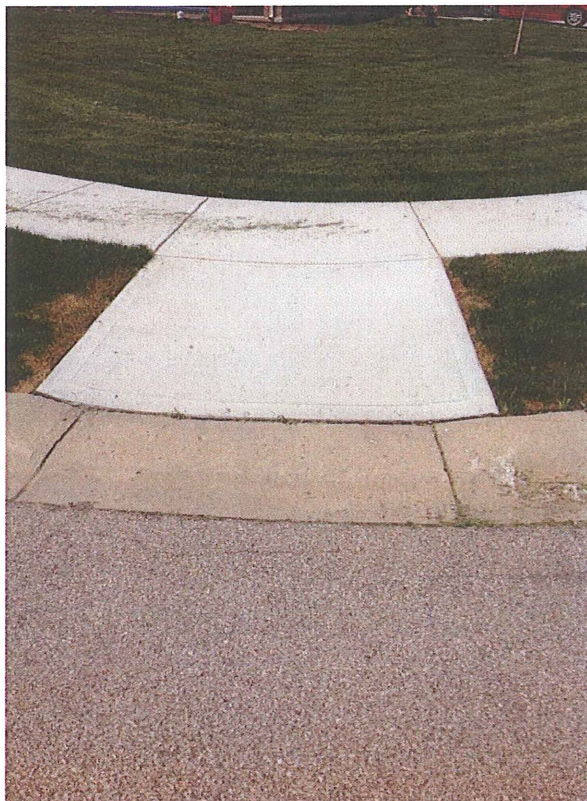
Penny Lane and Blue Jay way, NW

Landing	Yes
Curb Ramp Width Feet	6
Running Slope	6.8
Cross Slope	0.9

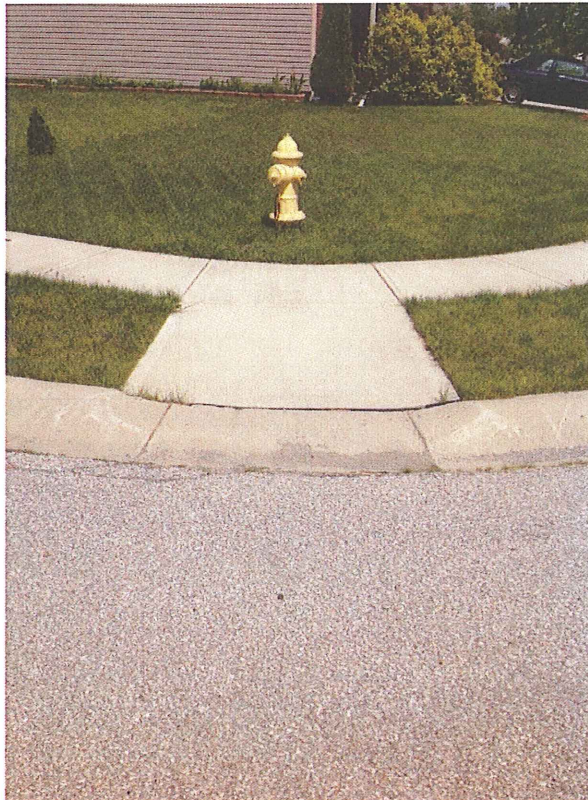
Penny Lane and Blue Jay way, NE

Landing	Yes
Curb Ramp Width Feet	5
Curb Ramp Width Inch	6
Running Slope	2.8
Cross Slope	0.4

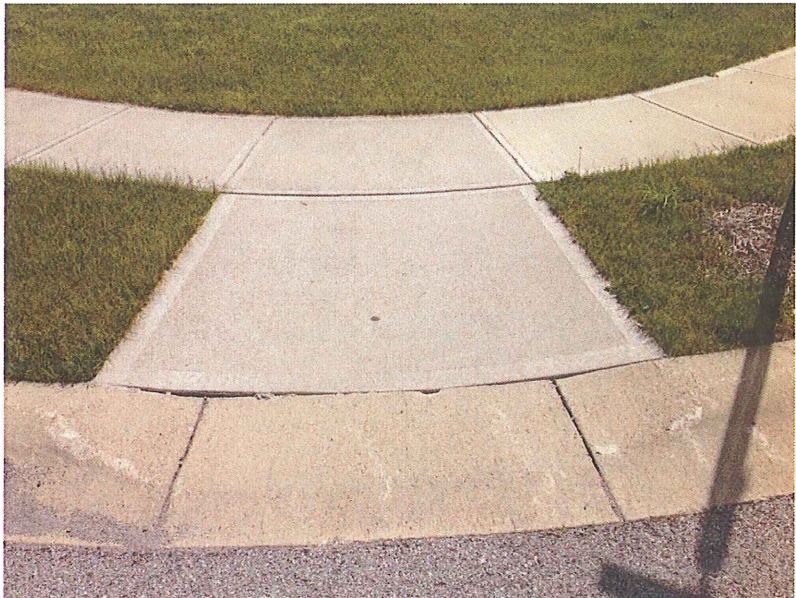
Photo of Curb

Penny Lane and Abbey rd, SW

Landing	Yes
Curb Ramp Width Feet	5
Curb Ramp Width Inch	4
Running Slope	5.1
Cross Slope	0.9

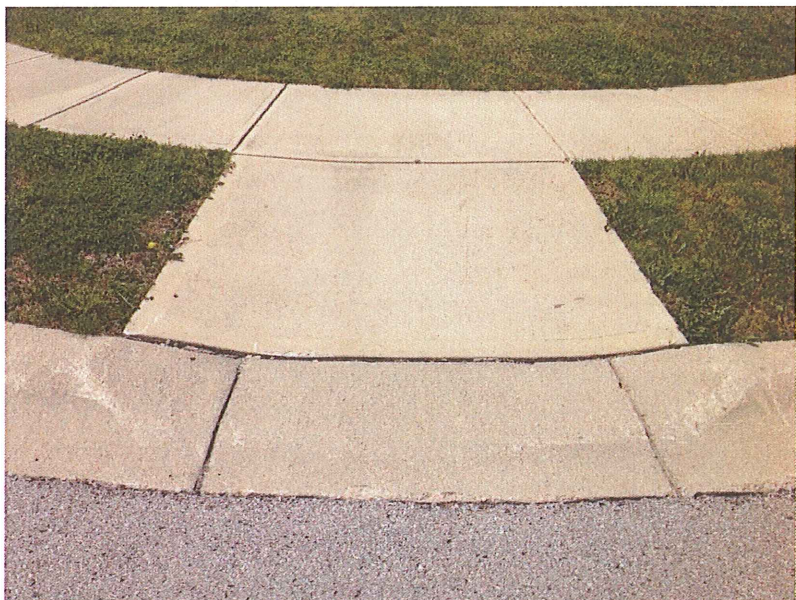
Photo of Curb

Penny Lane and Abbey Rd, NW

Landing	Yes
Curb Ramp Width Feet	6
Running Slope	5.5
Cross Slope	0.2

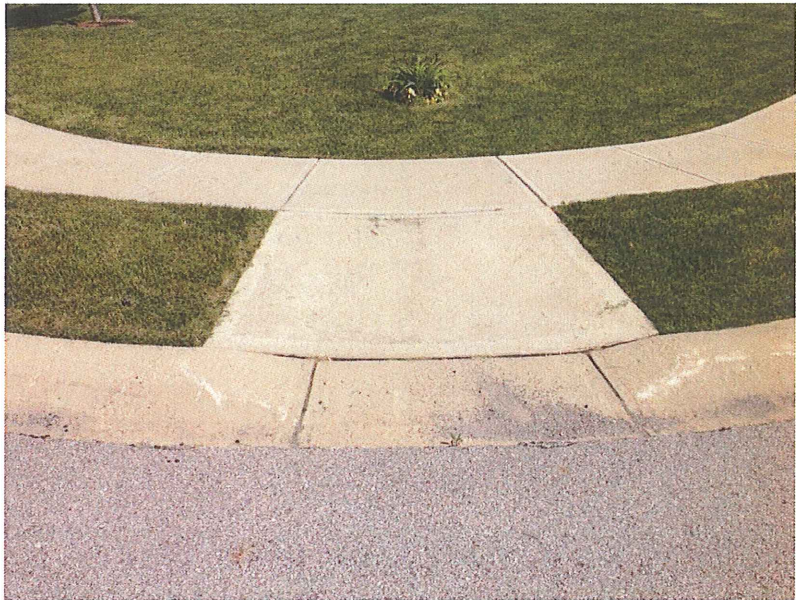
Photo of Curb

Penny Lane and Abbey Rd, SE

Landing	Yes
Curb Ramp Width Feet	5
Curb Ramp Width Inch	8
Running Slope	5.6
Cross Slope	0.1

Truncated Domes	No
Comments	3/4" gap at gutter

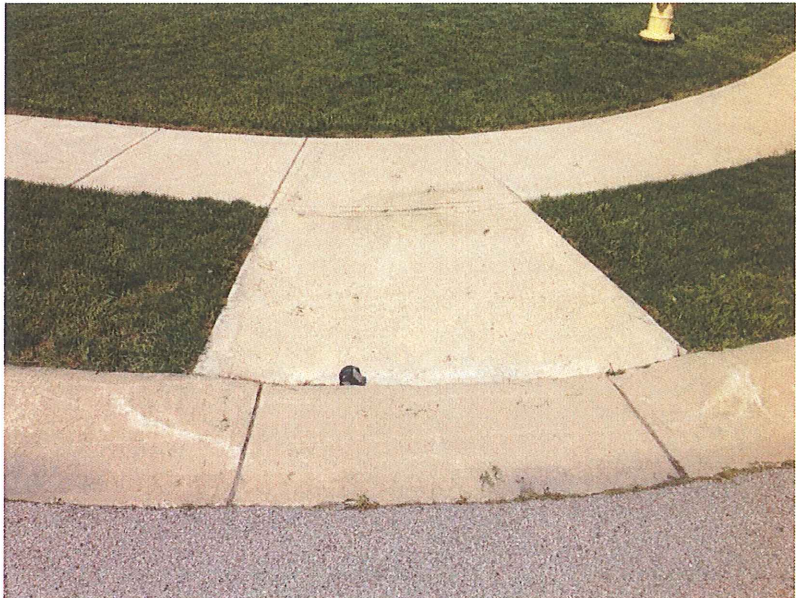
Photo of Curb

Penny Lane and Abbey Rd, NE

Landing	Yes
Curb Ramp Width Feet	5
Running Slope	5.7
Cross Slope	0.4

Truncated Domes	No
Comments	Ramp settlement 1"

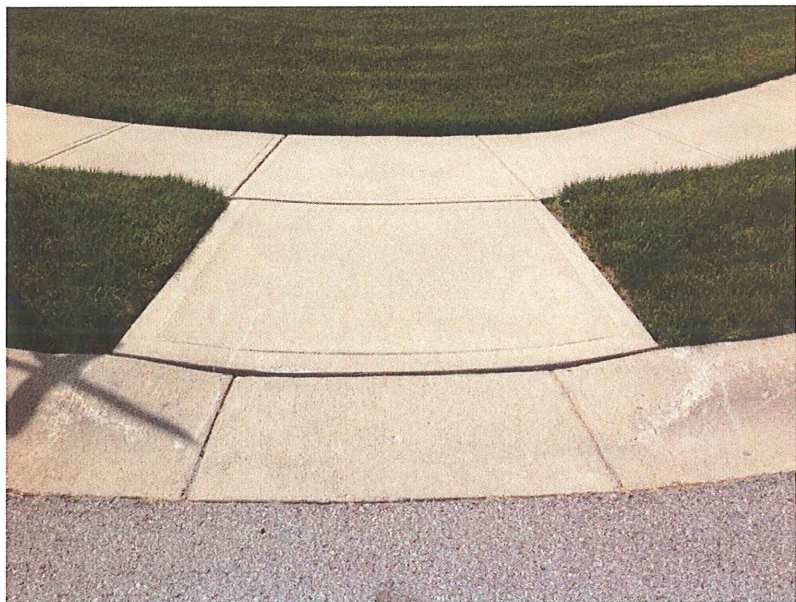
Photo of Curb

Abbey rd and Roundabout Circle, SW

Landing	Yes
Curb Ramp Width Feet	5
Curb Ramp Width Inch	6
Running Slope	4
Cross Slope	0.6

Truncated Domes	No
Comments	3/4" gap at gutter

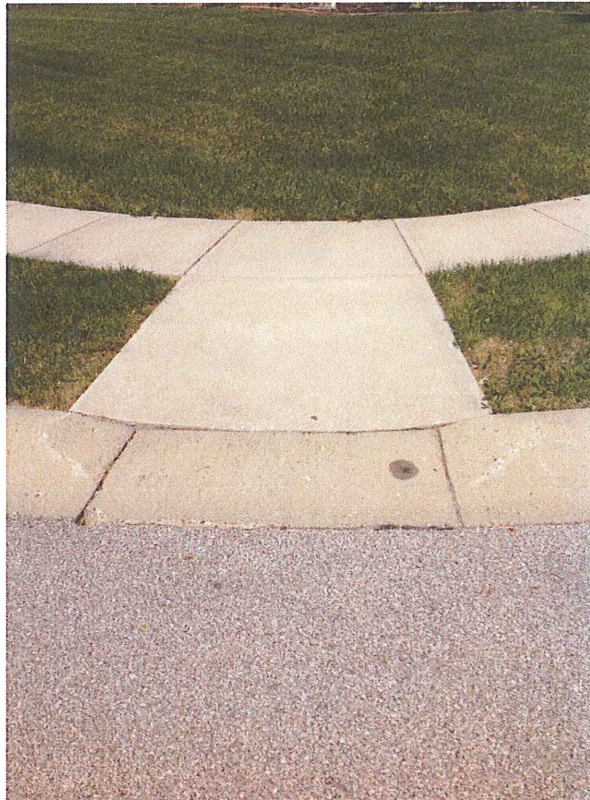
Squire and Blue Jay way, NE

Landing	Yes
Curb Ramp Width Feet	4
Curb Ramp Width Inch	8
Running Slope	7.3
Cross Slope	3

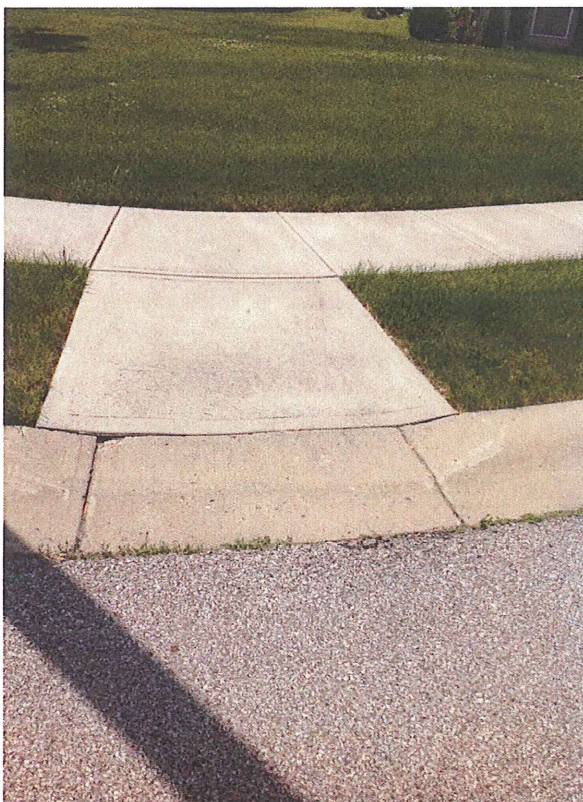
Squire and Blue Jay way, NW

Landing	Yes
Curb Ramp Width Feet	4
Curb Ramp Width Inch	8
Running Slope	3
Cross Slope	1.9

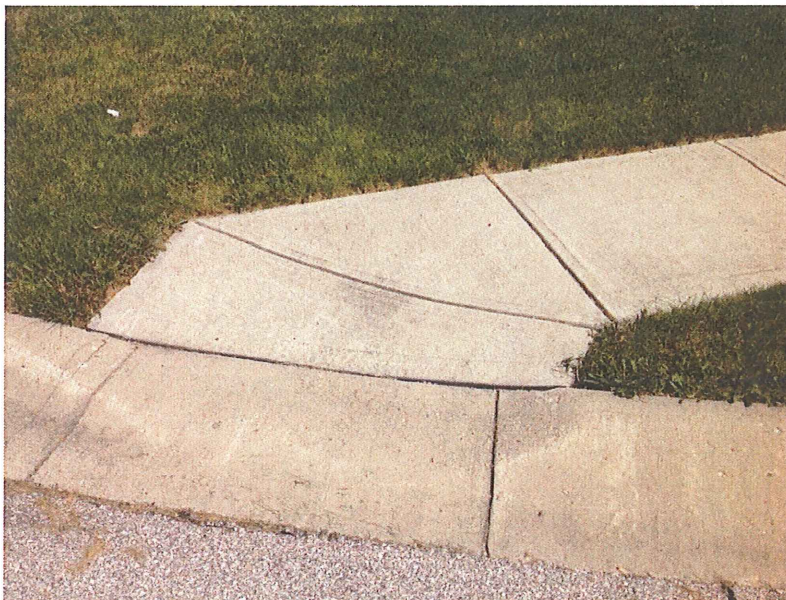
Squire and 401 E, SE

Landing	No
Curb Ramp Width Feet	5
Curb Ramp Width Inch	6
Running Slope	7.2
Cross Slope	0.5

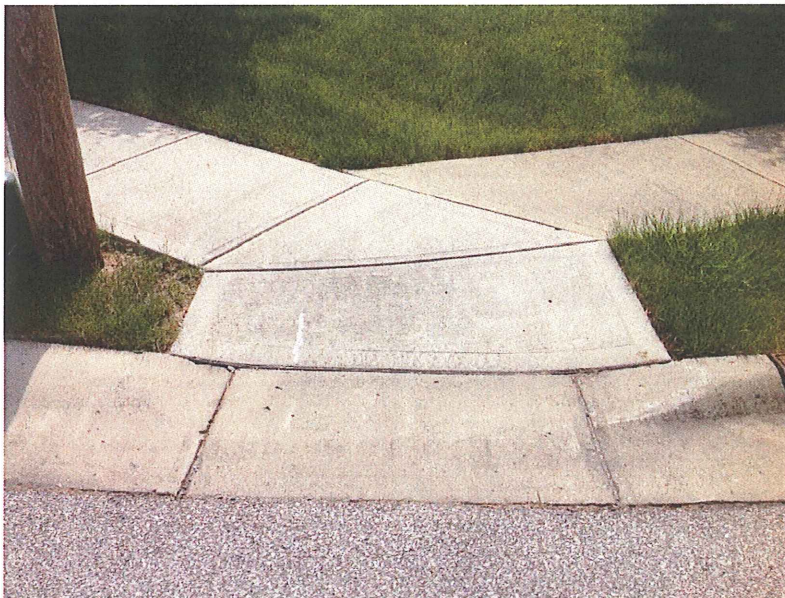
Squire and 401 e, SW

Landing	No
Curb Ramp Width Feet	6
Running Slope	9.6
Cross Slope	0.2

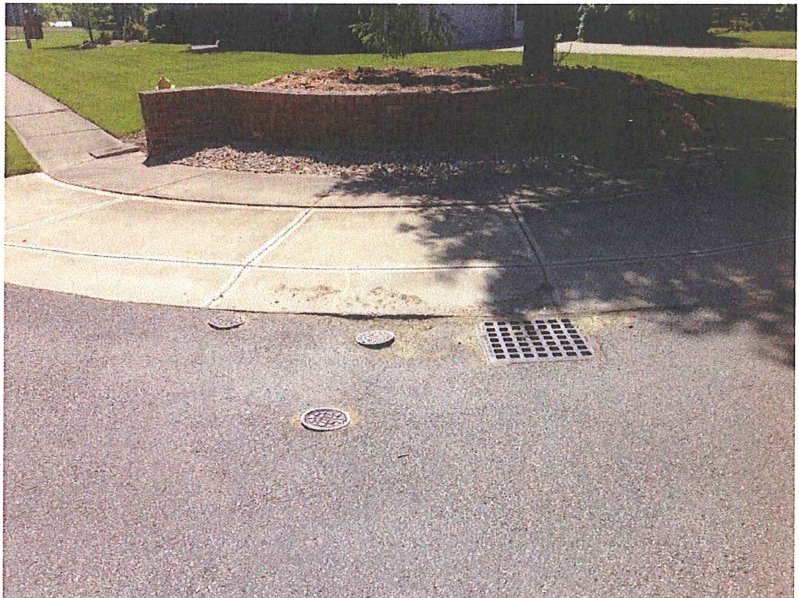
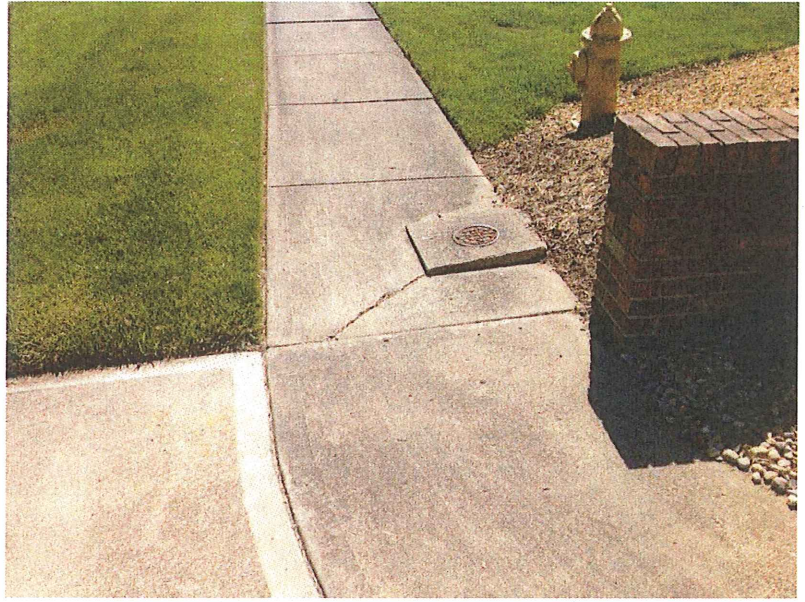
Photo of Curb

Woodland pl / Wall st, SE

Curb Ramp Width Feet	24
Running Slope	1.1
Cross Slope	0.4
Comments	3" rolled curb. Water valve boxes up 1-2". Casting

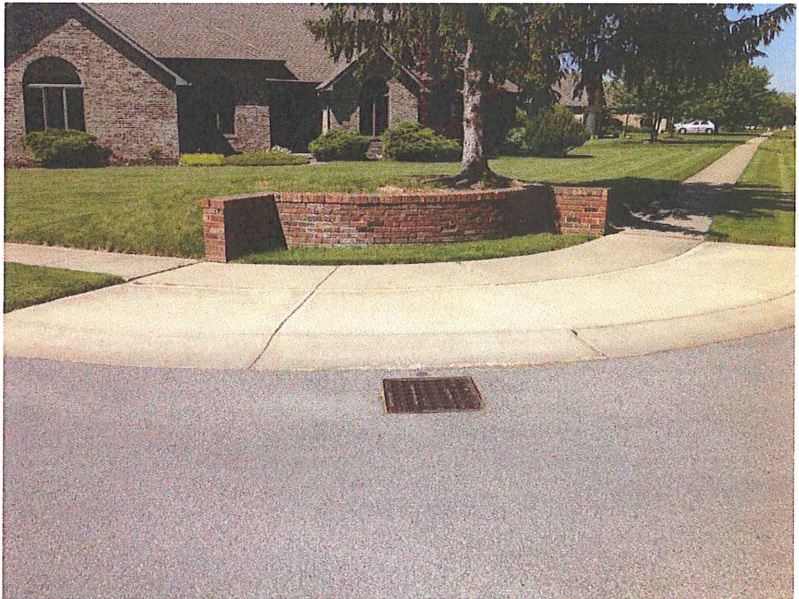
Photo of Curb

Woodland pl / Wall st, SW

Landing	Yes
Curb Ramp Width Feet	26
Running Slope	0.9
Cross Slope	0.4
Comments	3" rolled curb. Casting in x walk

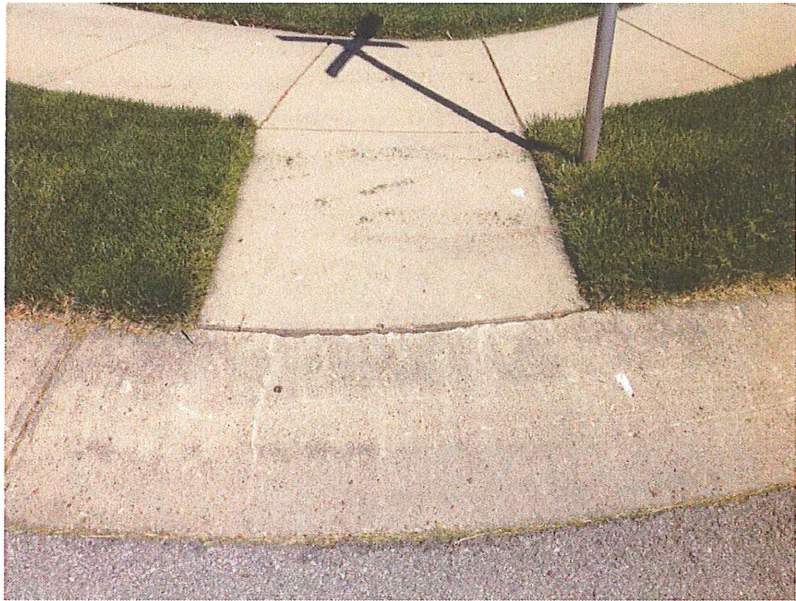
Photo of Curb

Woodland pl and Edgewood ct

Curb Ramp Width Feet	4
Running Slope	2.5
Cross Slope	1
Comments	3" rolled curb. 1" gap at gutter and at walk.

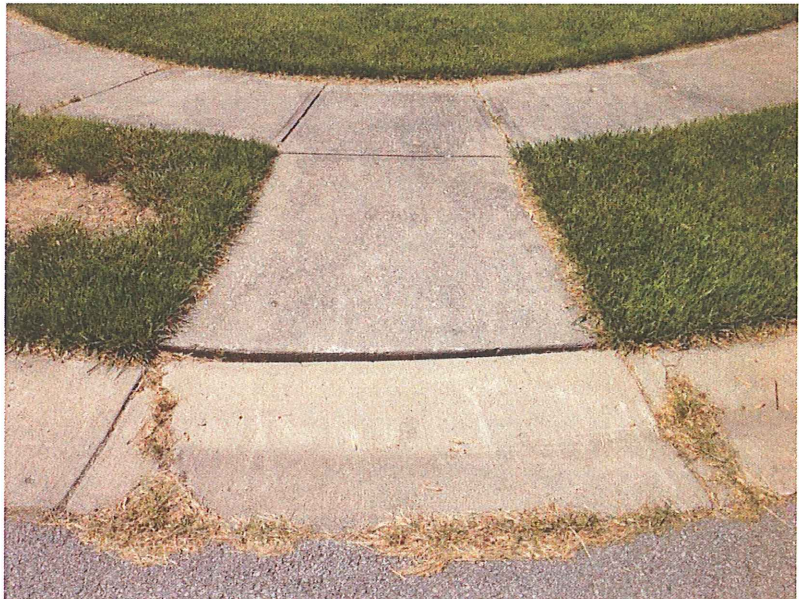
Edgewood and Woodland , SW

Landing	Yes
Curb Ramp Width Feet	4
Curb Ramp Width Inch	6
Running Slope	5.3
Cross Slope	0.9
Comments	1" gap and raised 1"

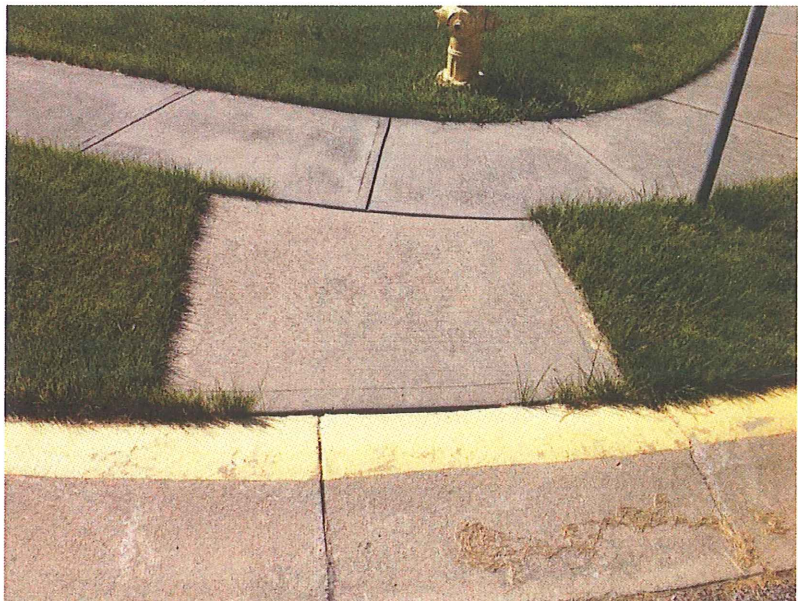
Karen dr / Woodland pl, SE

Truncated Domes	No
Comments	1" gap at gutter 3" rolled curb

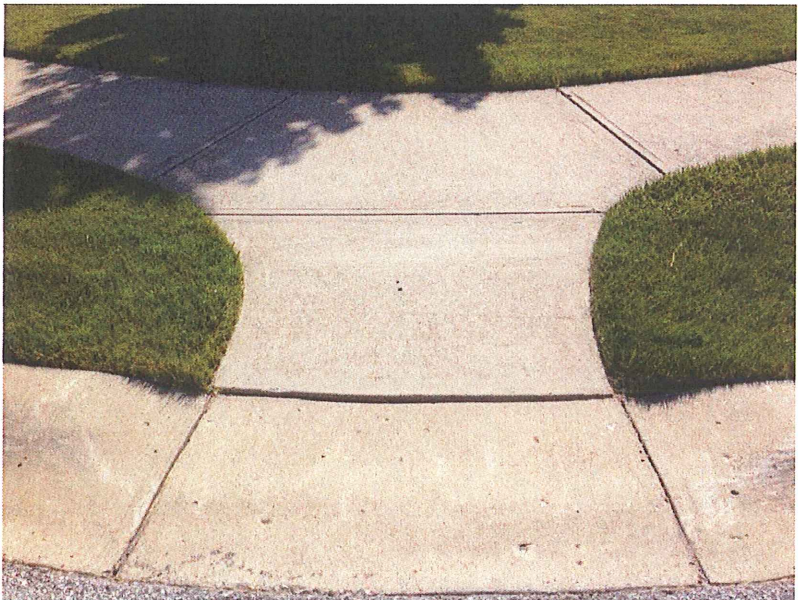
Karen dr / Karen ct, NE

Truncated Domes	No
Comments	Asphalt up 1". 3/4" gap at curb

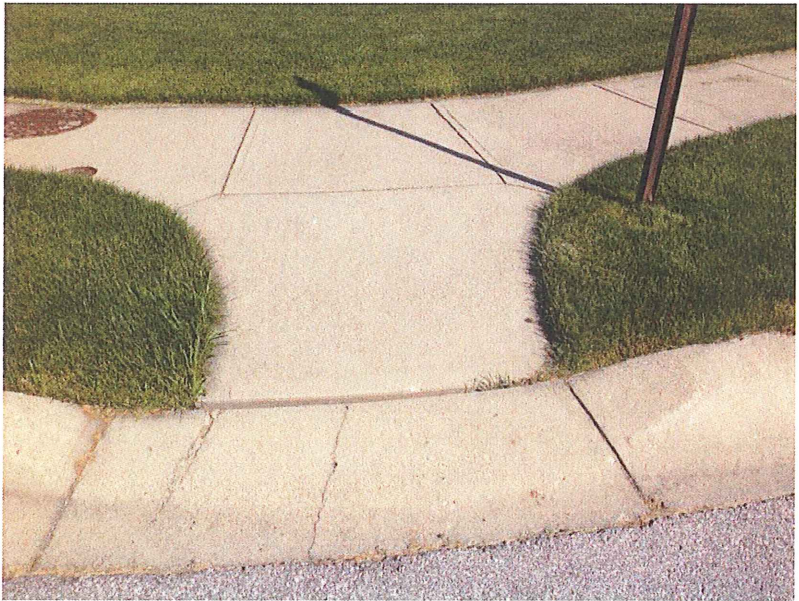
Karen dr / Karen ct, NW

Landing	Yes
Curb Ramp Width Feet	4
Curb Ramp Width Inch	2
Running Slope	4.2
Cross Slope	1.4
Comments	1.5" gap at gutter

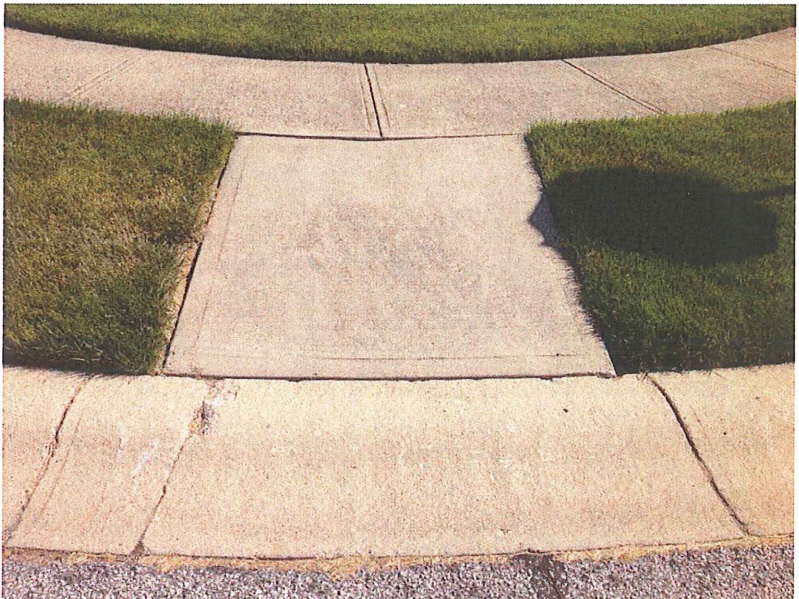
Karen dr / Woodland pl, NE

Truncated Domes	No
Comments	3/4" gap at gutter and walk. 3" rolled curb

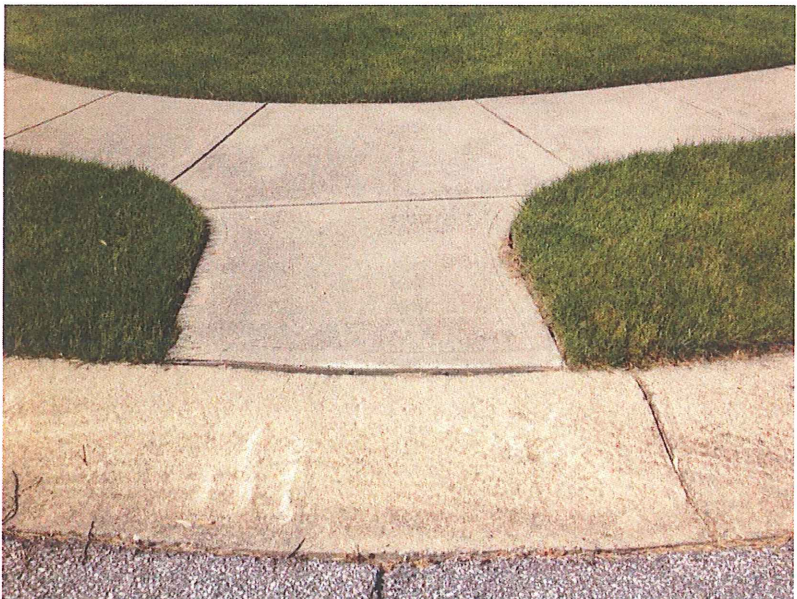
Karen dr / Terrel dr, SW

Truncated Domes	No
Comments	3" rolled curb. 3/4" gap

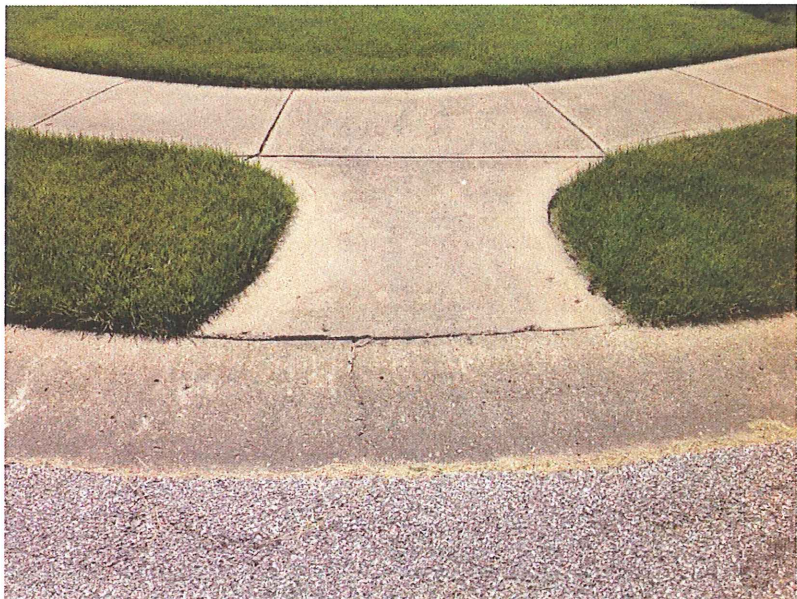
Karen dr / Deer Trace , SE

Truncated Domes	No
Comments	3" rolled curb

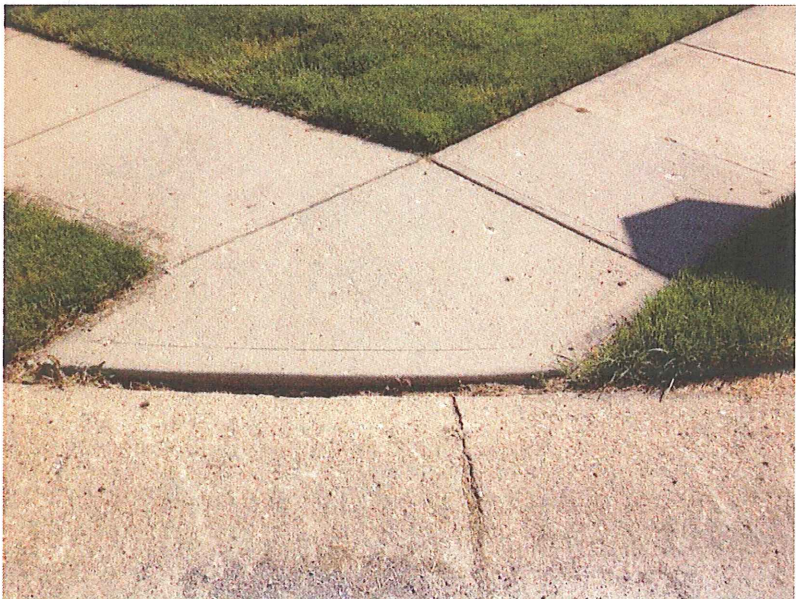
Karen dr / Deer Trace ct, NE

Truncated Domes	No
Comments	2" gap. 3" rolled curb

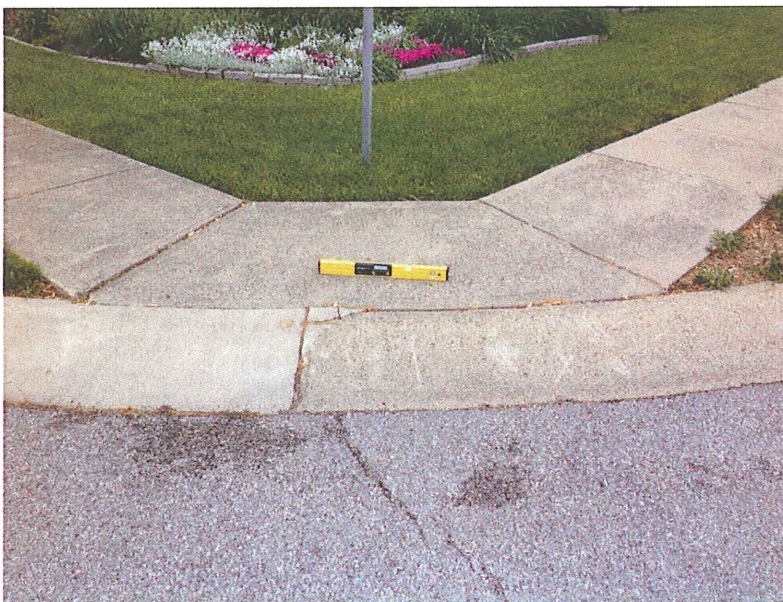
Karen and Meadows dr, NW

Comments	3" rolled curb. 1" gap at gutter
----------	----------------------------------

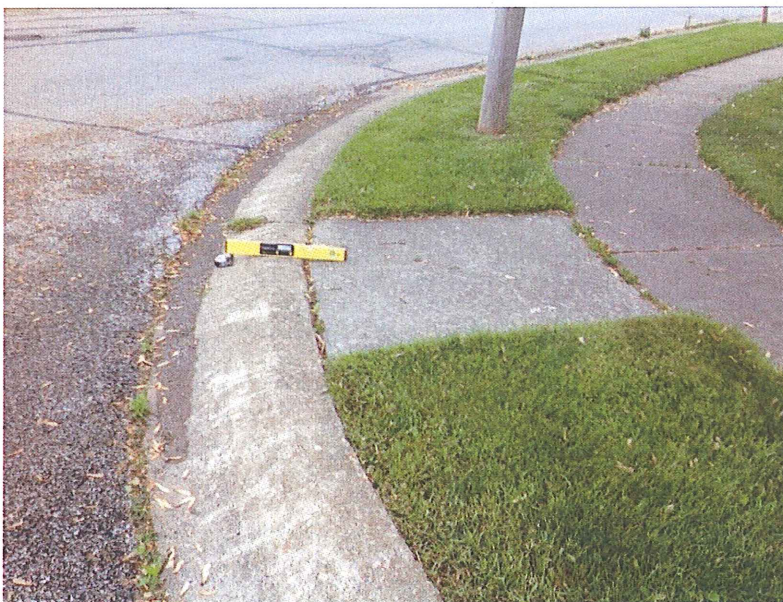
Karen and Meadows dr, SW

Comments	1" gap at gutter. 3" rolled curb
----------	----------------------------------

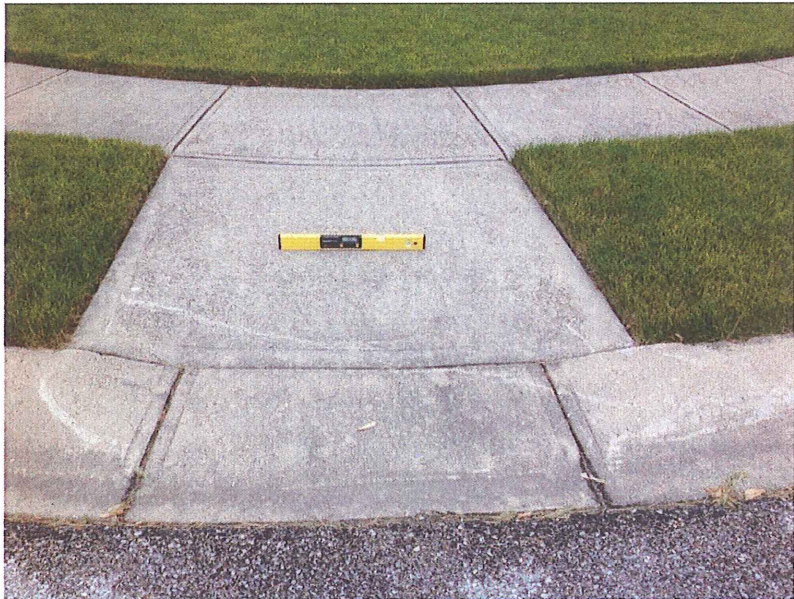
Meadows ct and meadows dr, NW

Curb Ramp Width Feet	5
Curb Ramp Width Inch	8
Running Slope	6.4
Cross Slope	1.1

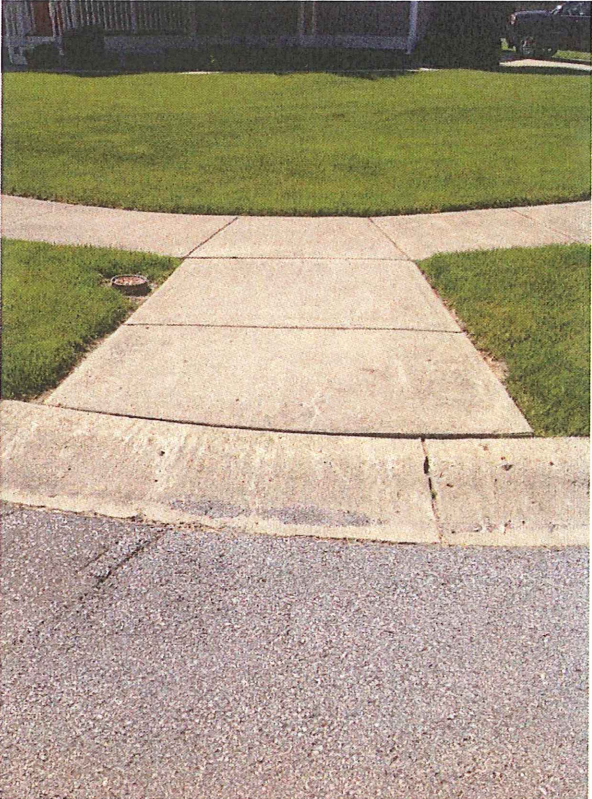
Karen dr / Fawn ct, SE

Truncated Domes	No
Comments	1" gap. 3" rolled curb

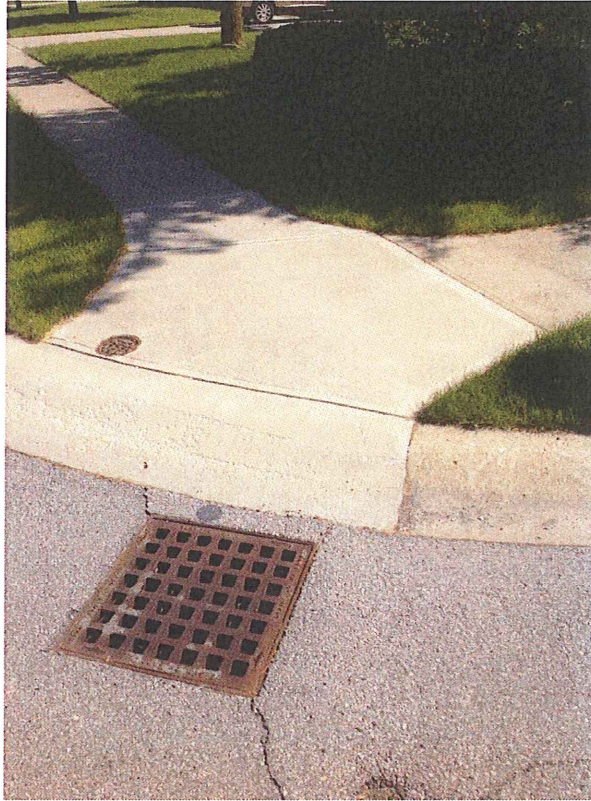
Karen dr / Fawn ct, NE

Truncated Domes	No
Comments	3" rolled curb. Casting w 2" openings

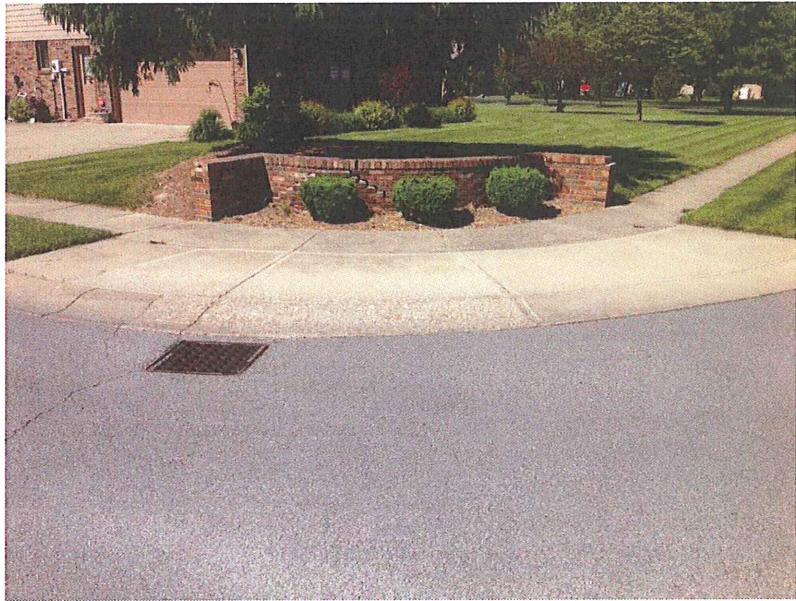
Karen dr / Wall st, SW

Curb Ramp Width Feet	18
Running Slope	0.3
Cross Slope	0.6
Comments	Casting in x walk

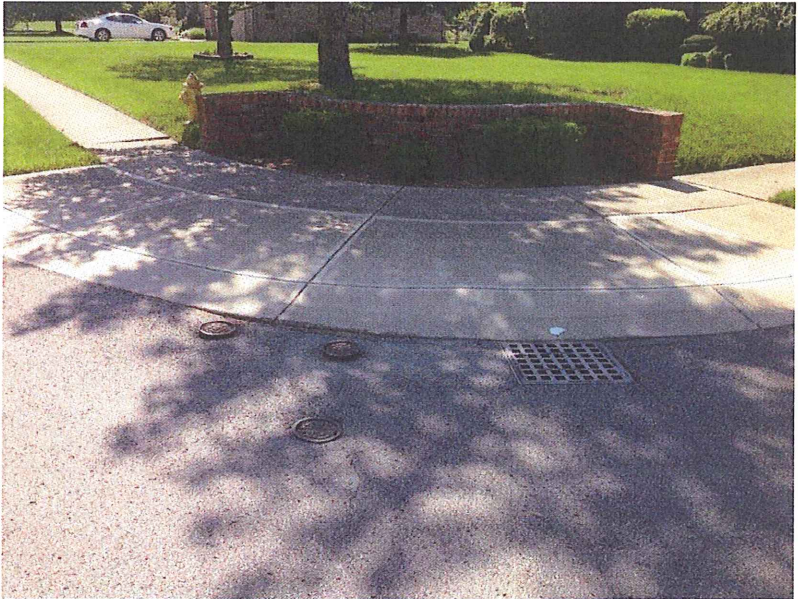
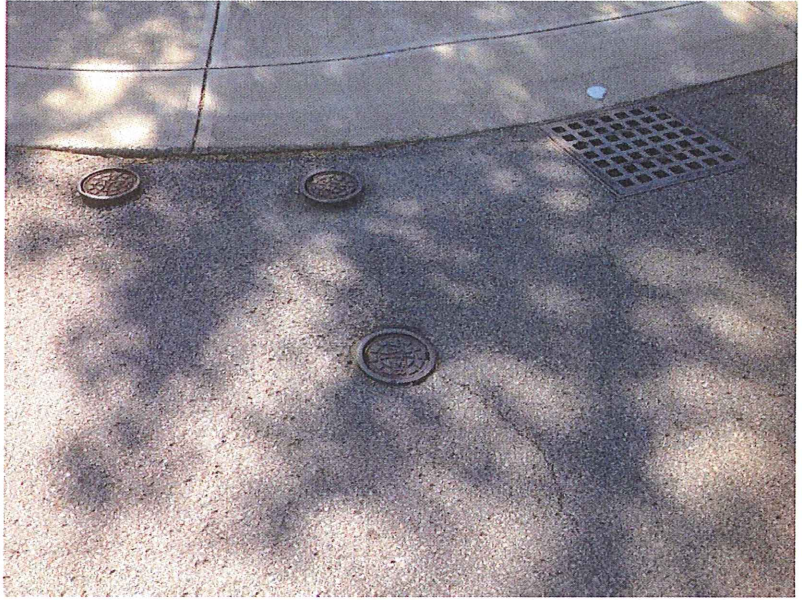
Karen dr / Wall st, SE

Landing	Yes
Curb Ramp Width Feet	18
Running Slope	0.1
Cross Slope	0.6
Comments	3" rolled curb. Water valves up 1" and casting in x walk

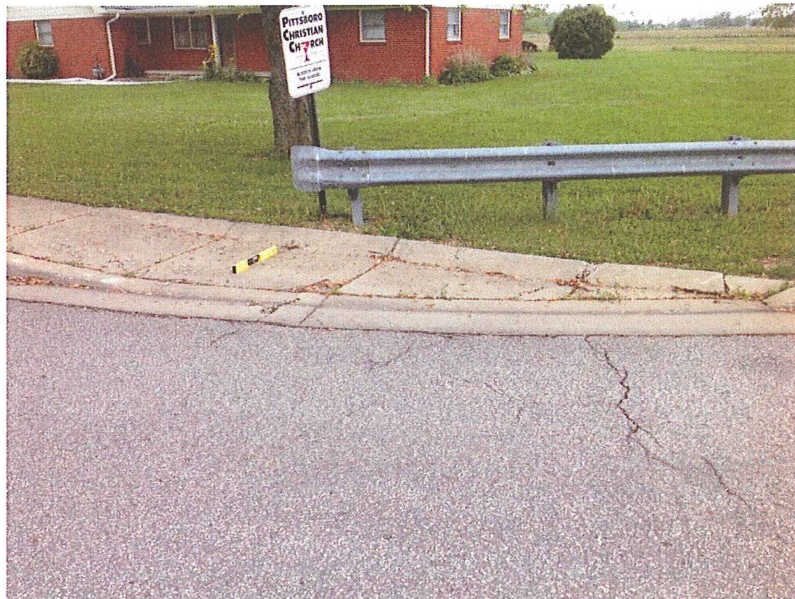
Photo of Curb

Truncated Domes	No
Comments	Cracked

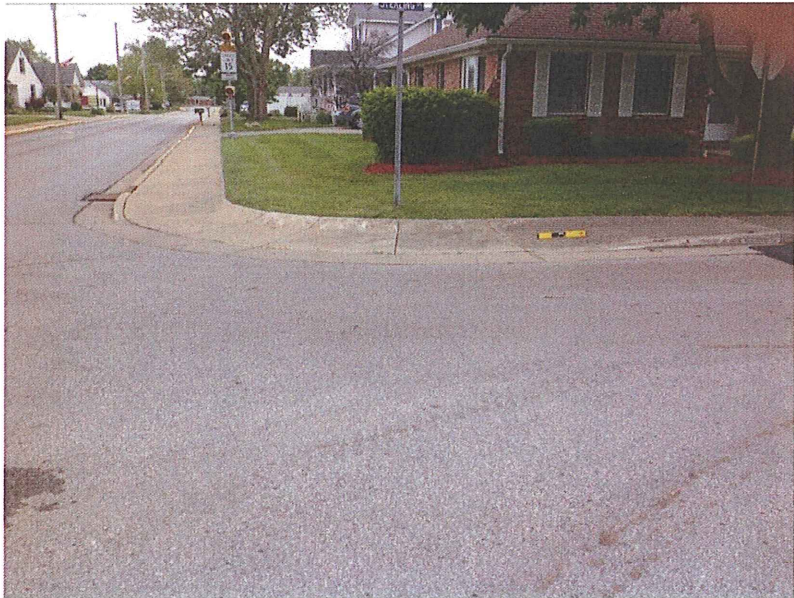
Sterling and Meridian , SW

Curb Ramp Width Feet	4
Running Slope	2

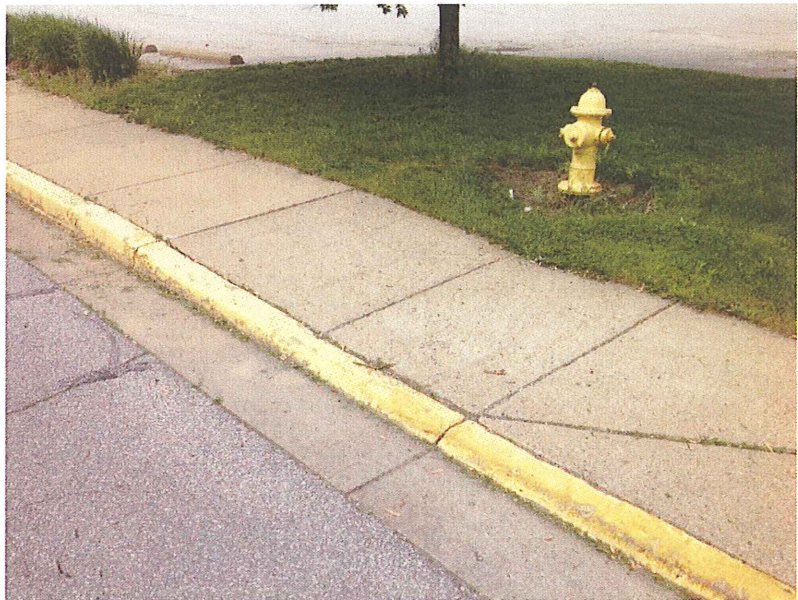
Truncated Domes	No
-----------------	----

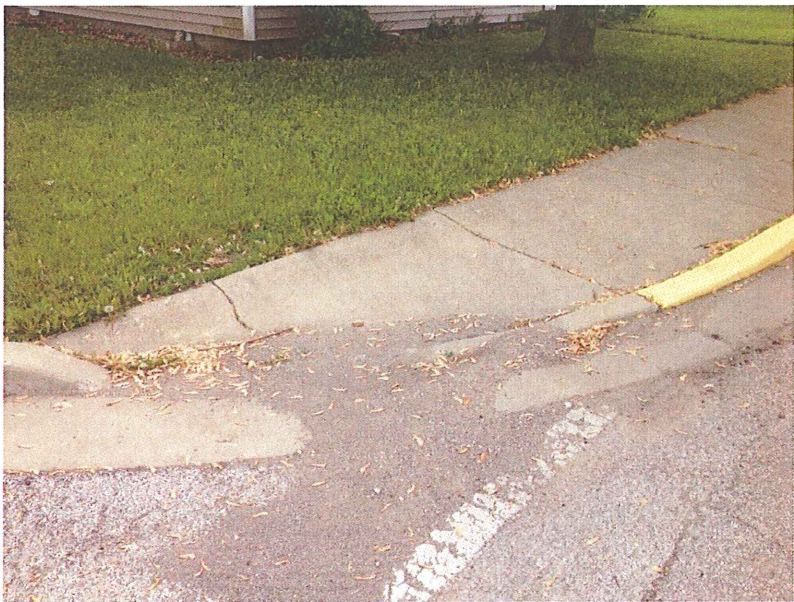
Meridian and lodge, SE

Intersection	Meridian and lodge
Corner	SE
Date	2015-05-14
Surveyor	Jack
Type of Curb Ramp	Blended

Landing	Yes
Curb Ramp Width Feet	5
Running Slope	7.8
Cross Slope	8.9

Truncated Domes	No
Comments	Curb 1" above ramp

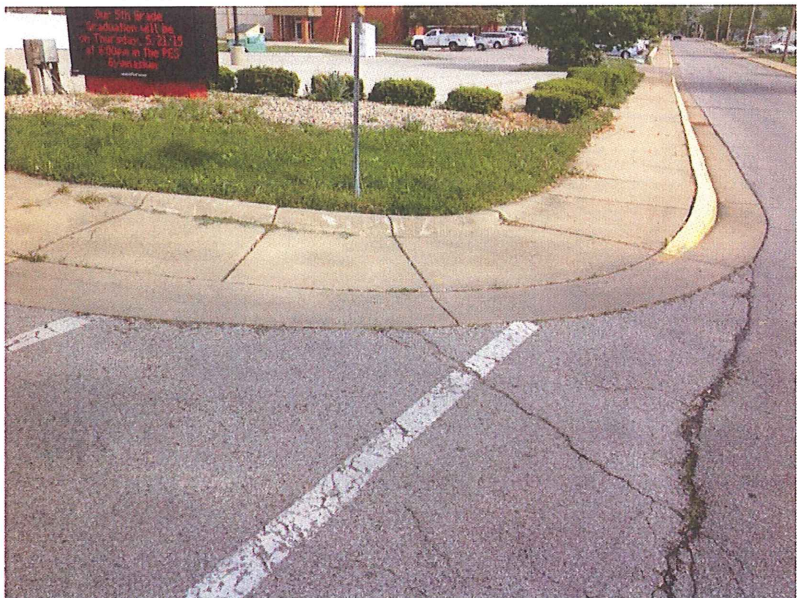
Osborn and meridian, NW

Intersection	Osborn and meridian
Corner	NW
Date	2015-05-14
Surveyor	Jack
Type of Curb Ramp	Blended

Landing	Yes
Slip Resistant	No
Curb Ramp Width Feet	4
Curb Ramp Width Inch	4
Running Slope	5.7
Cross Slope	2.8

Truncated Domes	No
Comments	Center slope 2.0

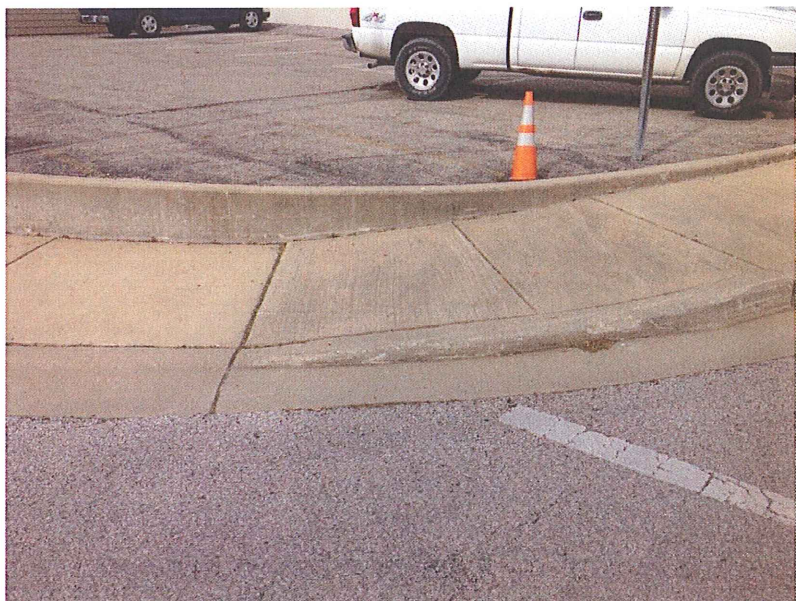
Osborne and meridian , SW

Intersection	Osborne and meridian
Corner	SW
Date	2015-05-14
Surveyor	Jack
Type of Curb Ramp	Blended

Landing	Yes
Slip Resistant	Yes
Curb Ramp Width Feet	5
Running Slope	9.699999999999999
Cross Slope	5.4

Truncated Domes	No
-----------------	----

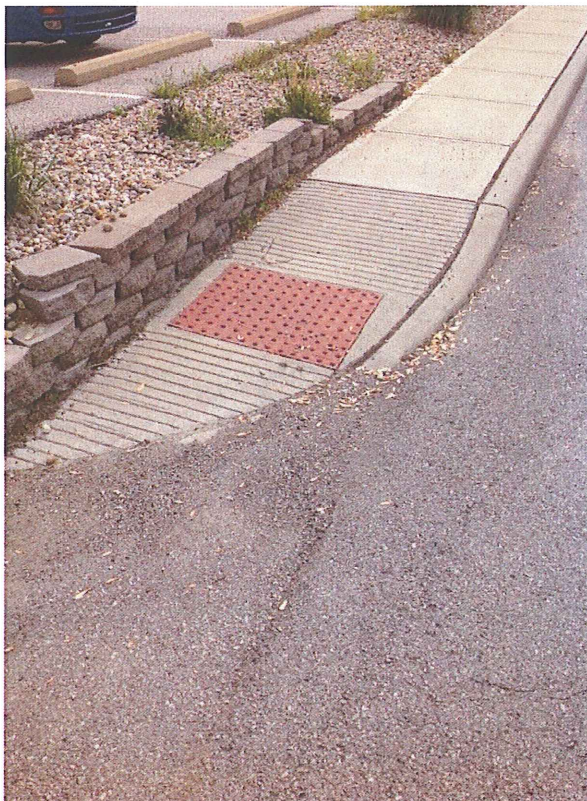
Osborne and north lot, NE

Landing	Yes
Slip Resistant	Yes
Curb Ramp Width Feet	3
Curb Ramp Width Inch	6
Running Slope	8.1
Cross Slope	6.3

Truncated Domes	Yes
-----------------	-----

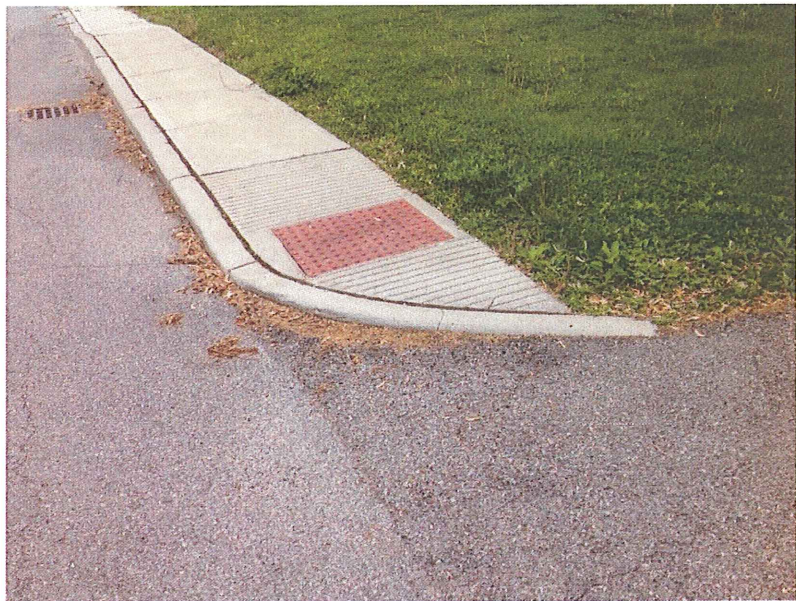
Osborne and McCord, SE

Intersection	Osborne and McCord
Corner	SE
Date	2015-07-14
Surveyor	Jack
Type of Curb Ramp	Blended
Nearby Facilities (Check for Yes)	School in 3 Blocks

Landing	Yes
Curb Ramp Width Feet	3
Curb Ramp Width Inch	6
Running Slope	5.3
Cross Slope	5.3

Truncated Domes	Yes
Comments	Curb up 1.5" above asphalt
