CITY OF PITTSBORO, INDIANA

CURB RAMP INVENTORY

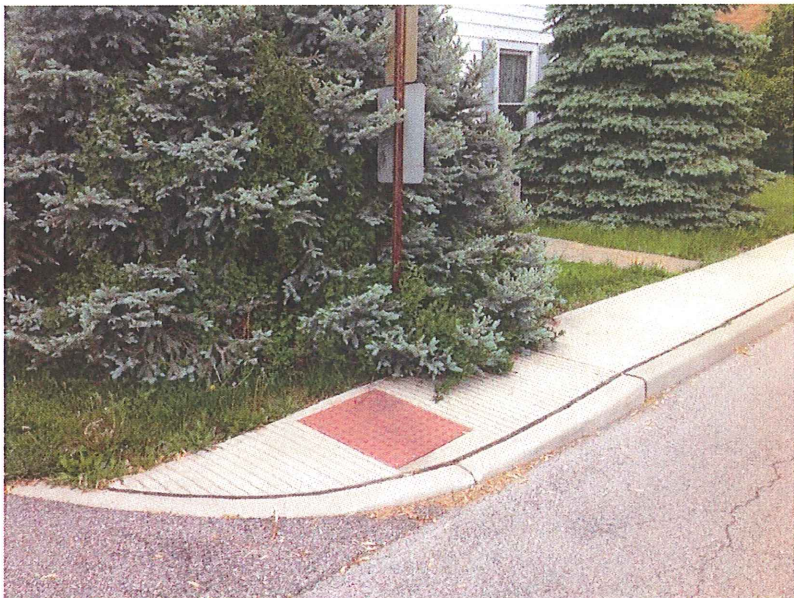
Osborne and McCord, SW

Intersection	Osborne and McCord
Corner	SW
Date	2015-05-14
Surveyor	Jack
Type of Curb Ramp	Blended
Nearby Facilities (Check for Yes)	School in 3 Blocks

Landing	Yes
Slip Resistant	Yes
Curb Ramp Width Feet	3
Curb Ramp Width Inch	6
Running Slope	2.9
Cross Slope	5.5
Clear Space	No

Truncated Domes	Yes
Comments	Bush and sign obstruction

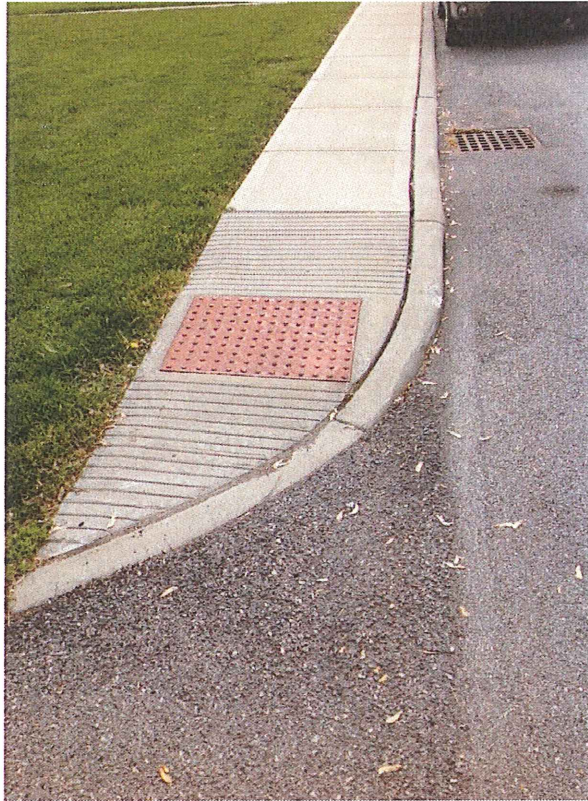
Osborne and McCord, NE

Intersection	Osborne and McCord
Corner	NE
Date	2015-05-14
Surveyor	Jack
Type of Curb Ramp	Blended
Nearby Facilities (Check for Yes)	School in 3 Blocks

Landing	Yes
Slip Resistant	Yes
Curb Ramp Width Feet	3
Curb Ramp Width Inch	6
Running Slope	9.199999999999999
Cross Slope	7.2

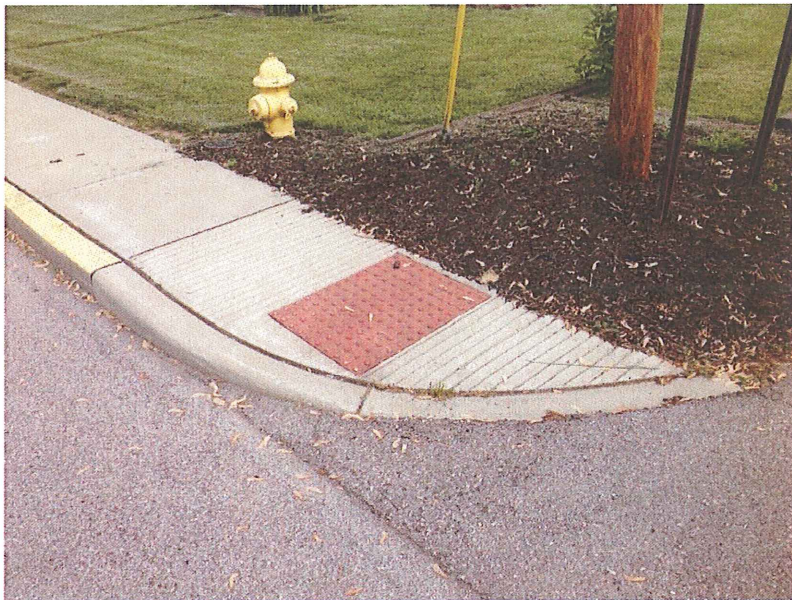
Osborne and McCord, NW

Intersection	Osborne and McCord
Corner	NW
Date	2015-05-14
Surveyor	Jack
Type of Curb Ramp	Blended
Nearby Facilities (Check for Yes)	School in 3 Blocks

Landing	Yes
Slip Resistant	Yes
Curb Ramp Width Feet	3
Curb Ramp Width Inch	6
Running Slope	6.2
Cross Slope	2.4

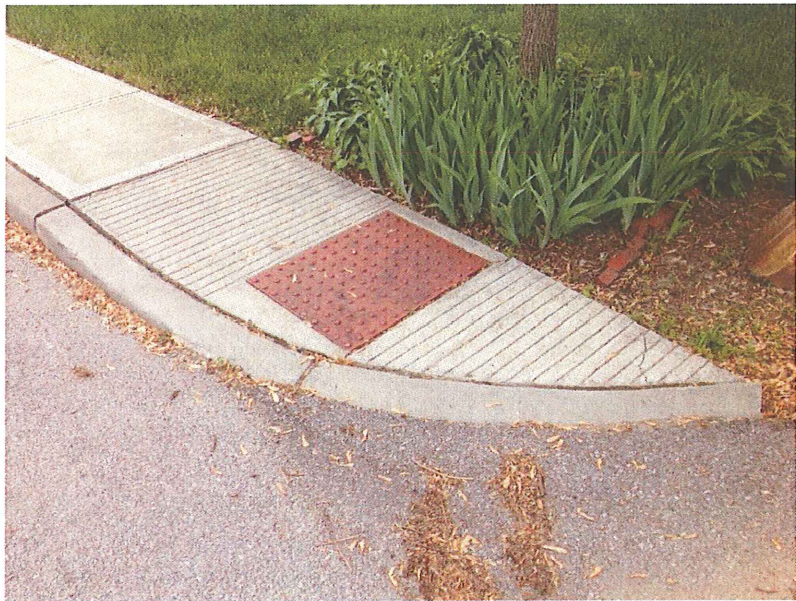
Osborne and sparks , SE

Intersection	Osborne and sparks
Corner	SE
Date	2015-05-14
Surveyor	Jack
Type of Curb Ramp	Blended

Landing	Yes
Slip Resistant	Yes
Curb Ramp Width Feet	3
Curb Ramp Width Inch	6
Running Slope	8.800000000000001
Cross Slope	5.4

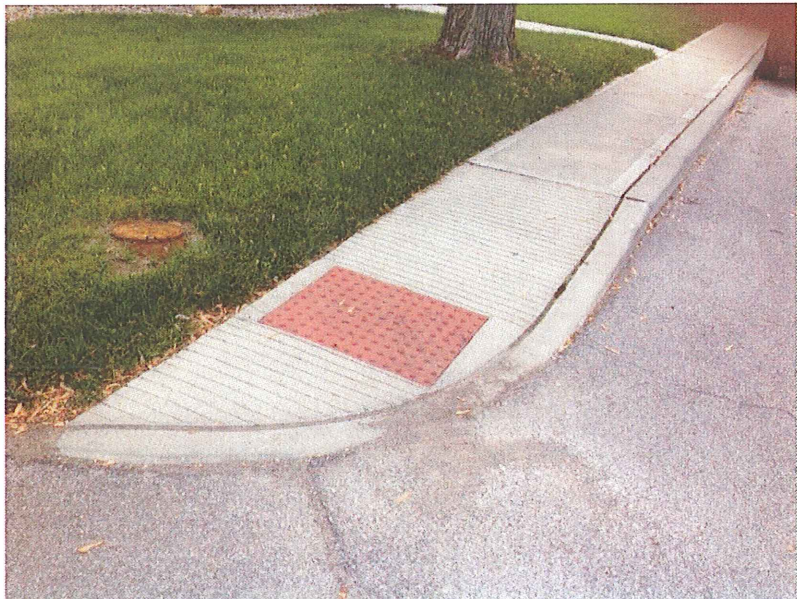
Osborne and sparks, NE

Intersection	Osborne and sparks
Corner	NE
Date	2015-05-14
Surveyor	Jack
Type of Curb Ramp	Blended
Nearby Facilities (Check for Yes)	School in 3 Blocks

Landing	Yes
Slip Resistant	Yes
Curb Ramp Width Feet	3
Curb Ramp Width Inch	6
Running Slope	7
Cross Slope	6.2

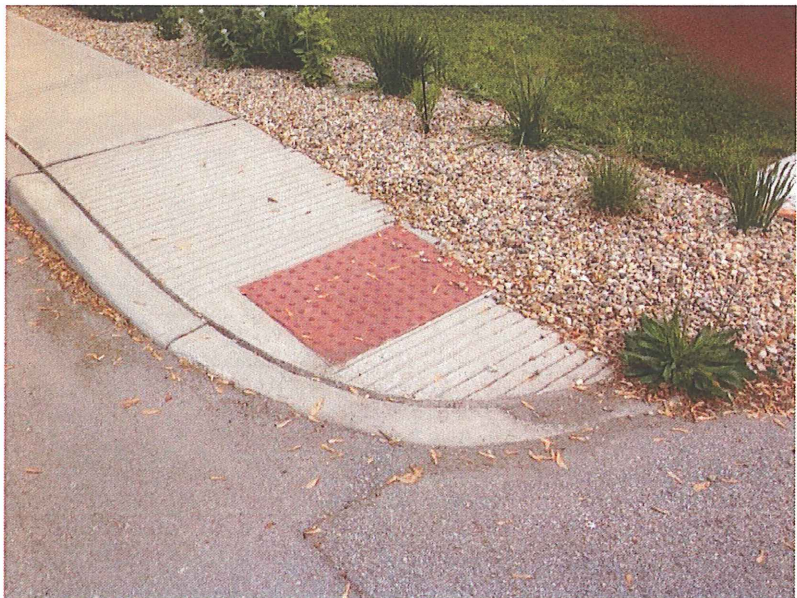
Osborne and sparks, NW

Intersection	Osborne and sparks
Corner	NW
Date	2015-05-14
Surveyor	Jack
Type of Curb Ramp	Blended
Nearby Facilities (Check for Yes)	School in 3 Blocks

Landing	Yes
Slip Resistant	Yes
Curb Ramp Width Feet	3
Curb Ramp Width Inch	6
Running Slope	6.2
Cross Slope	5.3

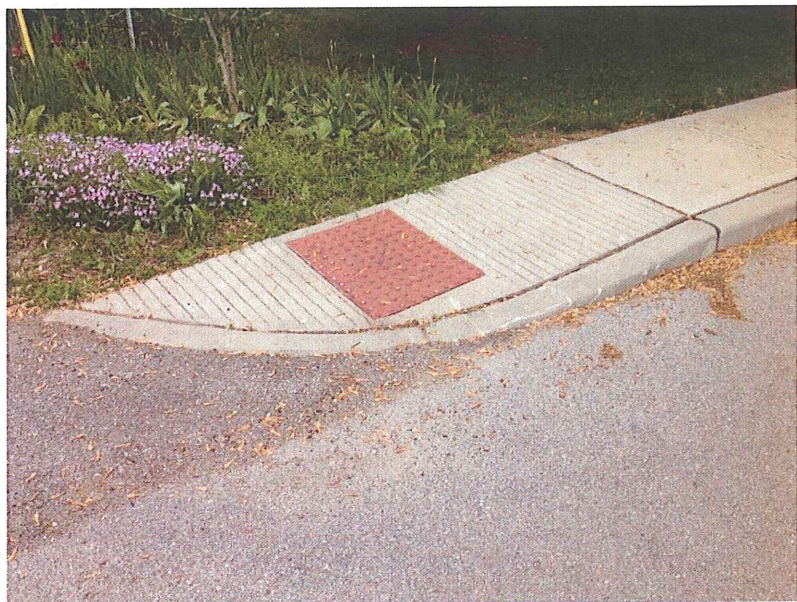
Osborne and sparks, SW

Intersection	Osborne and sparks
Corner	SW
Date	2015-05-14
Surveyor	Jack
Type of Curb Ramp	Blended

Landing	Yes
Slip Resistant	Yes
Curb Ramp Width Feet	3
Curb Ramp Width Inch	6
Running Slope	10.4
Cross Slope	6.5

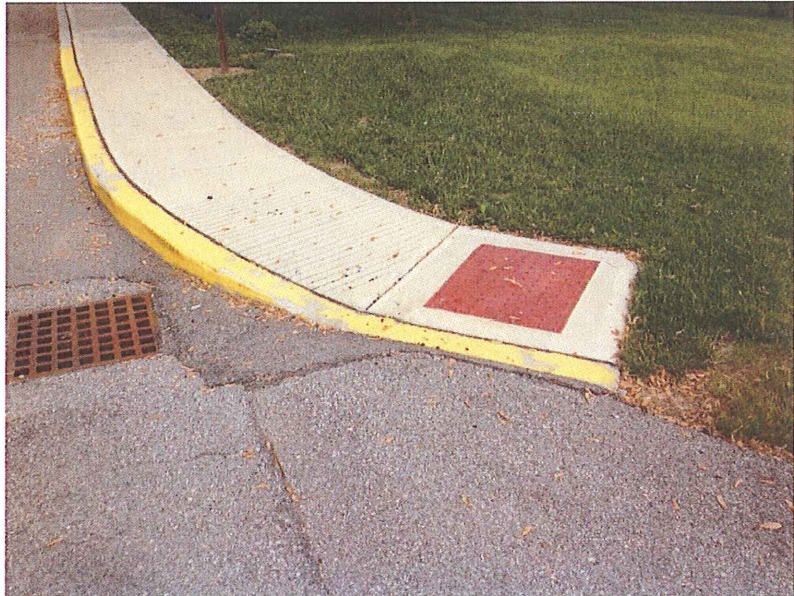
Osborne and school drive , NW

Intersection	Osborne and school drive
Corner	NW
Date	2015-05-14
Surveyor	Jack
Type of Curb Ramp	Blended

Curb Ramp Width Feet	3
Curb Ramp Width Inch	6
Running Slope	7.2
Cross Slope	3.8

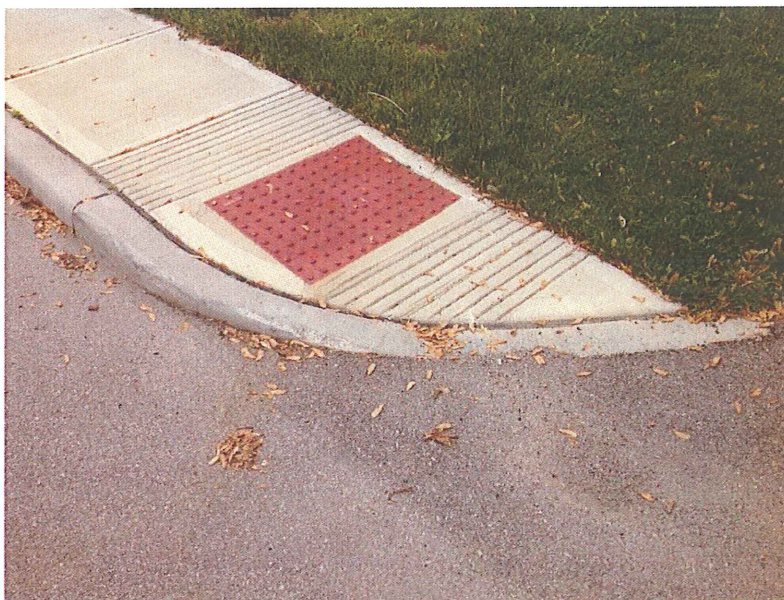
Osborne and Fisher, SE

Intersection	Osborne and Fisher
Corner	SE
Date	2015-05-14
Surveyor	Jack
Type of Curb Ramp	Blended
Nearby Facilities (Check for Yes)	School in 3 Blocks

Landing	Yes
Curb Ramp Width Feet	3
Curb Ramp Width Inch	4
Running Slope	17
Cross Slope	7.5

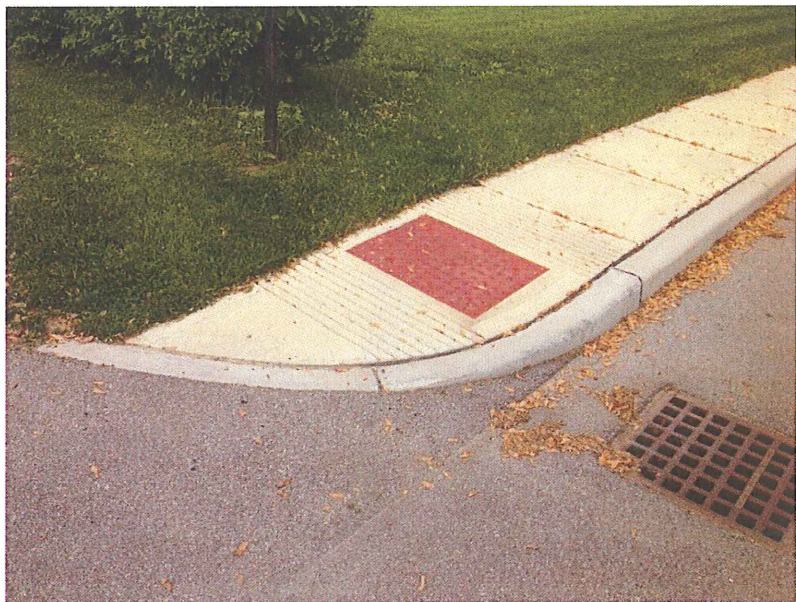
Osborne and Fisher , SW

Intersection	Osborne and Fisher
Corner	SW
Date	2015-05-14
Surveyor	Jack
Type of Curb Ramp	Blended

Landing	Yes
Curb Ramp Width Feet	3
Curb Ramp Width Inch	6
Running Slope	7.2
Cross Slope	6.9

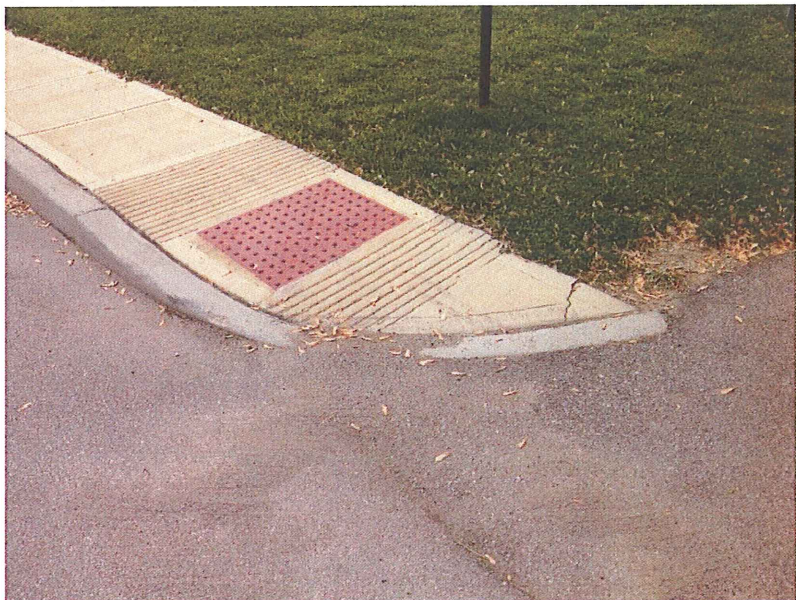
Osborne and Hamilton , SE

Intersection	Osborne and Hamilton
Corner	SE
Date	2015-05-14
Surveyor	Jack
Type of Curb Ramp	Blended
Nearby Facilities (Check for Yes)	School in 3 Blocks

Landing	Yes
Slip Resistant	Yes
Curb Ramp Width Feet	3
Curb Ramp Width Inch	5
Running Slope	12
Cross Slope	12.4

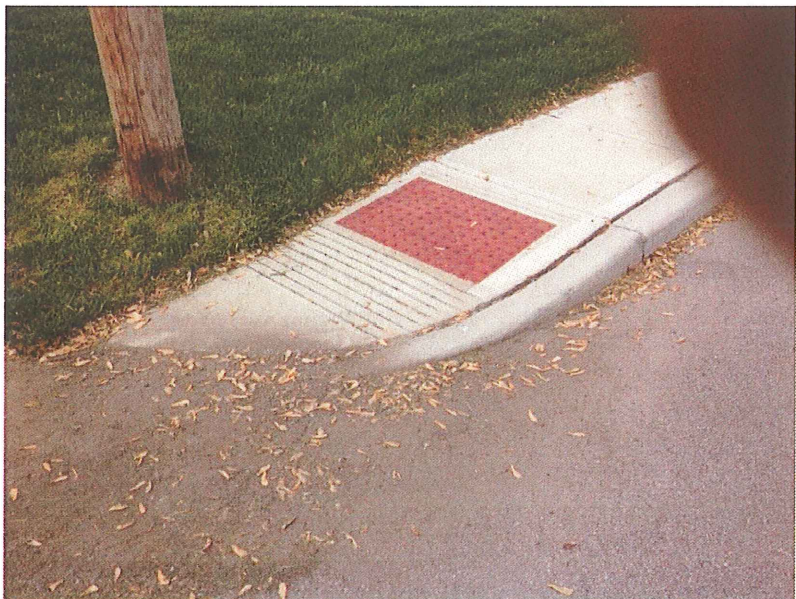
Osborne and Hamilton , SW

Intersection	Osborne and Hamilton
Corner	SW
Date	2015-05-14
Surveyor	Jack
Type of Curb Ramp	Blended
Nearby Facilities (Check for Yes)	School in 3 Blocks

Landing	Yes
Curb Ramp Width Feet	3
Curb Ramp Width Inch	5
Running Slope	14.2
Cross Slope	7.1

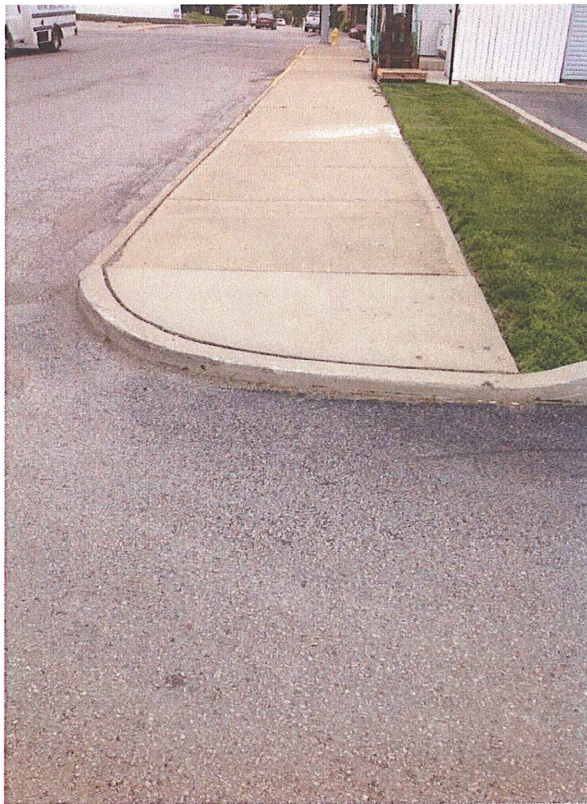
Olsen and Maple, NE

Intersection	Olsen and Maple
Corner	NE
Date	2015-05-20
Surveyor	Jack
Type of Curb Ramp	None

Crosswalk Width Inch	0
Comments	5" curb. Olsen st may have been relocated

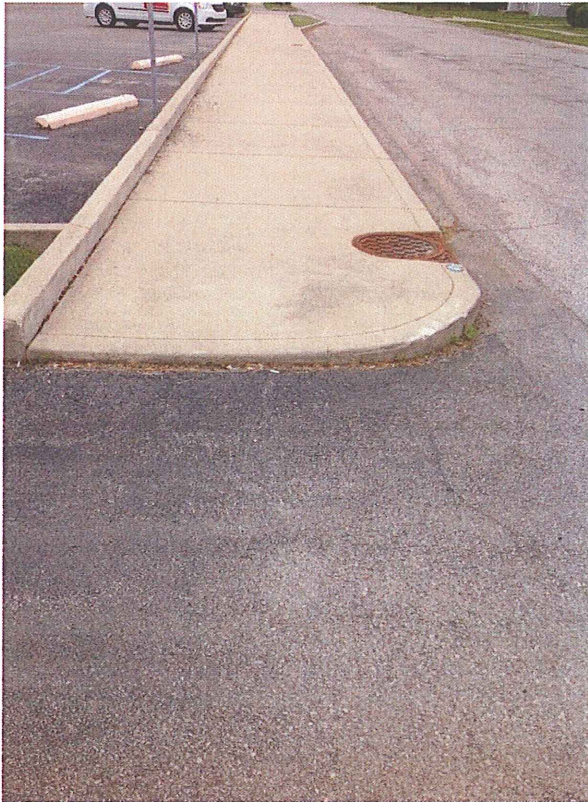
Maple and Olsen, SE

Intersection	Maple and Olsen
Corner	SE
Date	2015-05-20
Surveyor	Jack
Type of Curb Ramp	None

Crosswalk Width Inch	0
Comments	5" curb

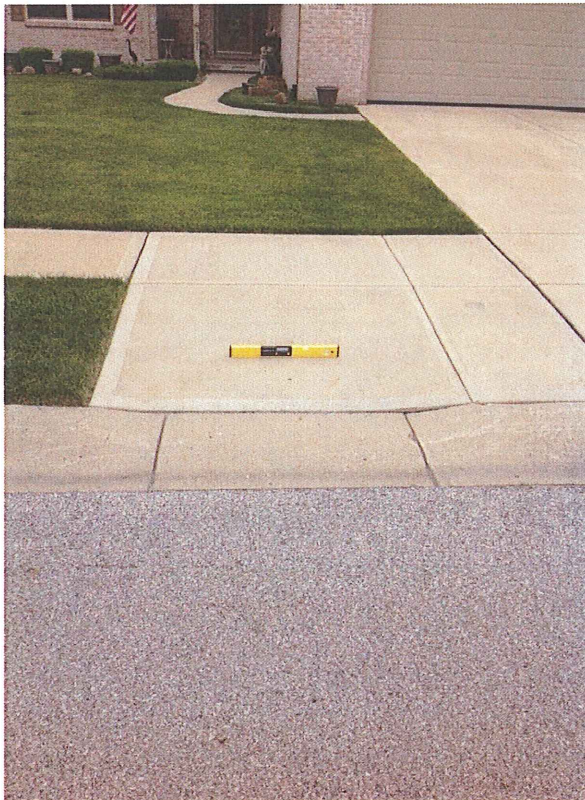
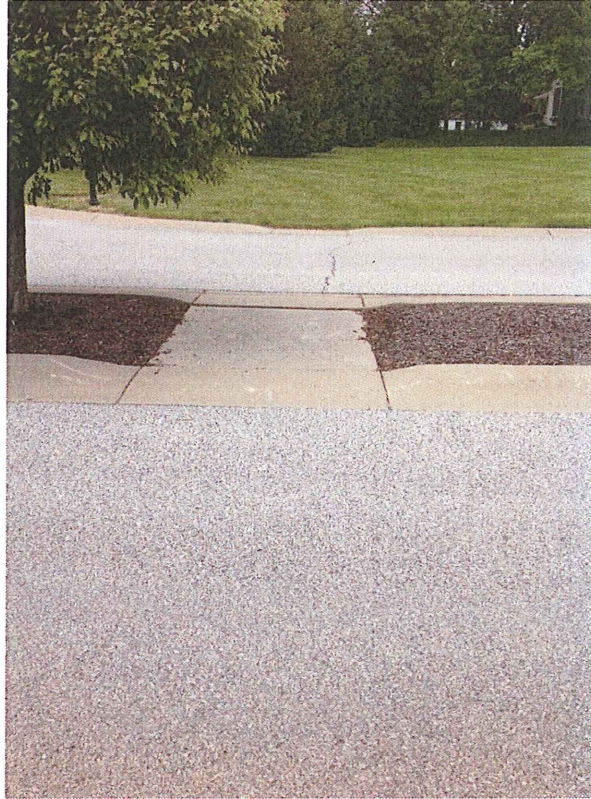
Woodridge dr and Maple. 50' east, SE

Intersection	Woodridge dr and Maple. 50' east
Corner	SE
Date	2015-05-20
Surveyor	Jack
Type of Curb Ramp	Perpendicular

Landing	Yes
Curb Ramp Width Feet	5
Running Slope	5.8
Cross Slope	0.4

Comments	Ramp in median island but not on North side of Woodridge
----------	--

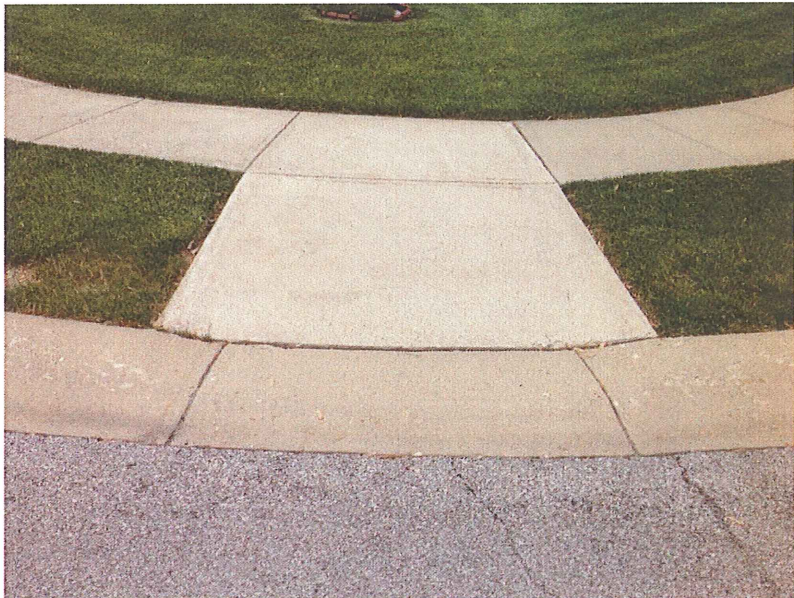
N Woodridge and s Woodridge , NW

Intersection	N Woodridge and s Woodridge
Corner	NW
Surveyor	Jack
Type of Curb Ramp	Diagonal

Landing	Yes
Curb Ramp Width Feet	6
Running Slope	7.9
Cross Slope	1.5

Truncated Domes	No
Comments	1" gap at gutter

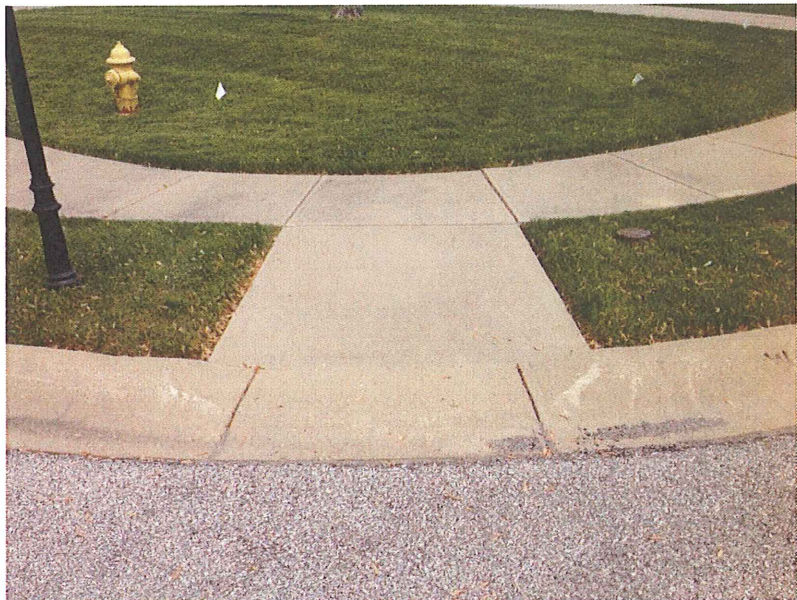
N Woodridge and s Woodridge , NE

Intersection	N Woodridge and s Woodridge
Corner	NE
Date	2015-05-14
Surveyor	Jack
Type of Curb Ramp	Diagonal

Curb Ramp Width Feet	5
Running Slope	6.5
Cross Slope	0.3

Truncated Domes	No
Comments	Ramp settlement 1"

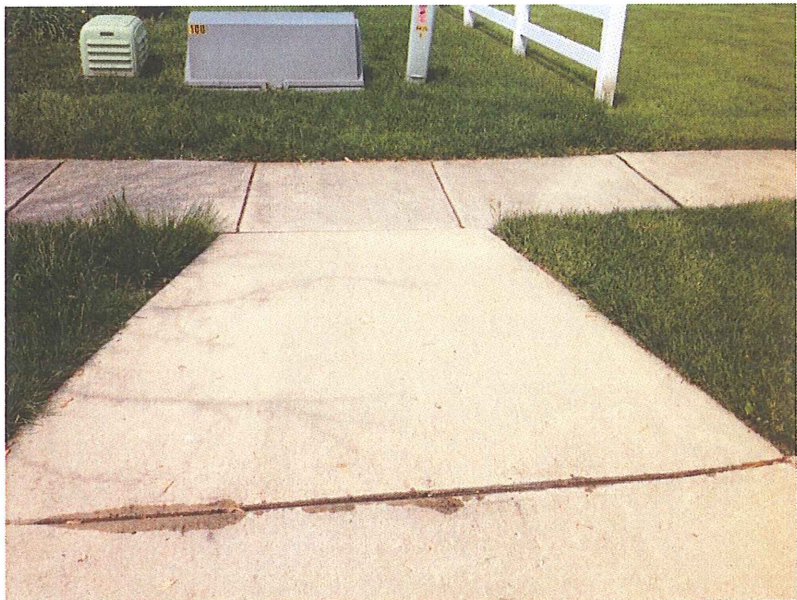
Intersection	150' south of Main st
Date	2015-05-15
Surveyor	Jack
Street 1	Burlington Pkwy
Type of Curb Ramp	Perpendicular

Landing	Yes
Curb Ramp Width Inch	5
Running Slope	5.4
Cross Slope	1.2
Flared Sides	Yes

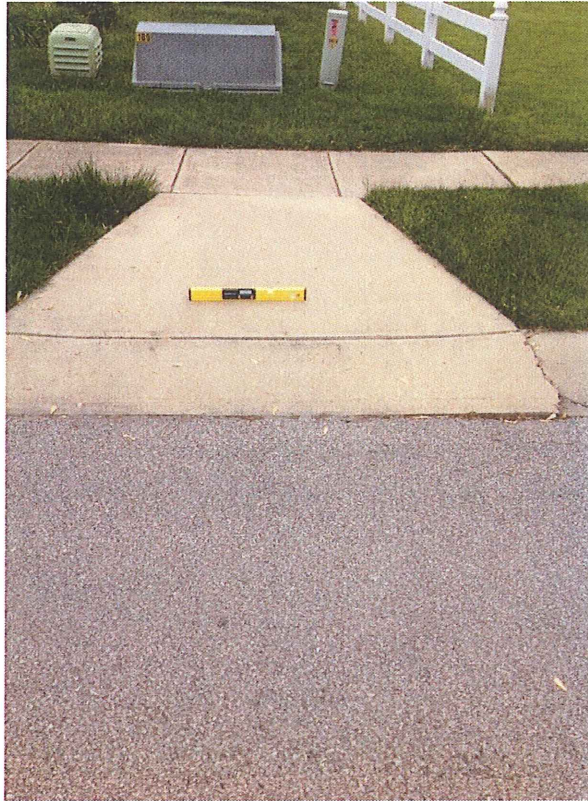
None

Truncated Domes	No
Comments	150' so of sr 136. Pinned wrong ramp is on west side of st

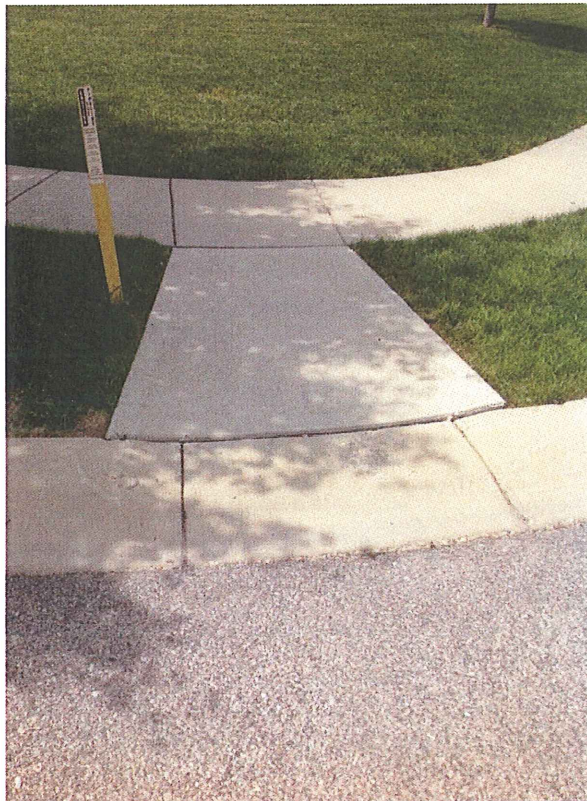
Burlington pkwy and Stamford dr. , NW

Landing	Yes
Curb Ramp Width Feet	3
Curb Ramp Width Inch	5
Running Slope	3.6
Cross Slope	0.6
Comments	1" gap at curb

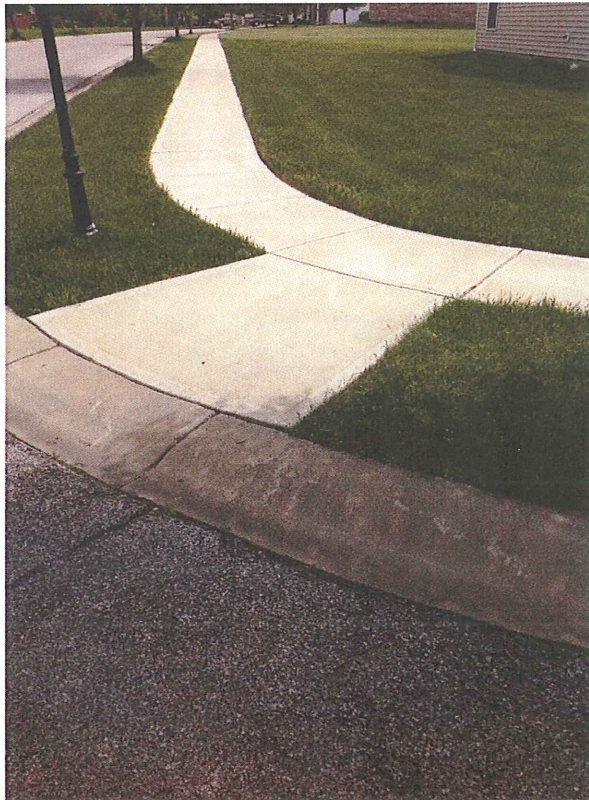
Burlington pkwy and Stamford dr. , SW

Truncated Domes	No
Visual Contrast	No

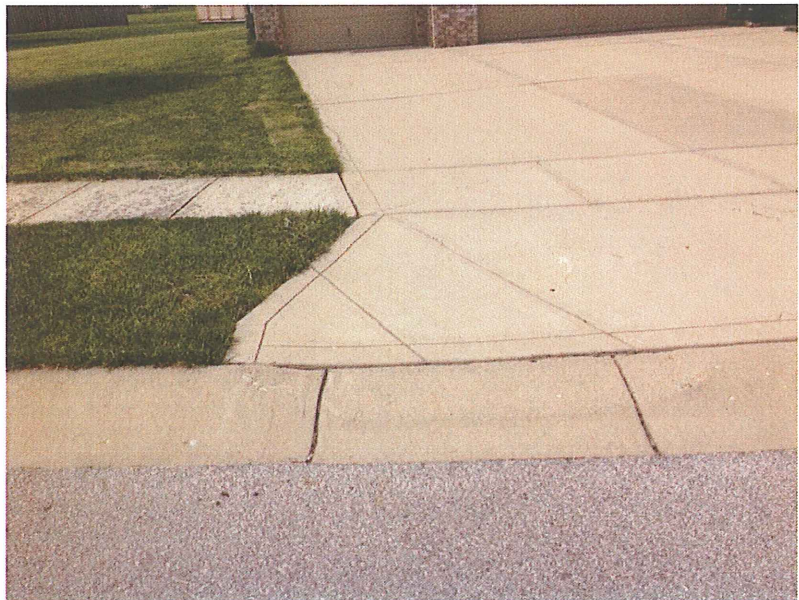
Burlington pkwy and Warrington ct, NW

Truncated Domes	No
Comments	Combined in drive

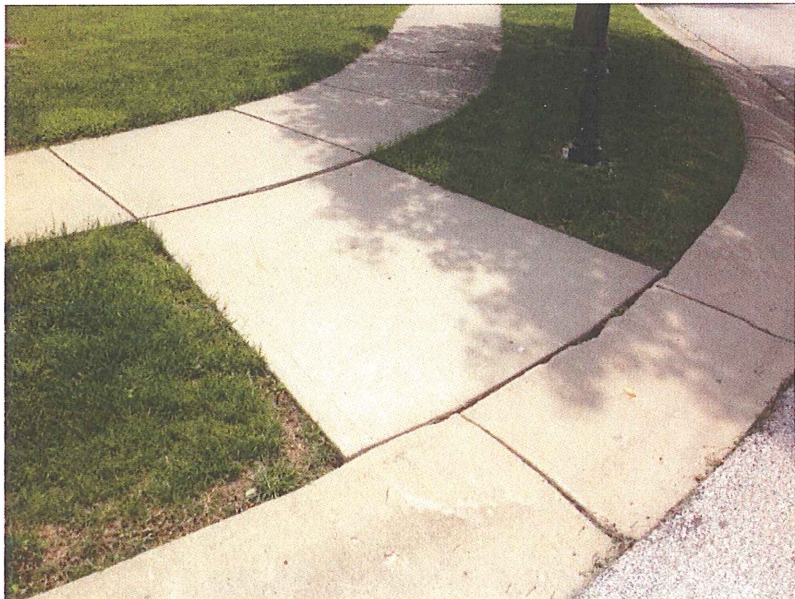
Burlington pkwy and Warrington ct, SW

Truncated Domes	No
Comments	2" gap at curb. Curb 2" higher than ramp.

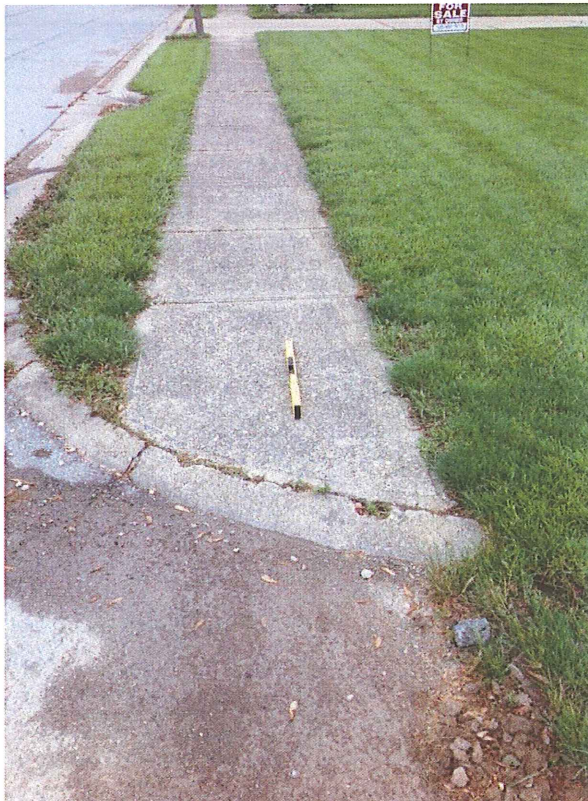
Walnut and Noyes , SW

Truncated Domes	No
Comments	3" rolled curb

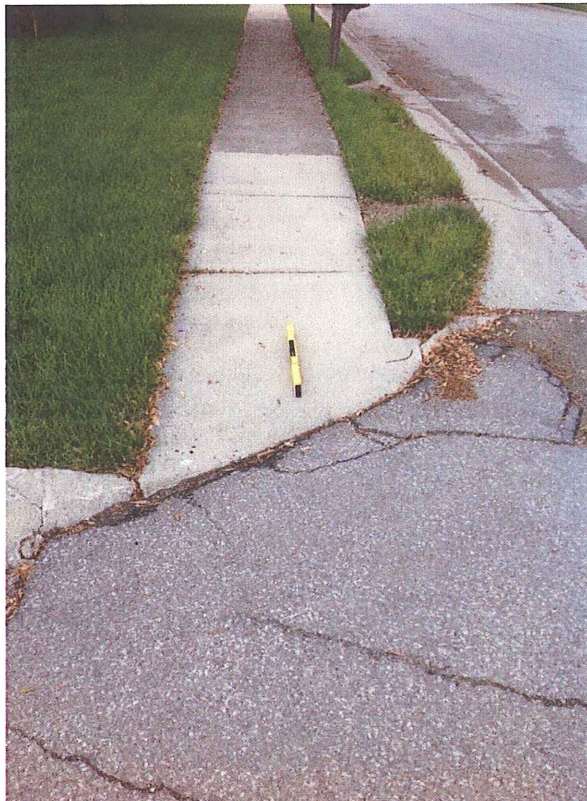
Walnut and Noyes , SE

Truncated Domes	No
Comments	Asphalt 1" higher

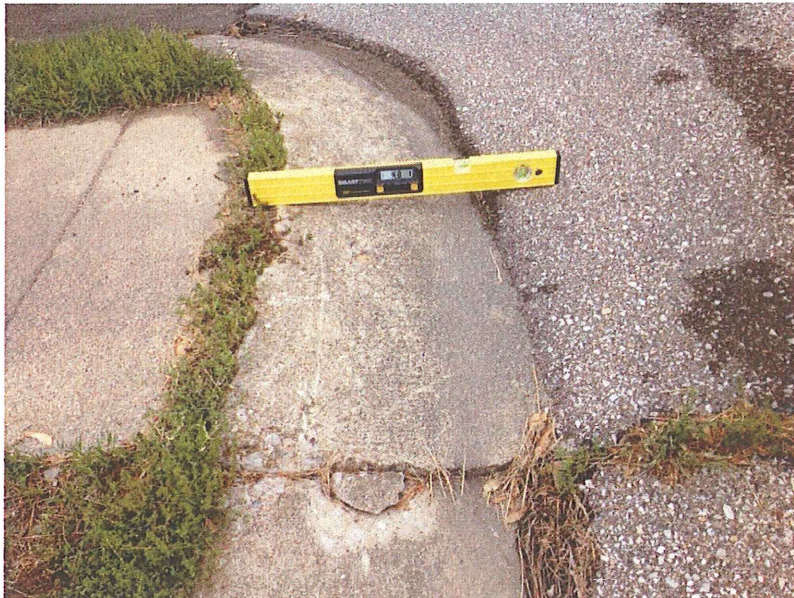
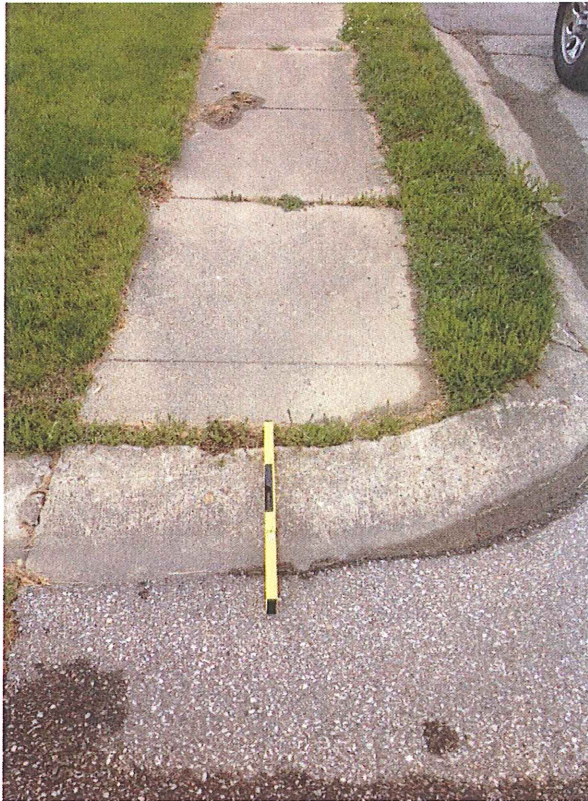
Smith and Noyes , SE

Truncated Domes	No
Comments	3" rolled curb

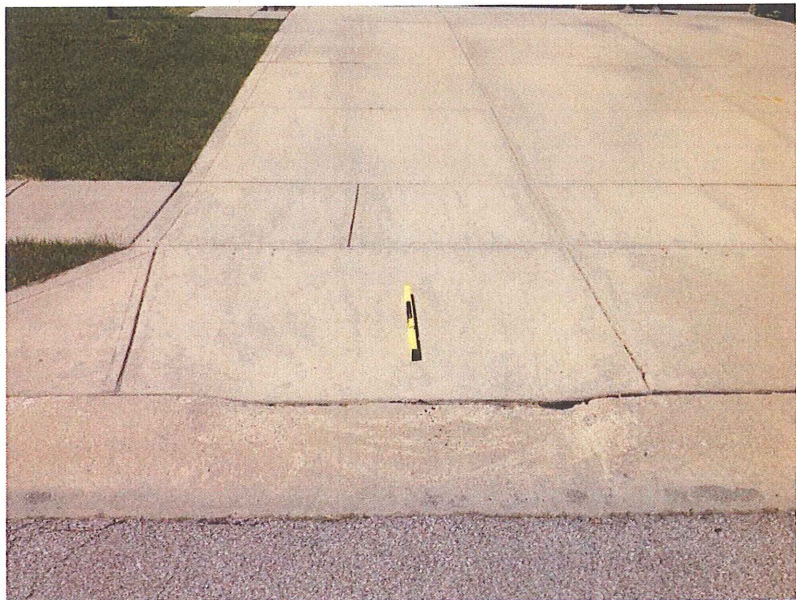
Photo of Curb

Landing	Yes
Slip Resistant	No
Curb Ramp Width Feet	6
Running Slope	9.4
Cross Slope	1.2

Truncated Domes	No
Comments	1" hole in gutter. Combined in driveway

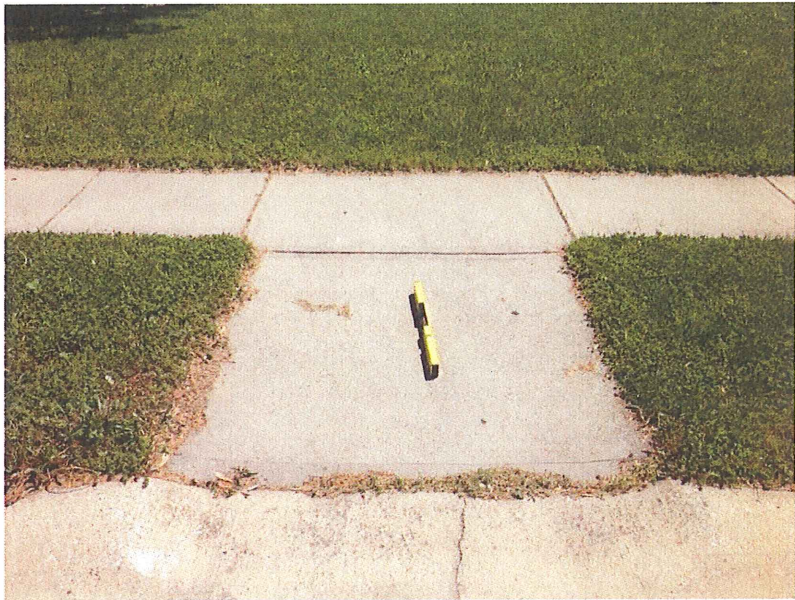
Photo of Curb

Landing	Yes
Running Slope	11.2
Cross Slope	0.3

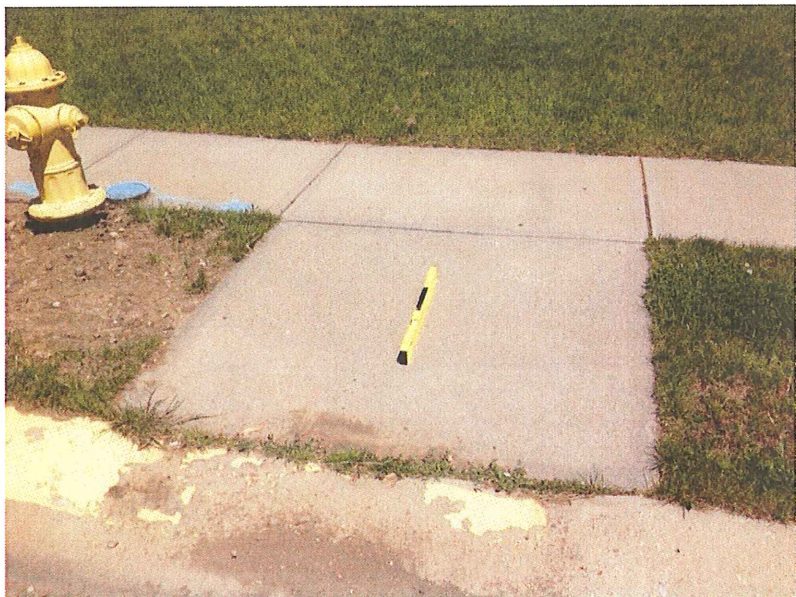
Photo of Curb

Landing	Yes
Slip Resistant	No
Curb Ramp Width Feet	6
Running Slope	9.699999999999999
Cross Slope	0
Clear Space	Yes
Flared Sides	No

Truncated Domes	No
Comments	Curb .5" higher

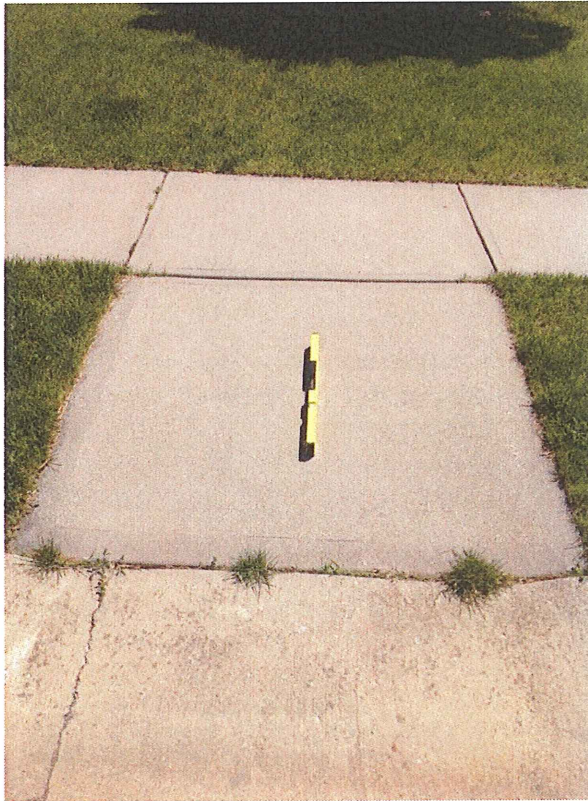
Photo of Curb

Landing	Yes
Slip Resistant	No
Curb Ramp Width Feet	5
Curb Ramp Width Inch	6
Running Slope	10.7
Cross Slope	0.4
Clear Space	Yes

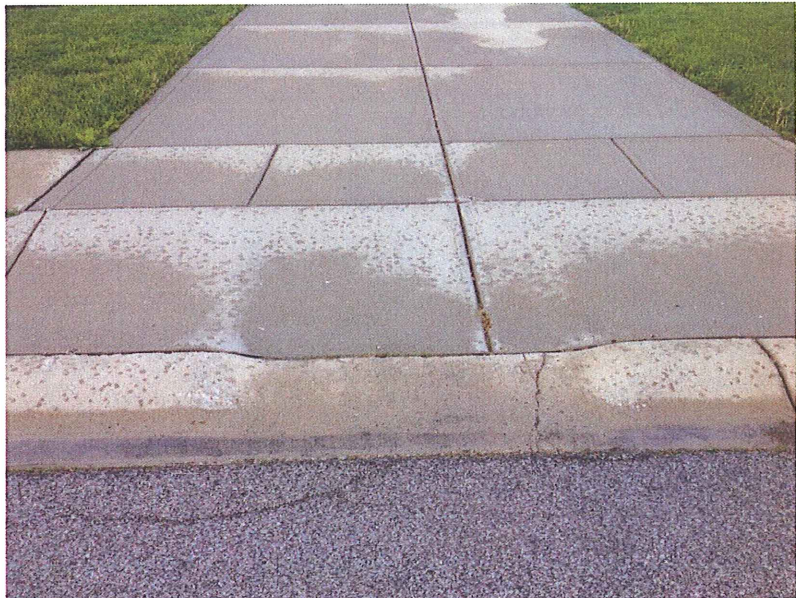
Photo of Curb

Landing	Yes
Curb Ramp Width Feet	4
Running Slope	5.3
Cross Slope	0.1

Truncated Domes	No
Placement	Combined in driveway

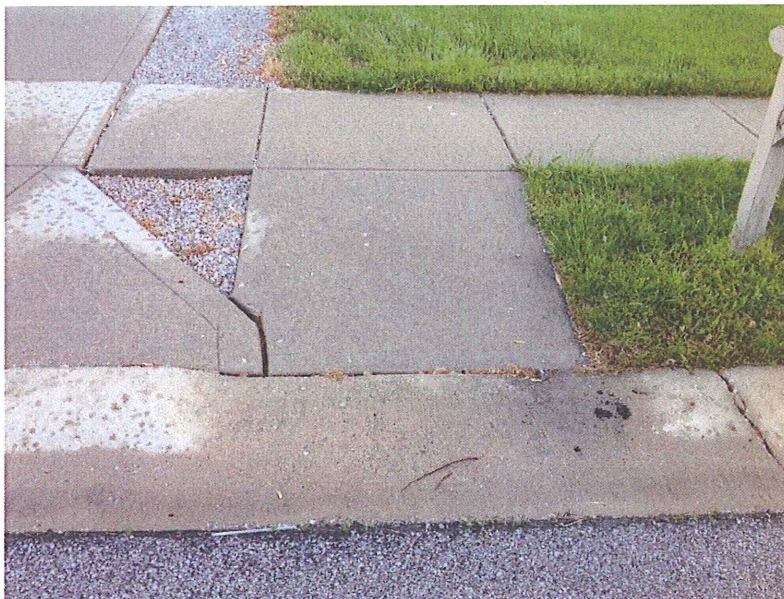
Photo of Curb

Landing	Yes
Curb Ramp Width Feet	4
Curb Ramp Width Inch	6
Running Slope	6.2
Cross Slope	0.4

Truncated Domes	No
Comments	1" gap at drive joint

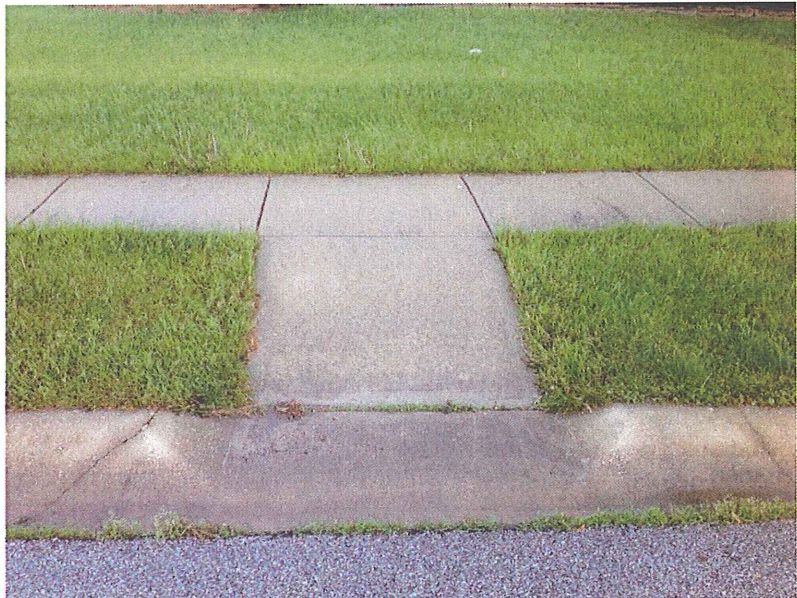
Photo of Curb

Landing	Yes
Curb Ramp Width Feet	4
Curb Ramp Width Inch	4
Running Slope	8.199999999999999
Cross Slope	0.2

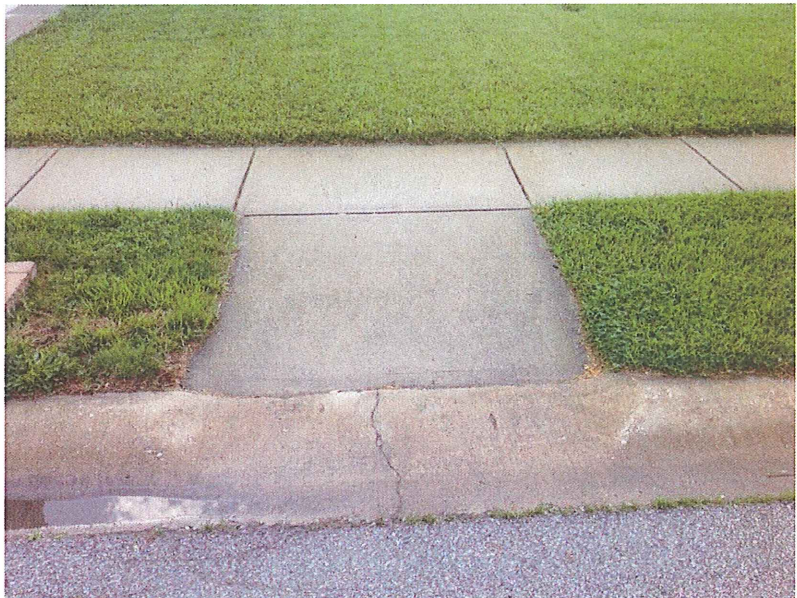
Photo of Curb

Landing	Yes
Curb Ramp Width Feet	5
Curb Ramp Width Inch	5
Running Slope	6.2
Cross Slope	0.4

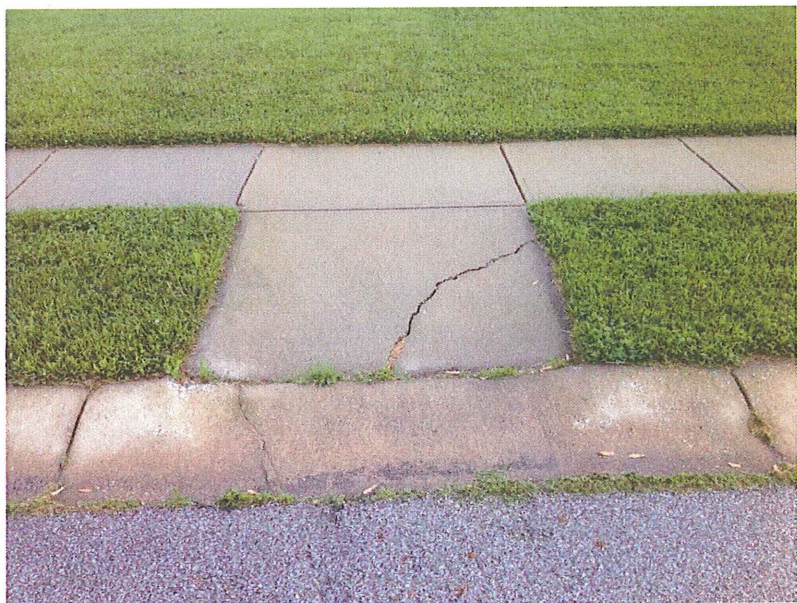
Photo of Curb

Broadmoor Bend and Lynn ct. , NE

Truncated Domes	No
Comments	Corner cracked settled 1"

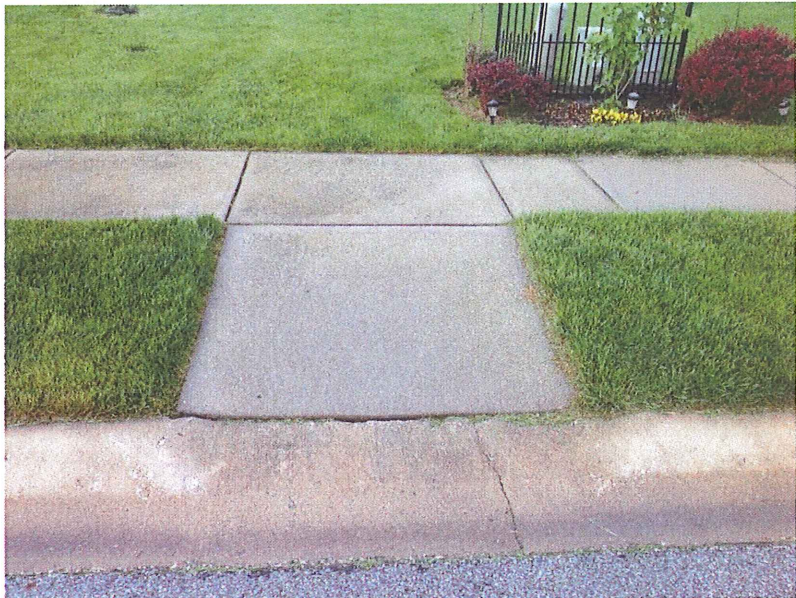
Photo of Curb

Landing	Yes
Curb Ramp Width Feet	5
Curb Ramp Width Inch	1
Running Slope	6.5
Cross Slope	0.3

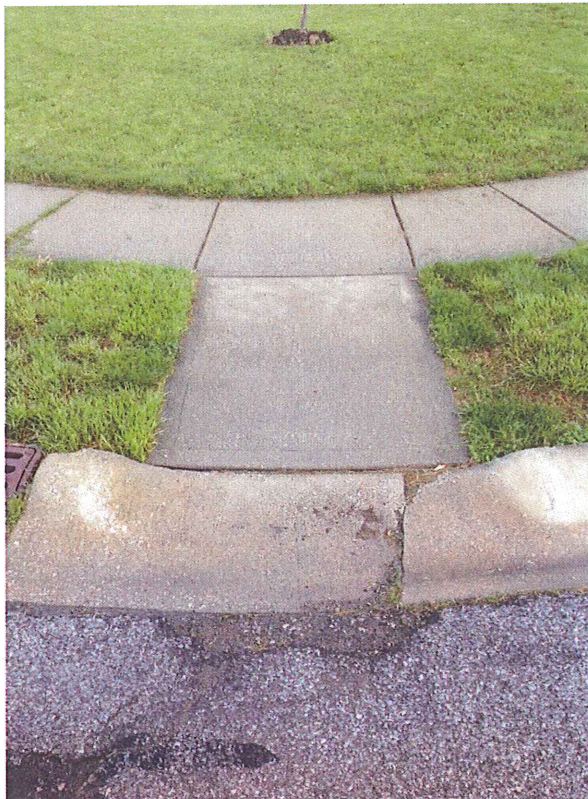
Photo of Curb

Broadmoor Bend and LaSalle In, NW

Truncated Domes	No
Comments	Cracked gutter 1" displaced

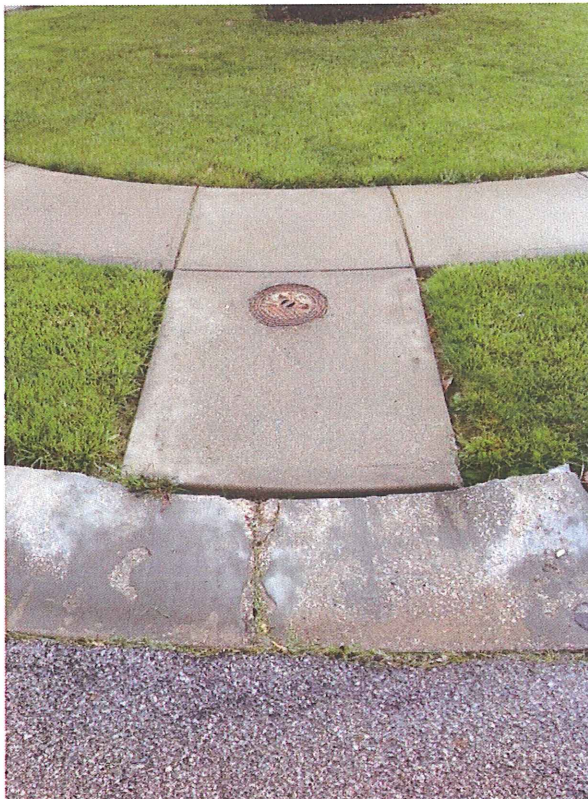
Photo of Curb

Landing	Yes
Curb Ramp Width Feet	4
Running Slope	6.1
Cross Slope	1.2

Truncated Domes	No
Comments	1.5" gap at gutter

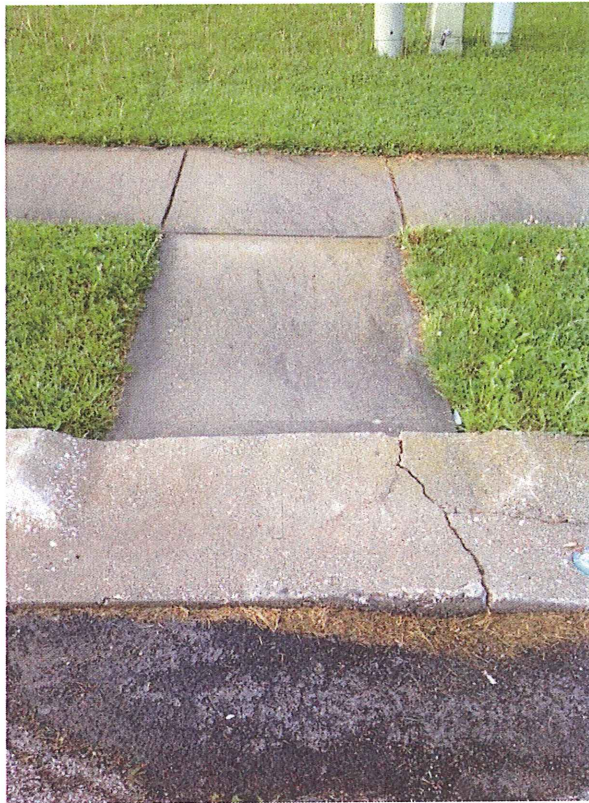
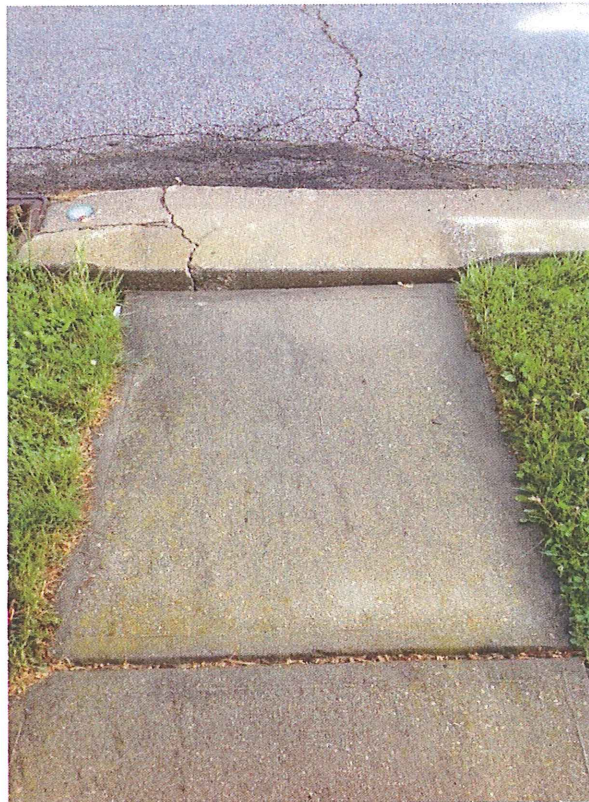
Photo of Curb

Broadmoor Bend and LaSalle In, NE

Truncated Domes	No
Comments	Ramp settled 3" trip hazard

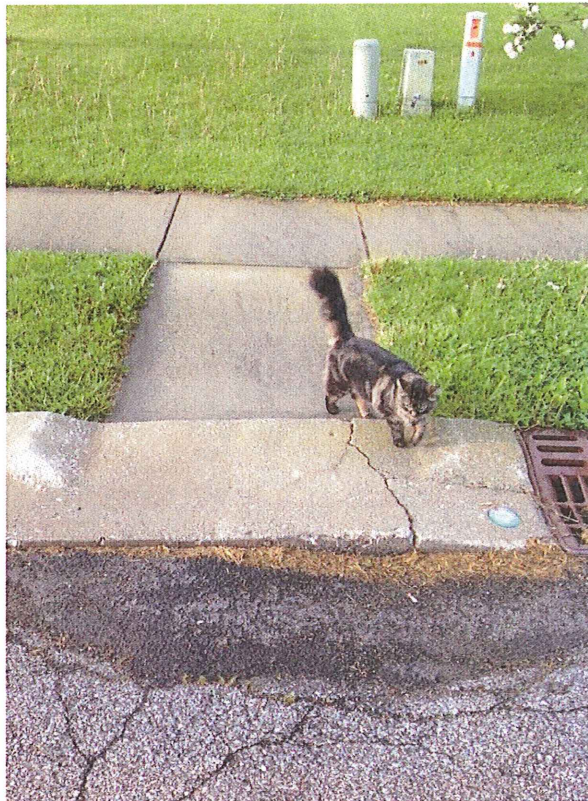
Photo

Landing	Yes
Curb Ramp Width Feet	4
Running Slope	4.4
Cross Slope	0.2
