CITY OF PITTSBORO, INDIANA

CURB RAMP INVENTORY

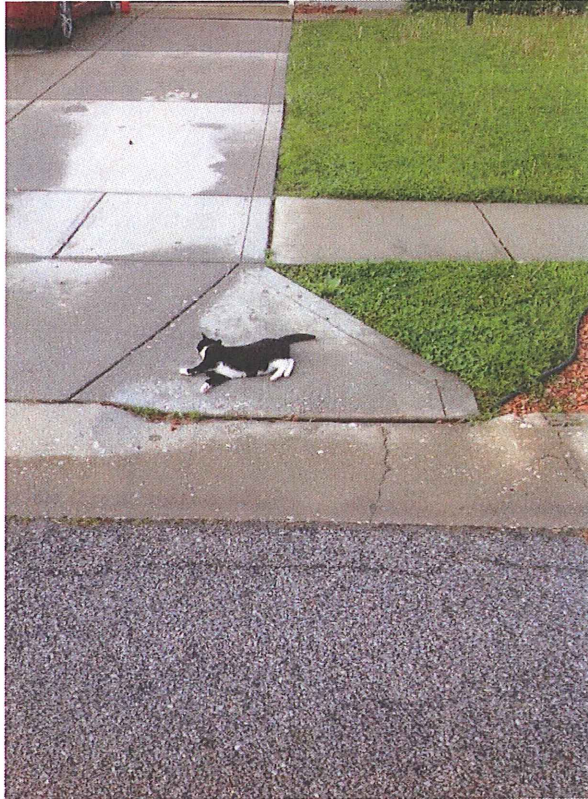
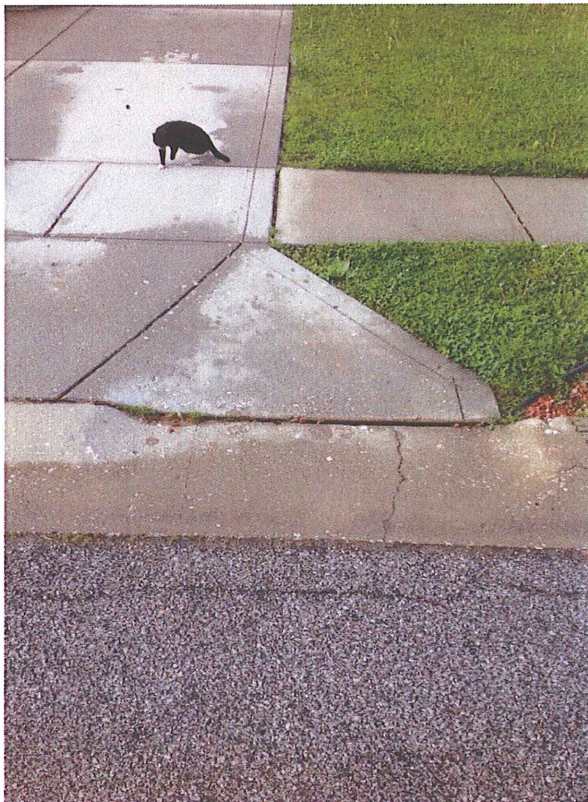
Photo of Curb

Landing	No
Curb Ramp Width Feet	4
Running Slope	4.1
Cross Slope	1.1

Truncated Domes	No
Placement	Combined with wing of driveway

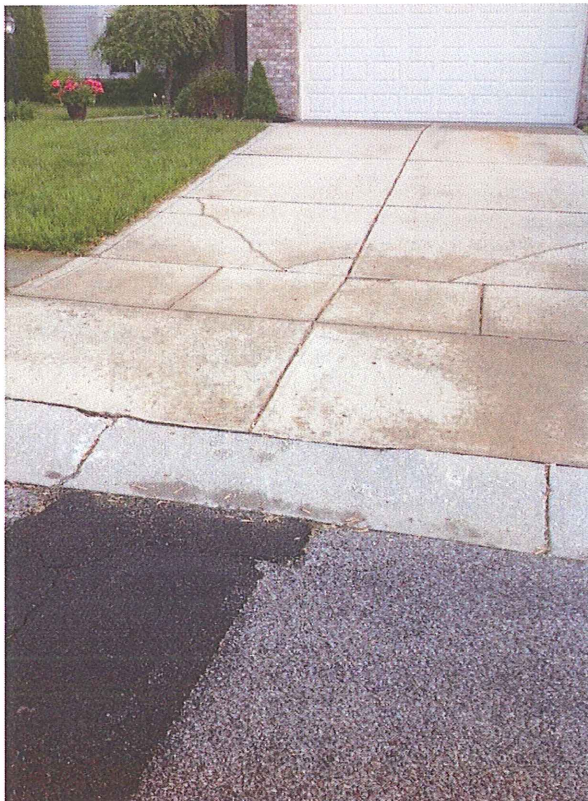
Photo of Curb

Landing	Yes
Curb Ramp Width Feet	4
Curb Ramp Width Inch	4
Running Slope	6.7
Cross Slope	0.3

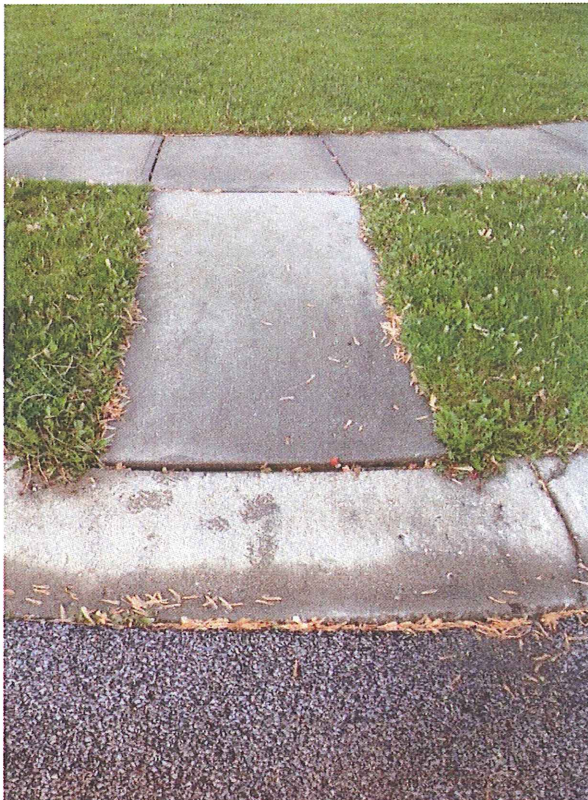
Photo of Curb

Landing	Yes
Curb Ramp Width Feet	4
Running Slope	4.7
Cross Slope	0.3

Truncated Domes	No
Comments	1" gap at gutter

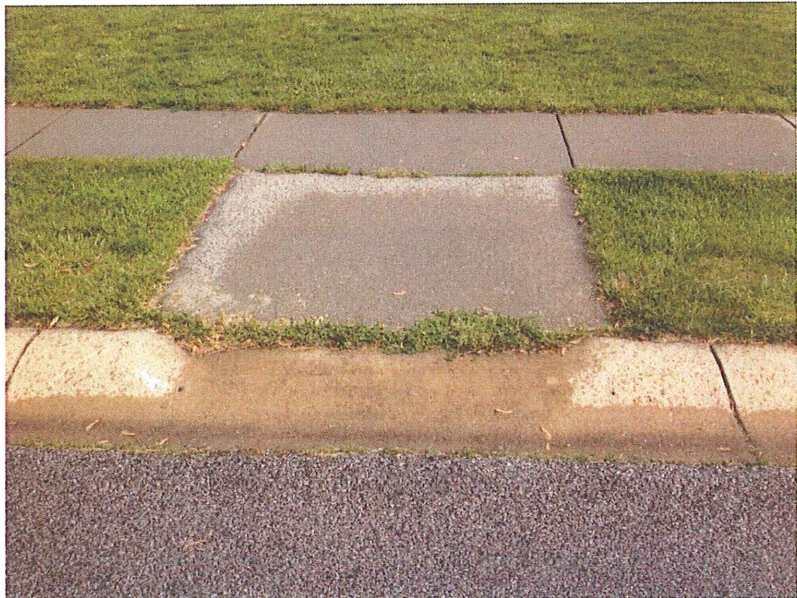
Photo of Curb

Landing	Yes
Curb Ramp Width Feet	6
Curb Ramp Width Inch	2
Running Slope	4.5
Cross Slope	0.4

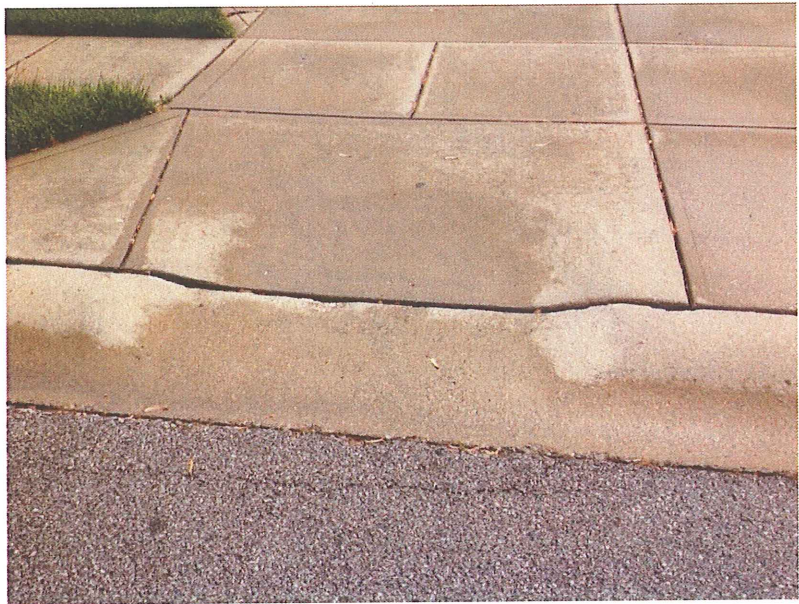
Photo of Curb

Landing	Yes
Curb Ramp Width Feet	4
Running Slope	6
Cross Slope	0.2

Truncated Domes	No
Comments	1" gap at gutter

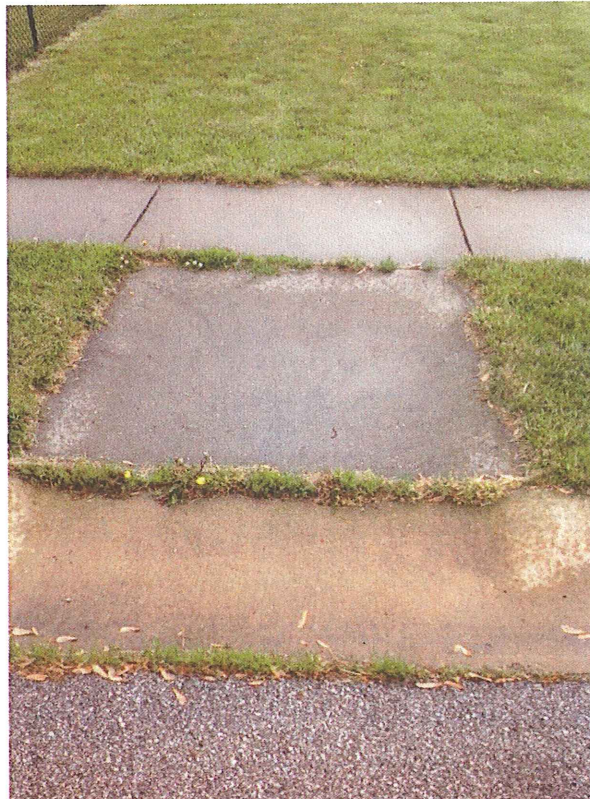
Photo of Curb

Landing	Yes
Curb Ramp Width Feet	5
Curb Ramp Width Inch	6
Running Slope	4.6
Cross Slope	0.7

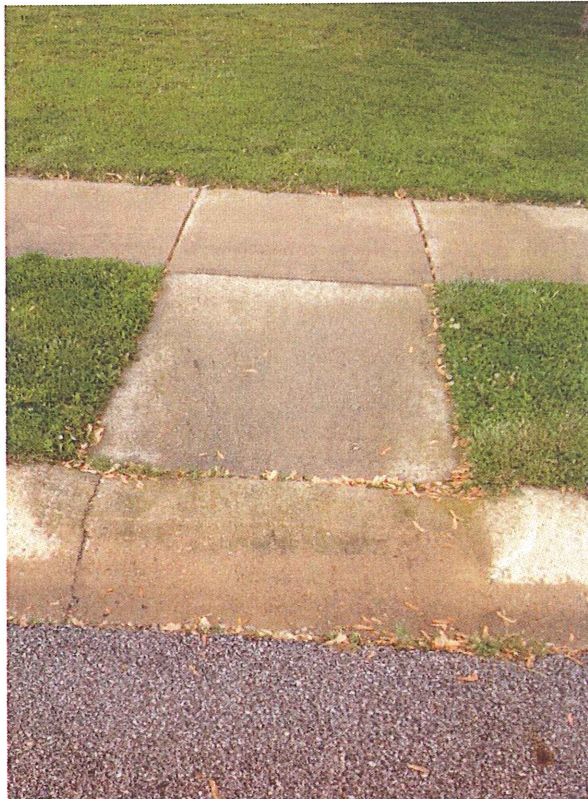
Photo of Curb

Landing	Yes
Curb Ramp Width Feet	4
Curb Ramp Width Inch	6
Running Slope	5.8
Cross Slope	0

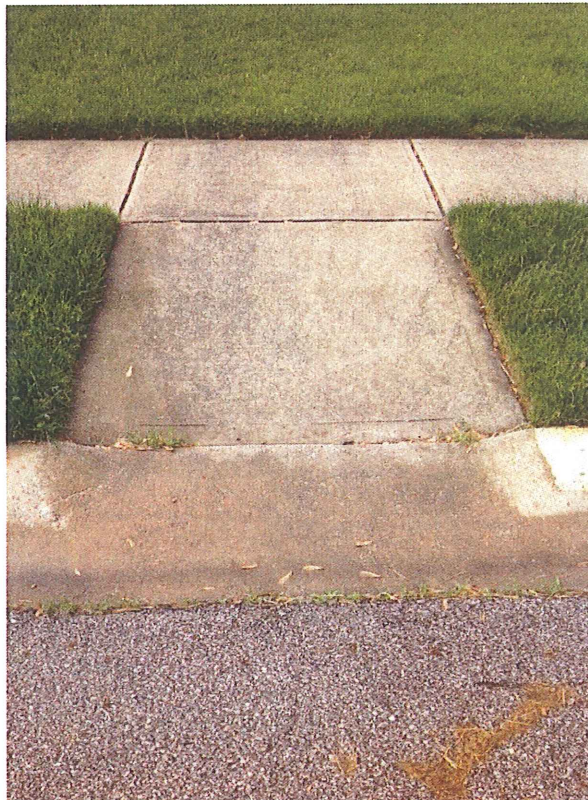
Photo of Curb

Landing	Yes
Curb Ramp Width Feet	5
Curb Ramp Width Inch	3
Running Slope	7.8
Cross Slope	0.4

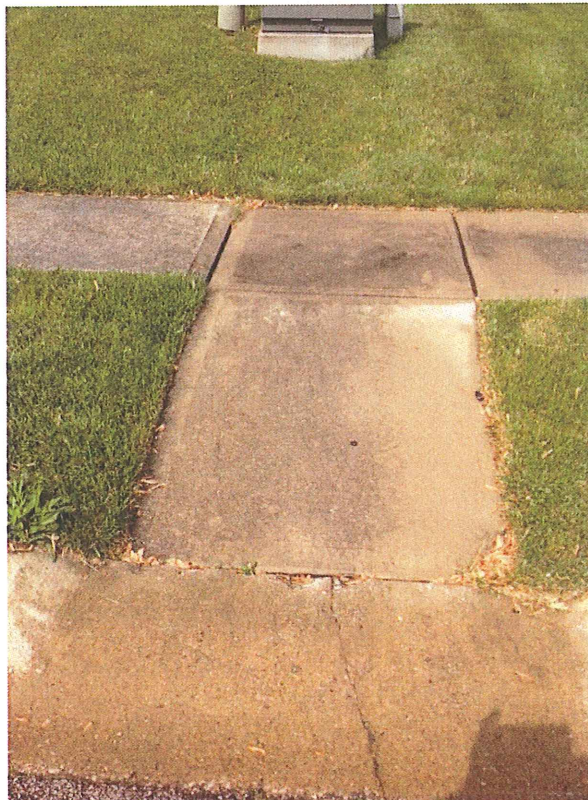
Photo of Curb

Landing	Yes
Curb Ramp Width Feet	4
Running Slope	7.1
Cross Slope	0.1

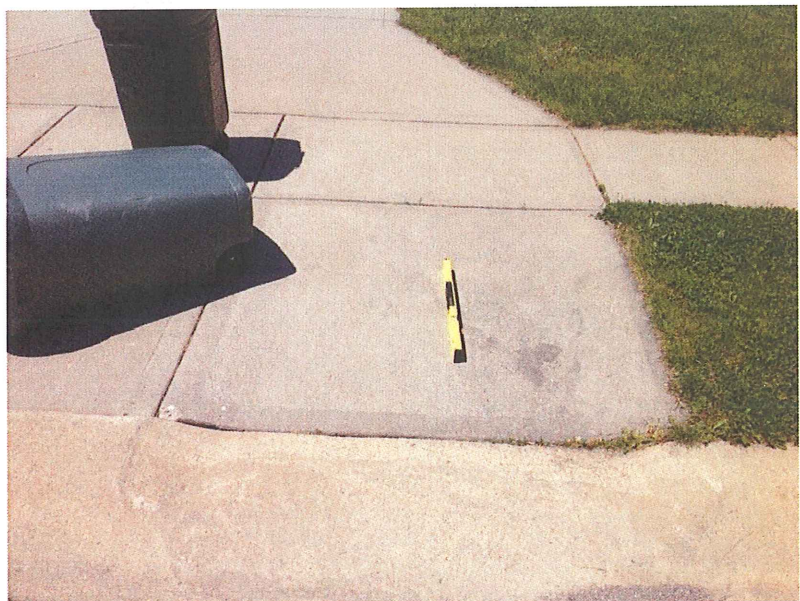
Photo of Curb

Landing	Yes
Slip Resistant	No
Curb Ramp Width Feet	6
Running Slope	10.5
Cross Slope	0.5
Clear Space	Yes
Flared Sides	No

Truncated Domes	No
Comments	Combined with driveway

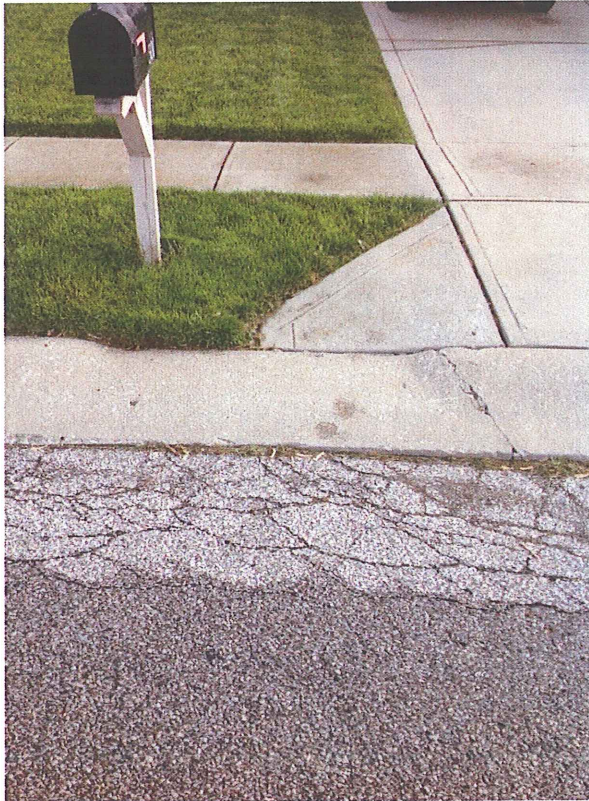
Photo of Curb

Landing	No
Curb Ramp Width Feet	2
Comments	Driveway wing

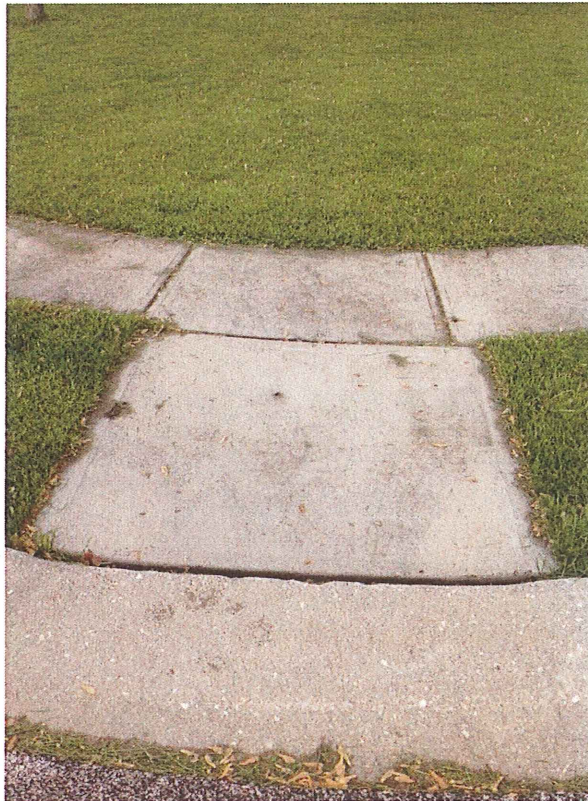
Photo of Curb

Truncated Domes	No
Comments	1.5" gap at gutter

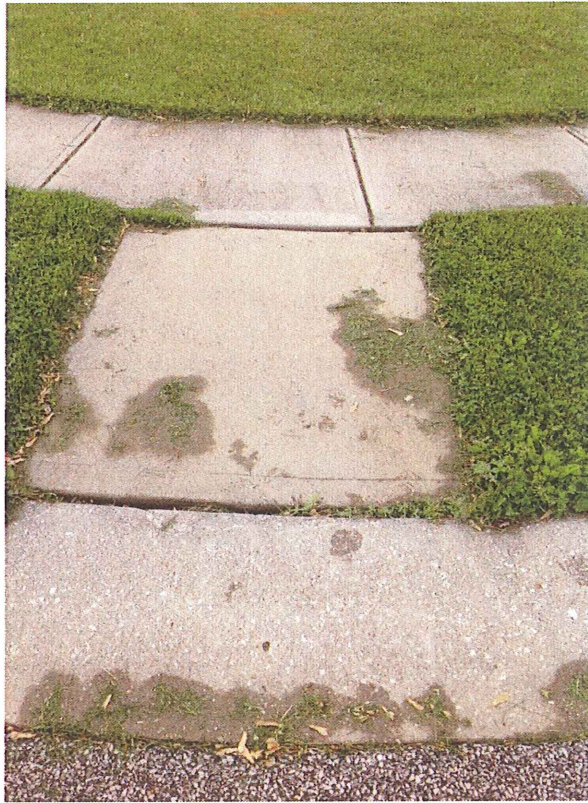
Photo of Curb

Truncated Domes	No
Comments	1" gaps at gutter and walk

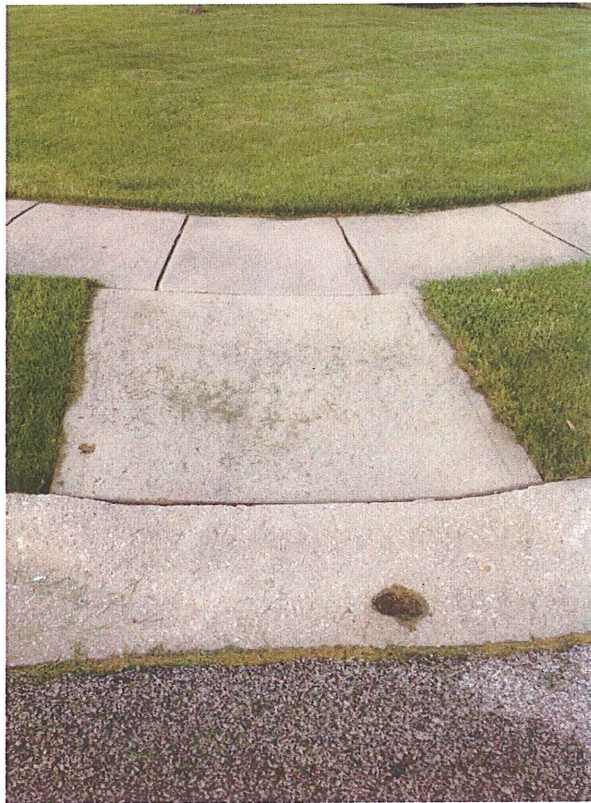
Photo of Curb

Truncated Domes	No
Comments	1" gap at gutter

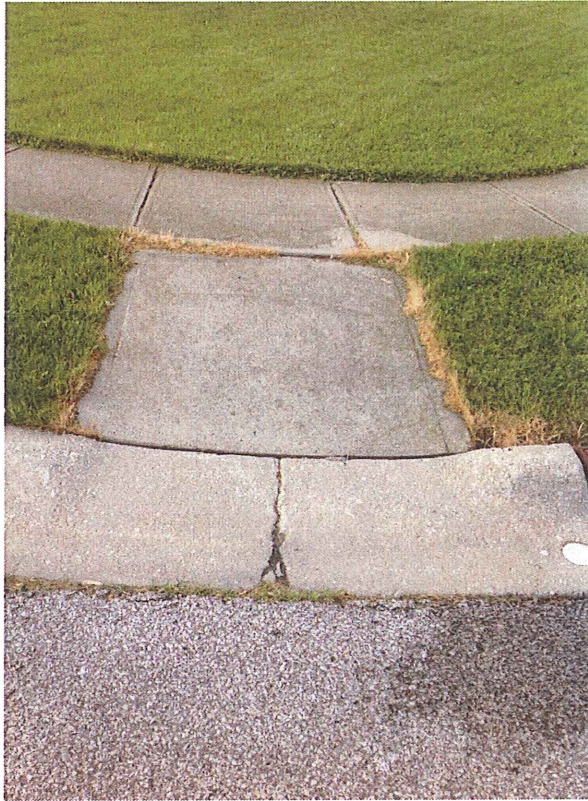
Photo of Curb

Truncated Domes	No
Comments	.5" gaps at gutter and walk

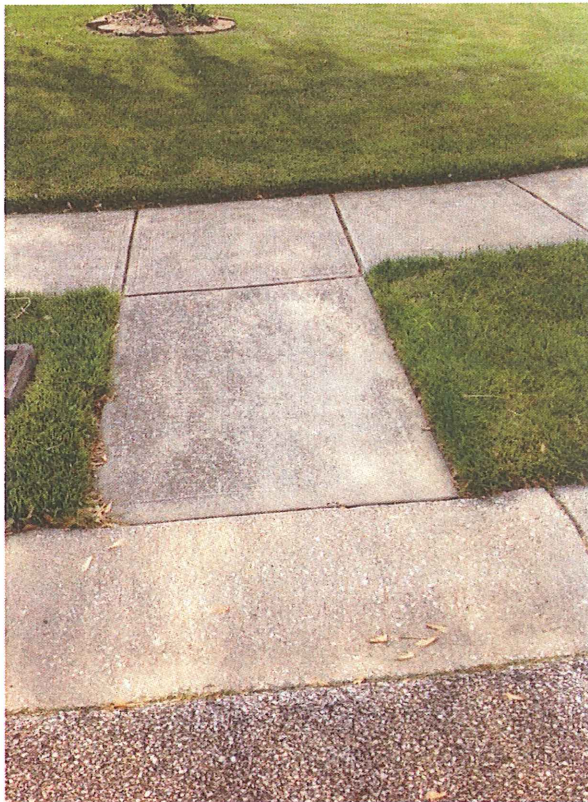
Photo of Curb

Truncated Domes	No
Comments	Ramp settlement .75"

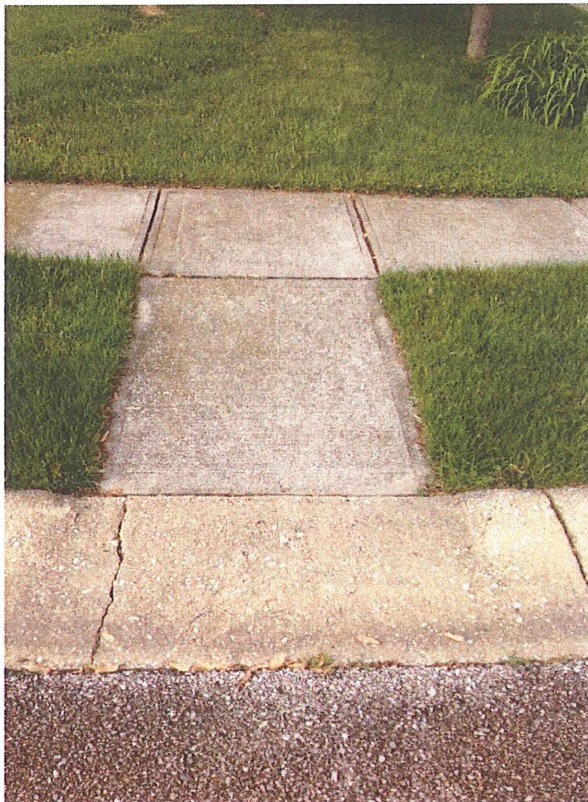
Photo of Curb

Truncated Domes	No
Comments	Ramp settlement 1"

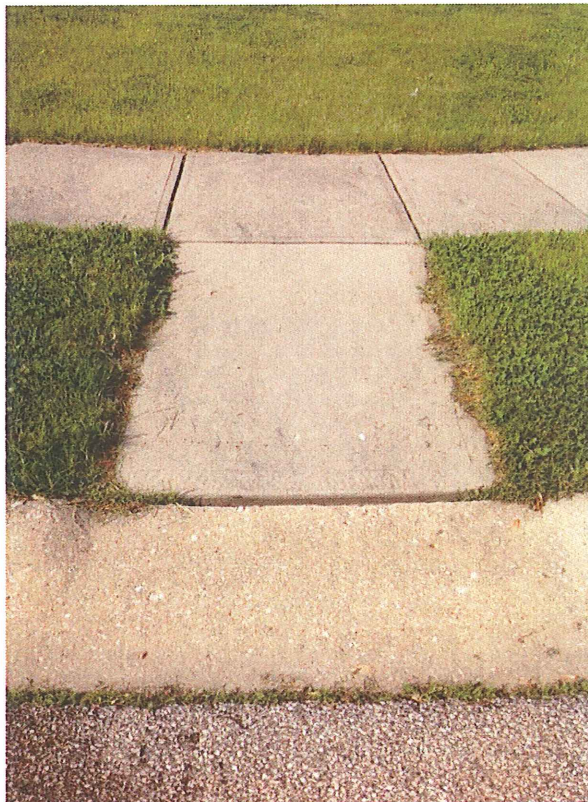
Photo of Curb

Truncated Domes	No
Comments	1" gap at gutter

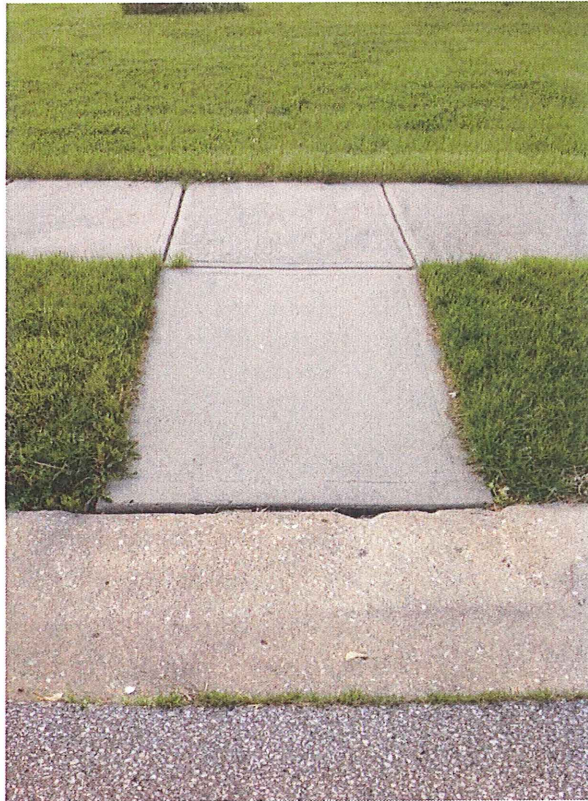
Photo of Curb

Truncated Domes	No
Comments	.75" gap at gutter

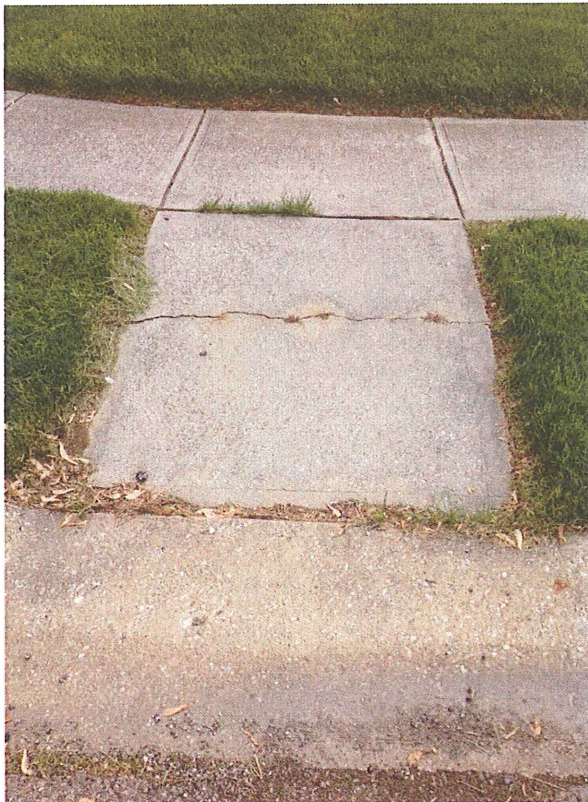
Photo of Curb

Intersection	Brixton Woods Dr and Brixton woods blvd
Corner	NE
Date	2015-05-15
Surveyor	Jack
Type of Curb Ramp	Perpendicular

Landing	Yes
Curb Ramp Width Feet	4
Curb Ramp Width Inch	2
Running Slope	8.4
Cross Slope	0.2

Truncated Domes	No
-----------------	----

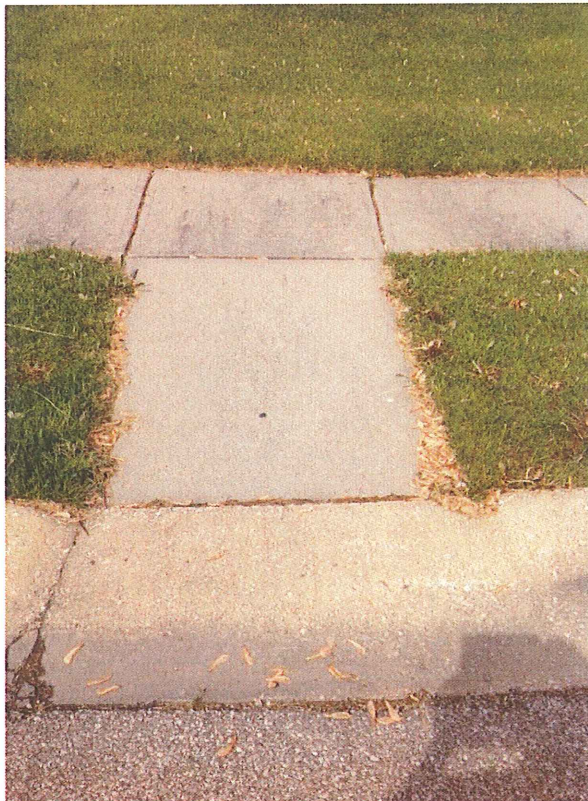
Photo of Curb

Intersection	Brixton Woods Dr and Brixton woods blvd
Corner	SW
Date	2015-05-15
Surveyor	Jack
Type of Curb Ramp	Perpendicular

Landing	Yes
Curb Ramp Width Feet	4
Running Slope	5.3
Cross Slope	0.4

Truncated Domes	No
-----------------	----

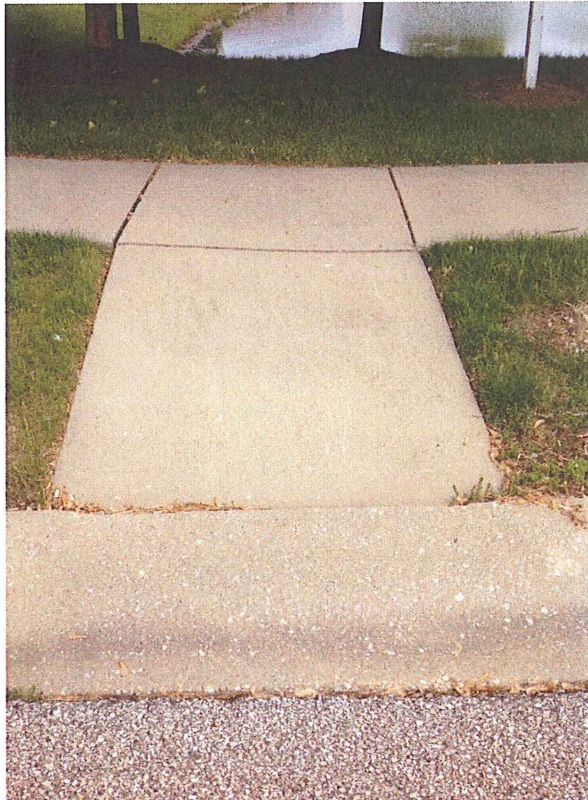
Photo of Curb

Intersection	Brixton Woods Dr and Brixton woods blvd
Corner	N
Date	2015-05-15
Surveyor	Jack
Type of Curb Ramp	Perpendicular

Landing	Yes
Curb Ramp Width Feet	5
Running Slope	7.5
Cross Slope	0.3

Truncated Domes	No
Comments	1" ramp settlement at gutter

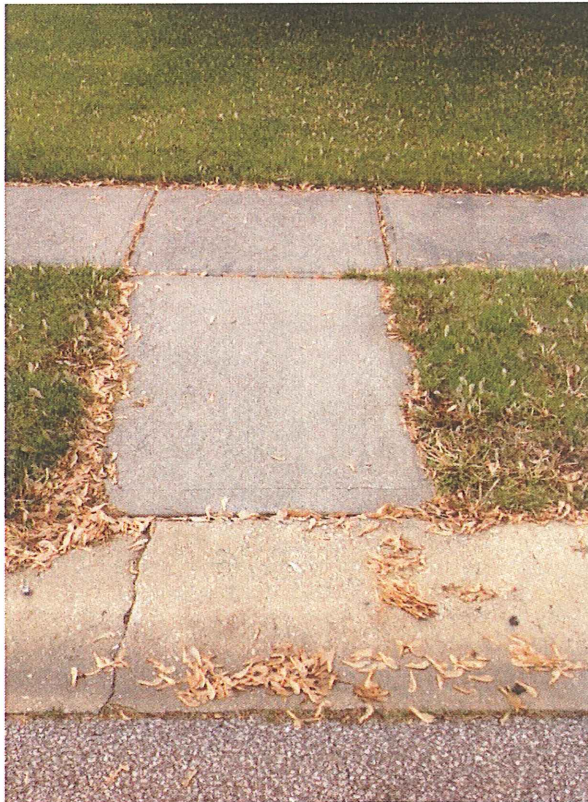
Photo of Curb

Intersection	Brixton Woods Dr and Brixton woods blvd
Corner	SW
Date	2015-05-15
Surveyor	Jack
Type of Curb Ramp	Perpendicular

Landing	Yes
Curb Ramp Width Feet	4
Curb Ramp Width Inch	2
Running Slope	2.4
Cross Slope	0.7

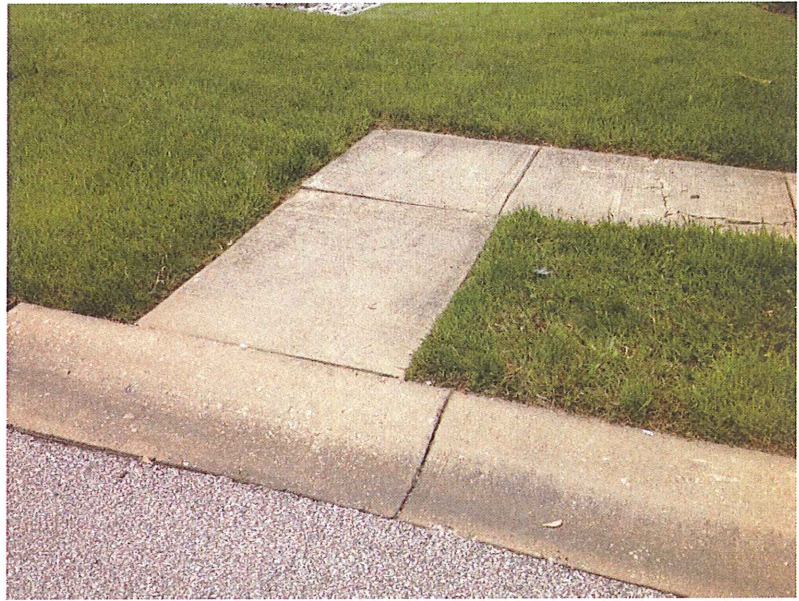
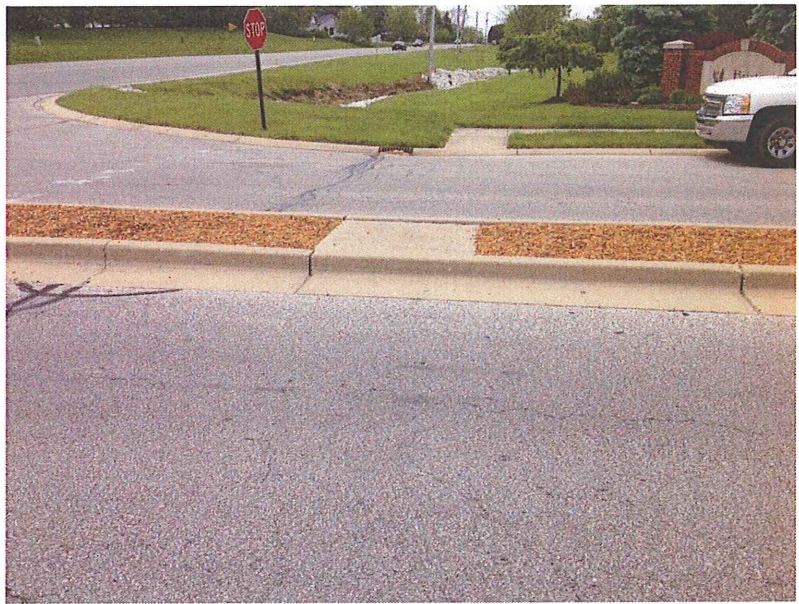
Photo of Curb

Intersection	Brixton woods blvd south end
Corner	NW
Date	2015-05-14
Surveyor	Jack
Type of Curb Ramp	Perpendicular

Landing	Yes
Curb Ramp Width Feet	4
Running Slope	4
Cross Slope	2

Truncated Domes	No
Comments	Raised median

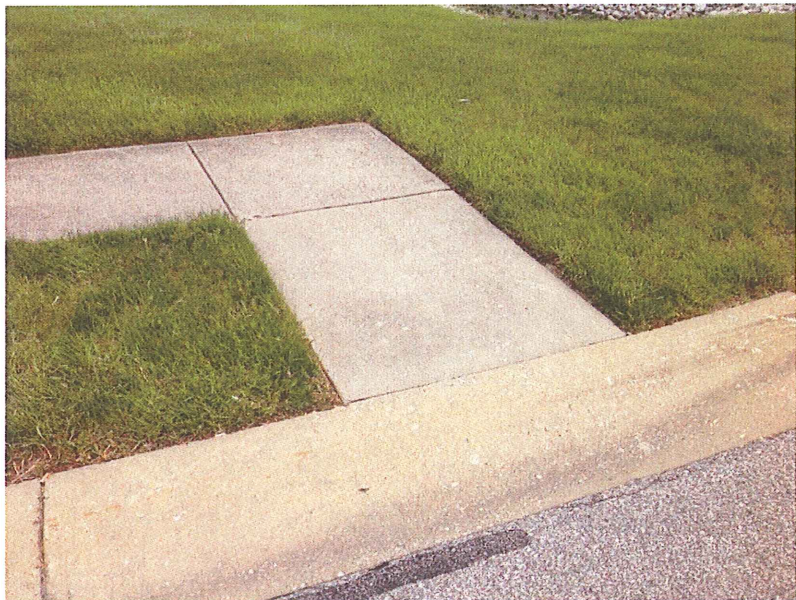
Photo of Curb

Intersection	Brixton woods blvd south end
Corner	NE
Date	2015-05-14
Surveyor	Jack
Type of Curb Ramp	Perpendicular

Landing	Yes
Curb Ramp Width Feet	4
Running Slope	2.4
Cross Slope	0.8

Truncated Domes	No
-----------------	----

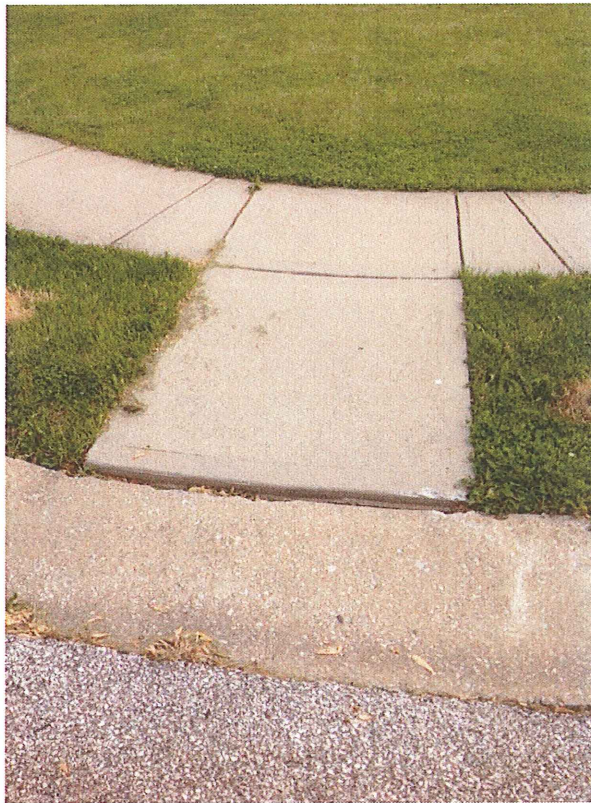
Photo of Curb

Intersection	Brixton Woods Dr and morse cir
Corner	NE
Date	2015-05-15
Surveyor	Jack
Type of Curb Ramp	Diagonal

Landing	Yes
Curb Ramp Width Feet	4
Curb Ramp Width Inch	2
Running Slope	3.4
Cross Slope	0.9

Truncated Domes	No
Comments	1.5" gap at gutter Location not pinned correct

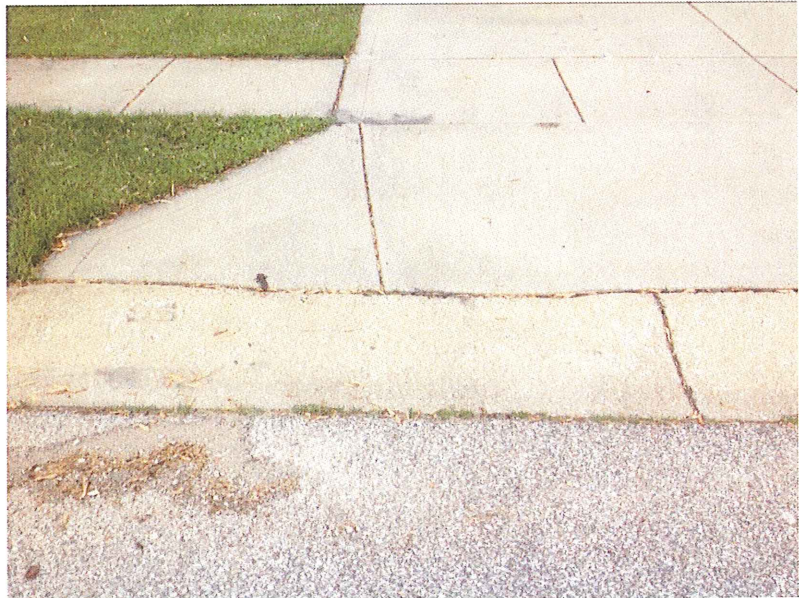
Photo of Curb

Intersection	Brixton Woods Dr and morse cir
Corner	NW
Date	2015-05-15
Surveyor	Jack
Type of Curb Ramp	Combined in driveway

Landing	Yes
Curb Ramp Width Feet	4
Running Slope	3.4
Cross Slope	0.9

Truncated Domes	Yes
Comments	Location not pinned correct

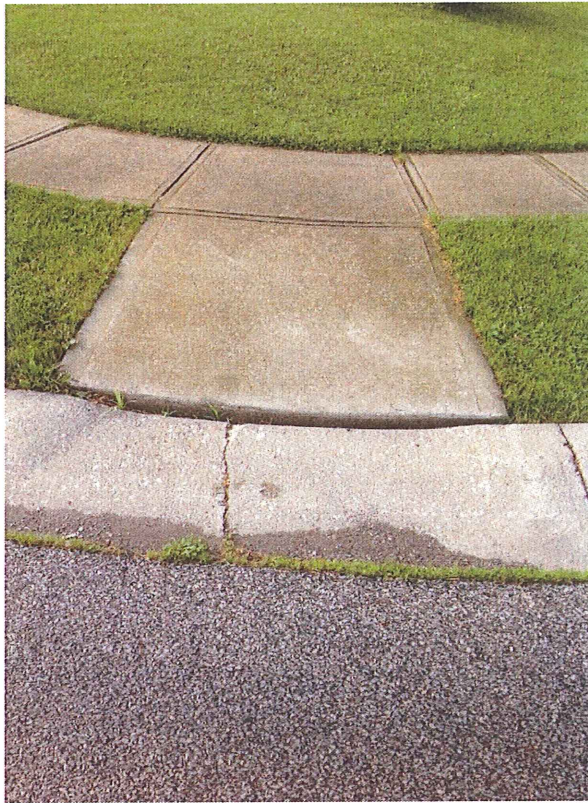
Photo of Curb

Intersection	Lockerbie In and Brixton woods w.
Corner	SE
Date	2015-05-15
Surveyor	Jack
Type of Curb Ramp	Diagonal

Landing	Yes
Curb Ramp Width Feet	5
Curb Ramp Width Inch	4
Running Slope	4.8
Cross Slope	0.7

Truncated Domes	No
Comments	Gutter settlement 2"

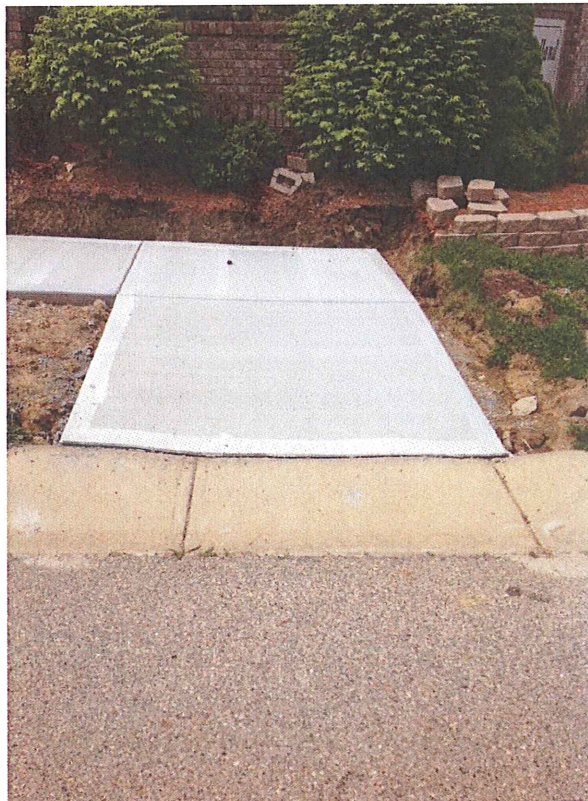
Photo of Curb

Intersection	Woodland hills n end
Corner	NW
Date	2015-05-14
Surveyor	Jack
Type of Curb Ramp	Perpendicular

Landing	Yes
Running Slope	7.3
Cross Slope	2.5

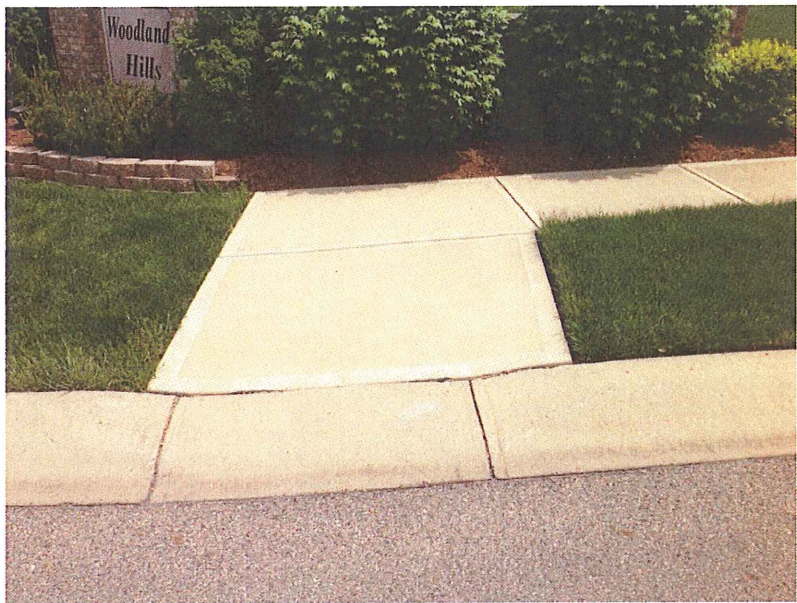
Photo of Curb

Intersection	Woodland hills n end
Corner	NE
Date	2015-05-14
Surveyor	Jack
Type of Curb Ramp	Perpendicular

Landing	Yes
Curb Ramp Width Feet	6
Running Slope	7
Cross Slope	2.3

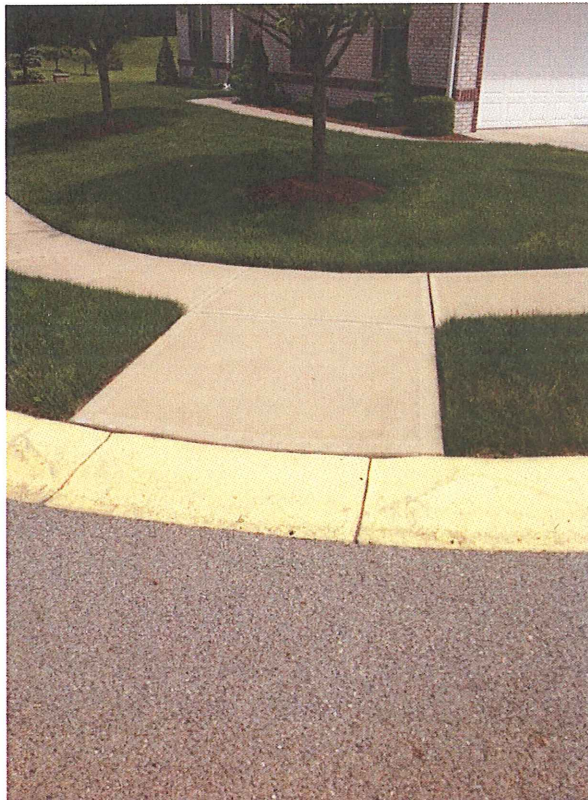
Photo of Curb

Intersection	Woodland hills and ridgeway
Corner	NE
Date	2015-05-14
Surveyor	Jack
Type of Curb Ramp	Diagonal

Landing	Yes
Curb Ramp Width Feet	5
Running Slope	5.7
Cross Slope	2.7

Truncated Domes	No
Comments	1" asphalt lip

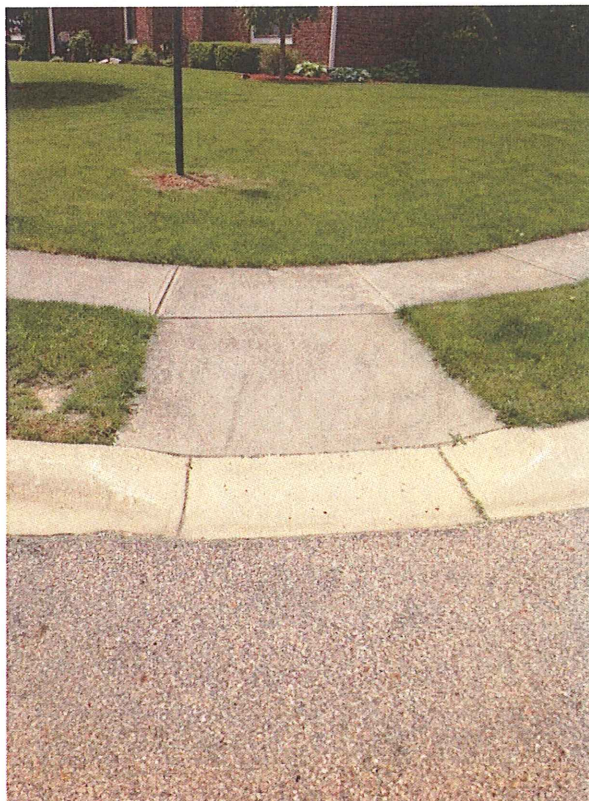
Photo of Curb

Intersection	Woodland hills and Johnston
Corner	SW
Date	2015-05-14
Surveyor	Jack
Type of Curb Ramp	Diagonal

Curb Ramp Width Feet	5
Curb Ramp Width Inch	4
Running Slope	7.8
Cross Slope	1.8

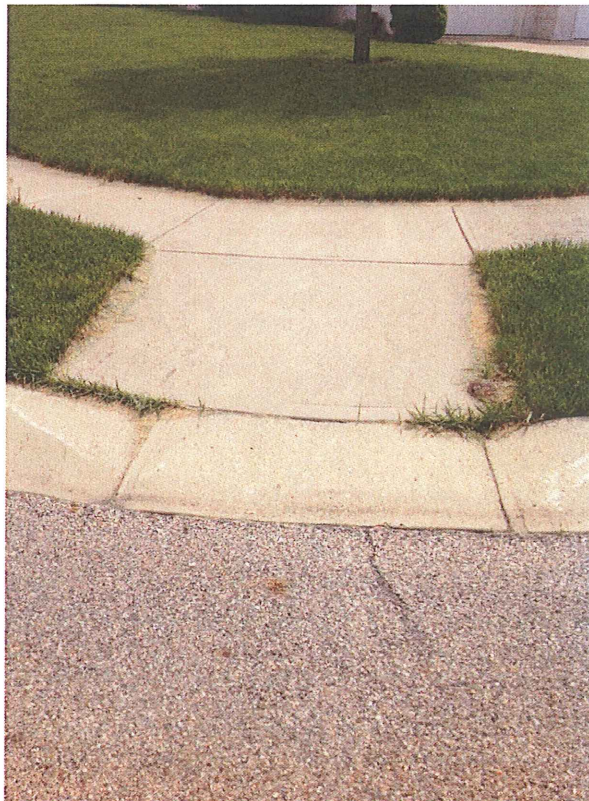
Photo of Curb

Intersection	Woodland hills and ridgeway
Corner	SE
Date	2015-05-14
Surveyor	Jack
Type of Curb Ramp	Diagonal

Curb Ramp Width Feet	6
Curb Ramp Width Inch	6
Running Slope	7
Cross Slope	2.6

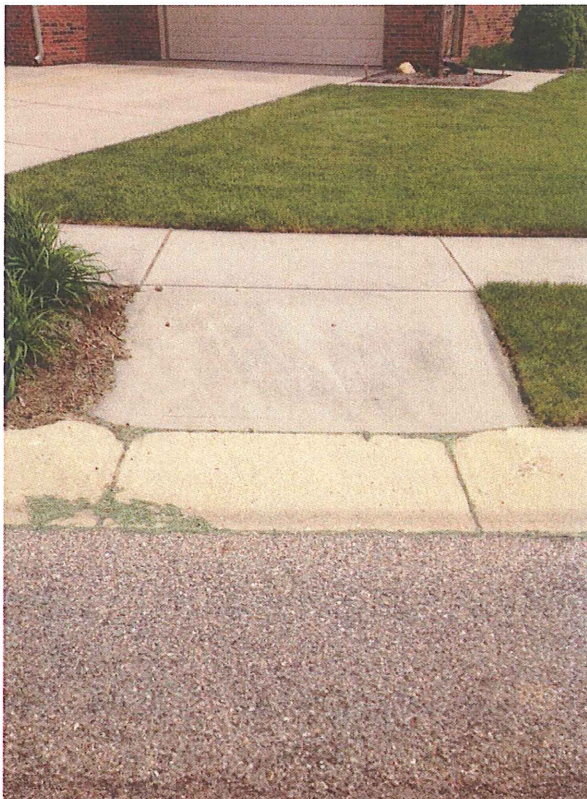
Photo of Curb

Intersection	Woodland hills and Lakeview
Corner	E
Date	2015-05-14
Surveyor	Jack
Type of Curb Ramp	Perpendicular

Landing	Yes
Curb Ramp Width Feet	6
Curb Ramp Width Inch	10
Running Slope	5.3
Cross Slope	2

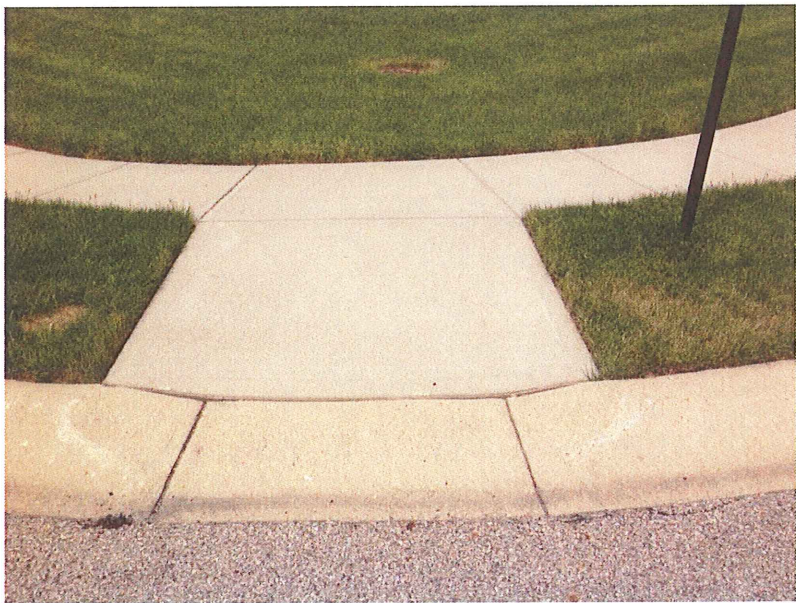
Photo of Curb

Intersection	Woodland hills and Lakeview
Corner	NW
Date	2015-05-14
Surveyor	Jack
Type of Curb Ramp	Diagonal

Landing	Yes
Curb Ramp Width Feet	6
Running Slope	6
Cross Slope	3.3

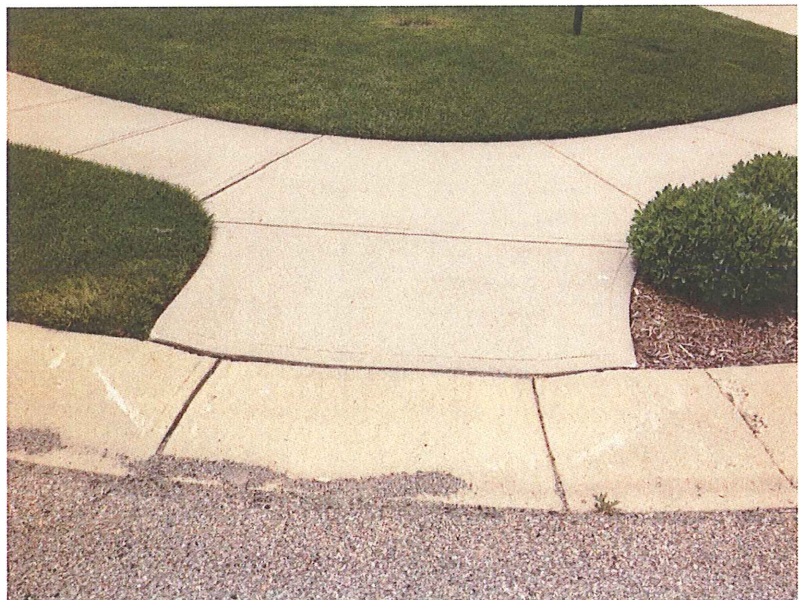
Photo of Curb

Intersection	Woodland hills and Lakeview
Corner	SW
Date	2015-05-14
Surveyor	Jack
Type of Curb Ramp	Diagonal

Landing	Yes
Curb Ramp Width Feet	6
Running Slope	5.1
Cross Slope	0.8

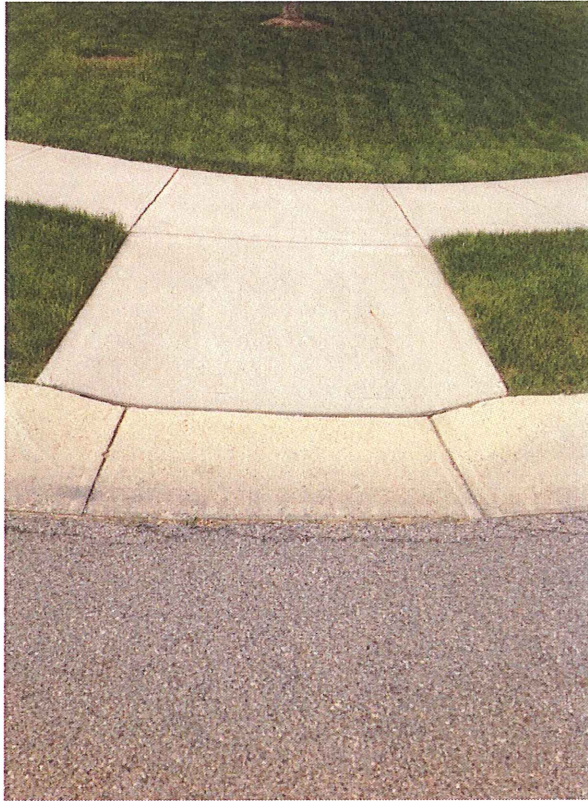
Photo of Curb

Intersection	Woodview and woodland hills
Corner	SW
Date	2015-05-14
Surveyor	Jack
Type of Curb Ramp	Diagonal

Landing	Yes
Curb Ramp Width Feet	5
Curb Ramp Width Inch	7
Running Slope	6.5
Cross Slope	3.7

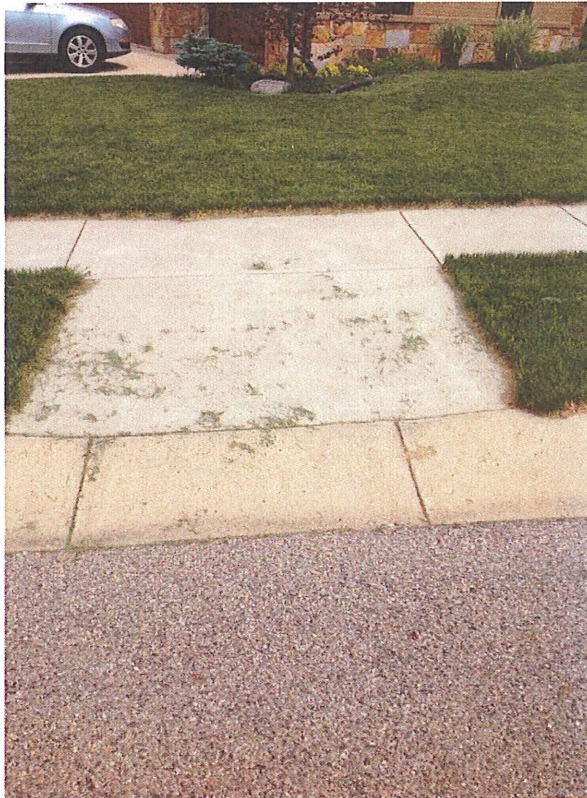
Photo of Curb

Intersection	Woodview and woodland hills
Corner	N
Date	2015-05-14
Surveyor	Jack
Type of Curb Ramp	Perpendicular

Landing	Yes
Curb Ramp Width Feet	7
Running Slope	5.2
Cross Slope	3

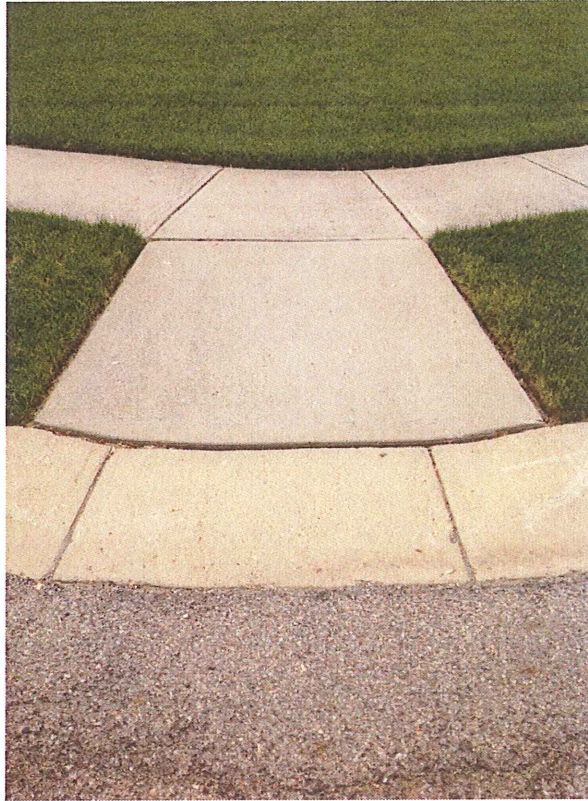
Photo of Curb

Intersection	Woodview and woodland hills
Corner	SE
Date	2015-05-14
Surveyor	Jack
Type of Curb Ramp	Diagonal

Landing	Yes
Curb Ramp Width Feet	4
Curb Ramp Width Inch	9
Running Slope	7
Cross Slope	3.3

Truncated Domes	No
Comments	.75" gap at curb

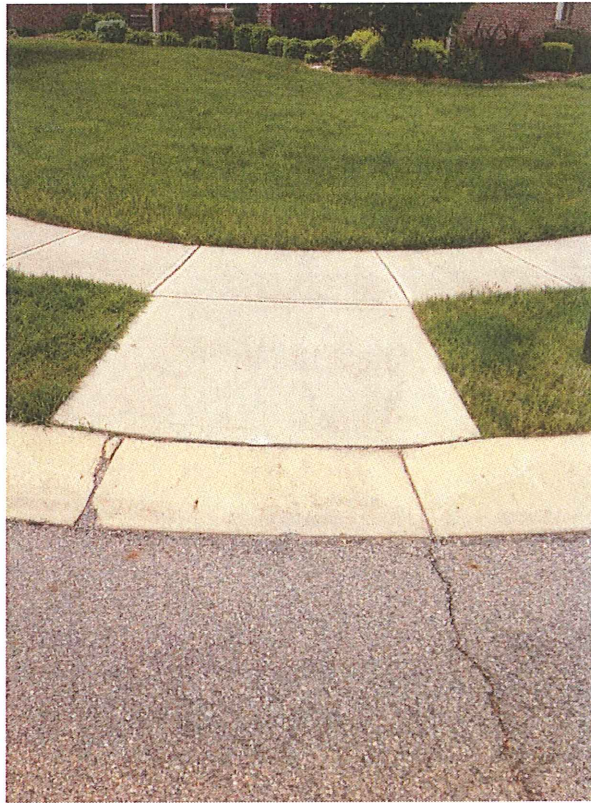
Photo of Curb

Intersection	woodland hills and woods edge
Corner	SW
Date	2015-05-14
Surveyor	Jack
Type of Curb Ramp	Diagonal

Landing	Yes
Curb Ramp Width Feet	5
Curb Ramp Width Inch	5
Running Slope	6.2
Cross Slope	1.5

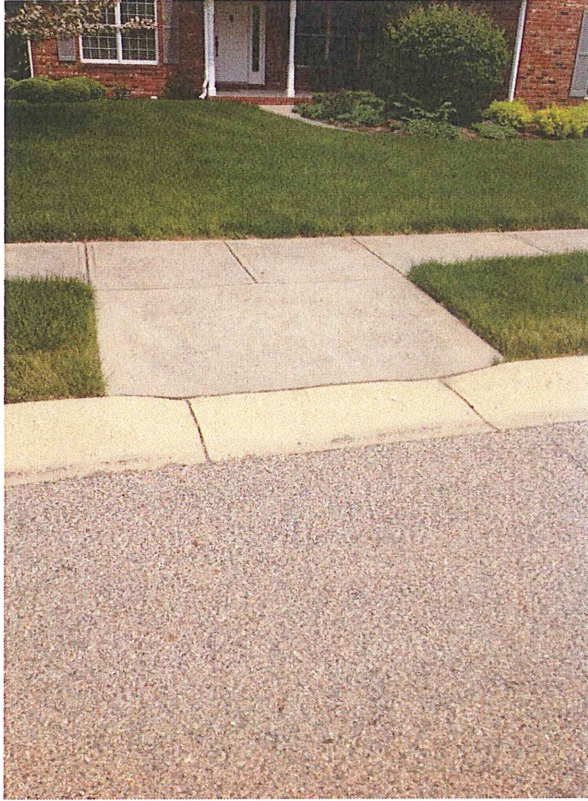
Photo of Curb

Intersection	Woodland hills and woods edge
Corner	N
Date	2015-05-14
Surveyor	Jack
Type of Curb Ramp	Perpendicular

Landing	Yes
Curb Ramp Width Feet	7
Curb Ramp Width Inch	7
Running Slope	5.1
Cross Slope	2

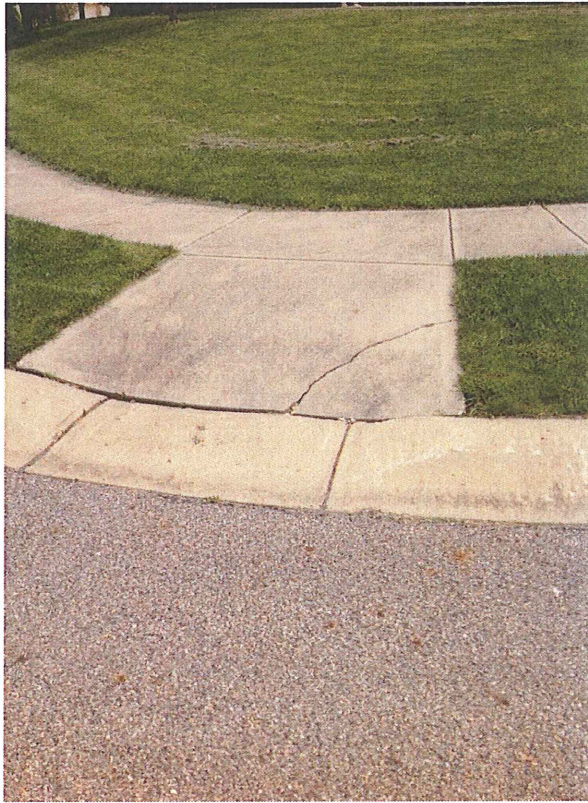
Photo of Curb

Truncated Domes	No
Comments	Cracked

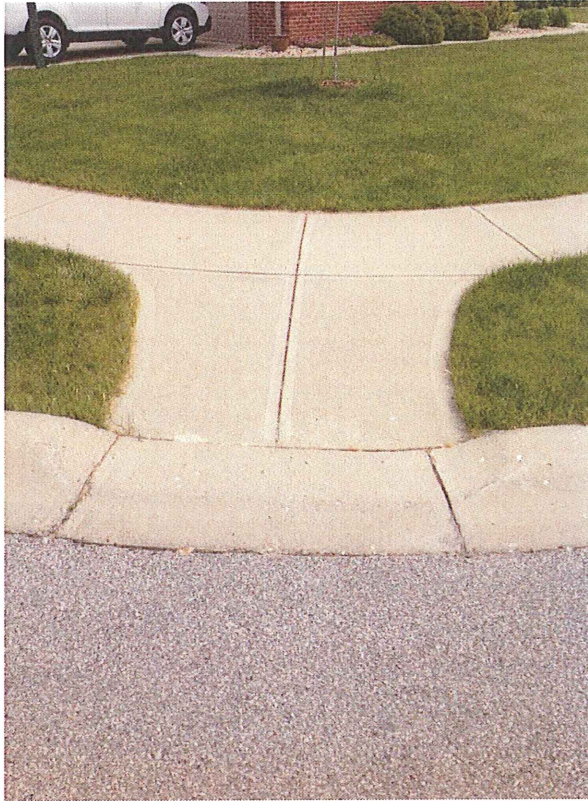
Photo of Curb

Truncated Domes	No
Comments	No ramp on opposite sides
