CITY OF PITTSBORO, INDIANA

CURB RAMP INVENTORY

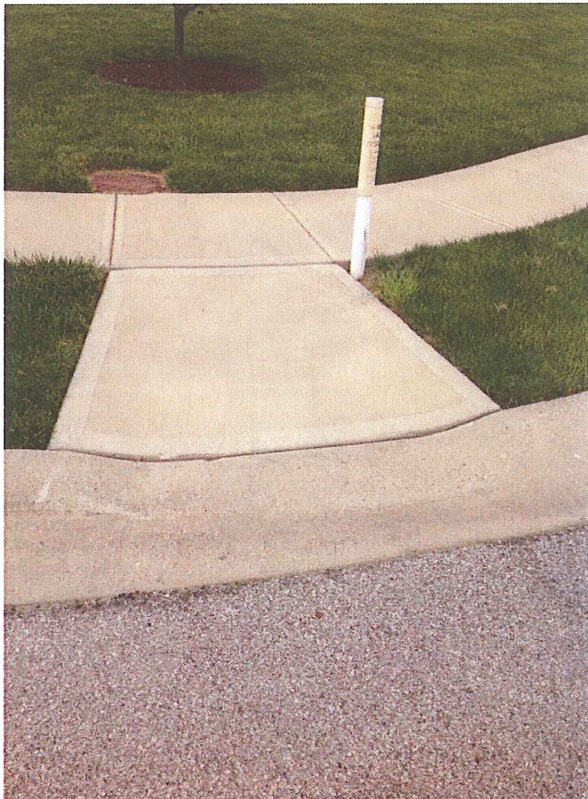
Photo of Curb

Truncated Domes	No
Comments	1" gap at walk

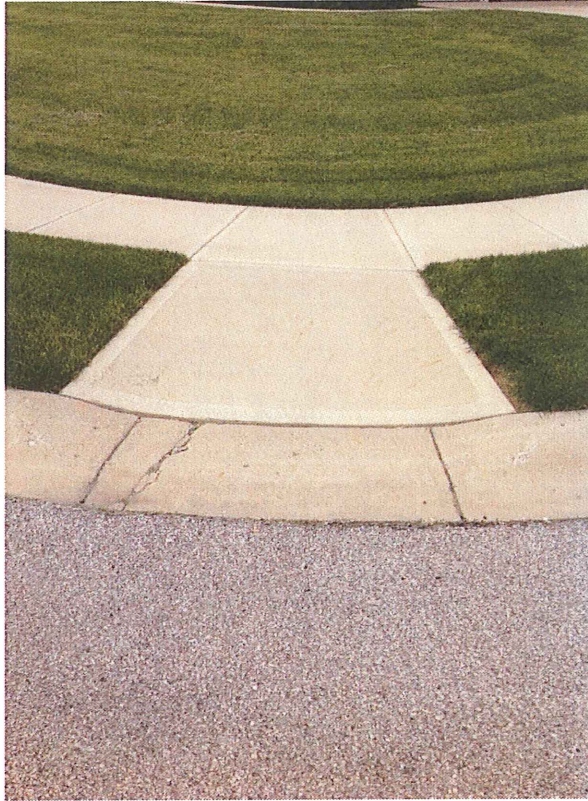
Photo of Curb

Truncated Domes	No
Comments	1" gap at curb

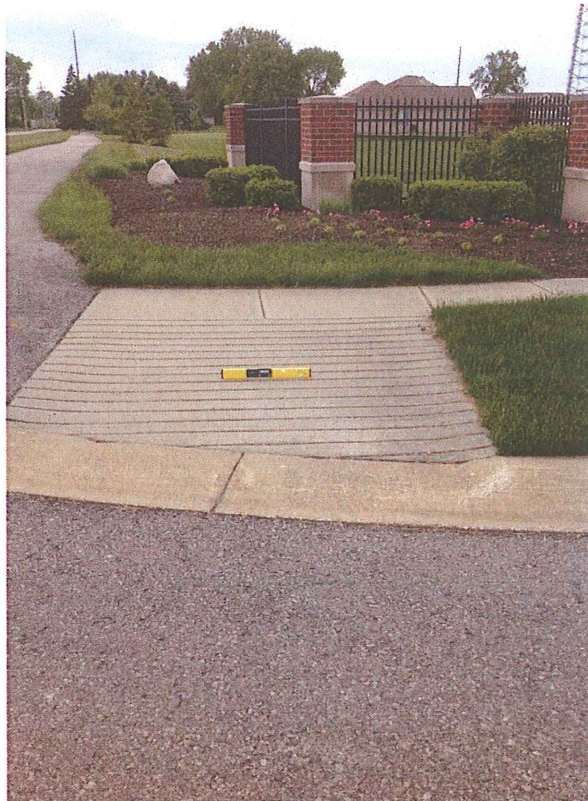
Photo of Curb

Truncated Domes	No
Comments	Subdivision with < 50% of lots built on.

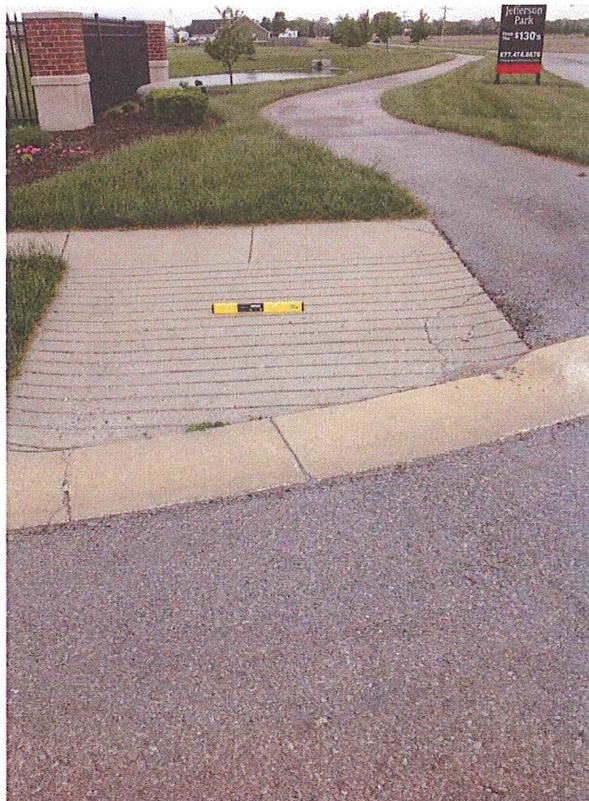
Photo of Curb

Comments	Subdivision with < 50% of lots built on.
----------	--

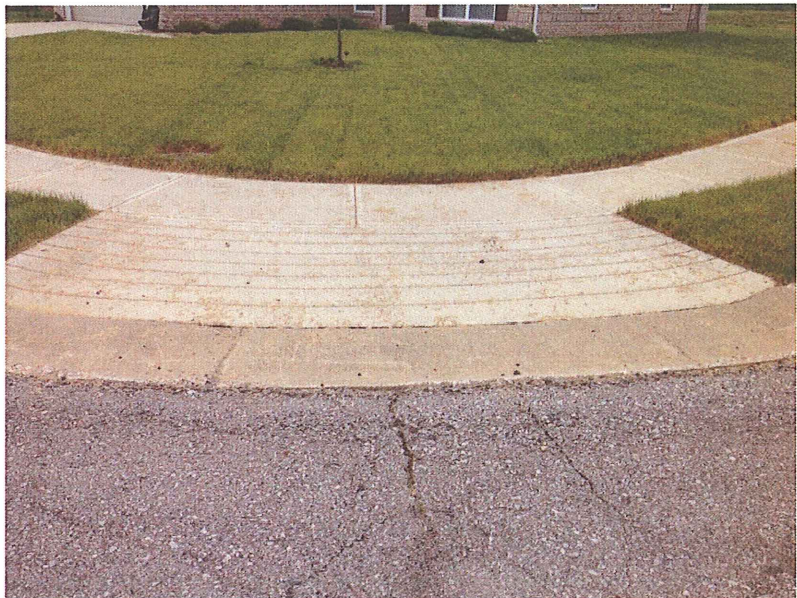
Photo of Curb

Comments	Subdivision with < 50% of lots built on.
----------	--

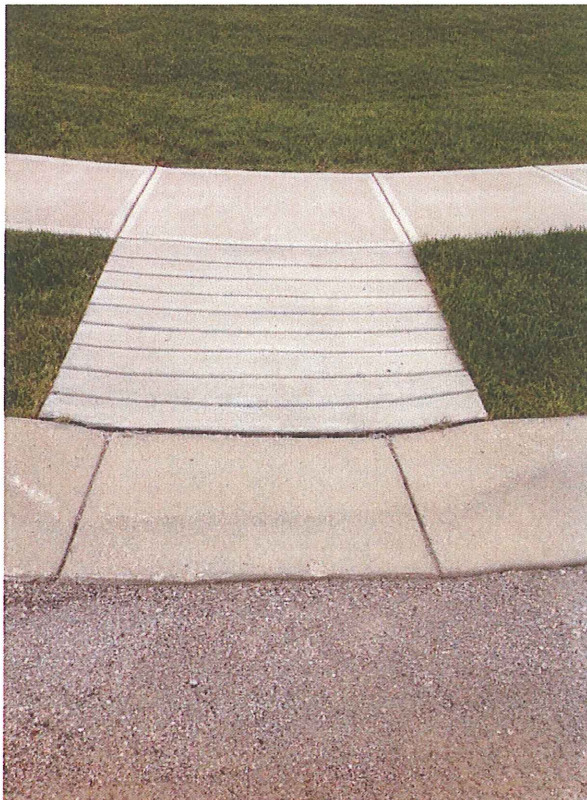
Photo of Curb

Landing	Yes
Curb Ramp Width Feet	5
Running Slope	4.8
Cross Slope	0
Comments	Subdivision with only 4 houses built
