CITY OF PITTSBORO, INDIANA

SIDEWALK INVENTORY

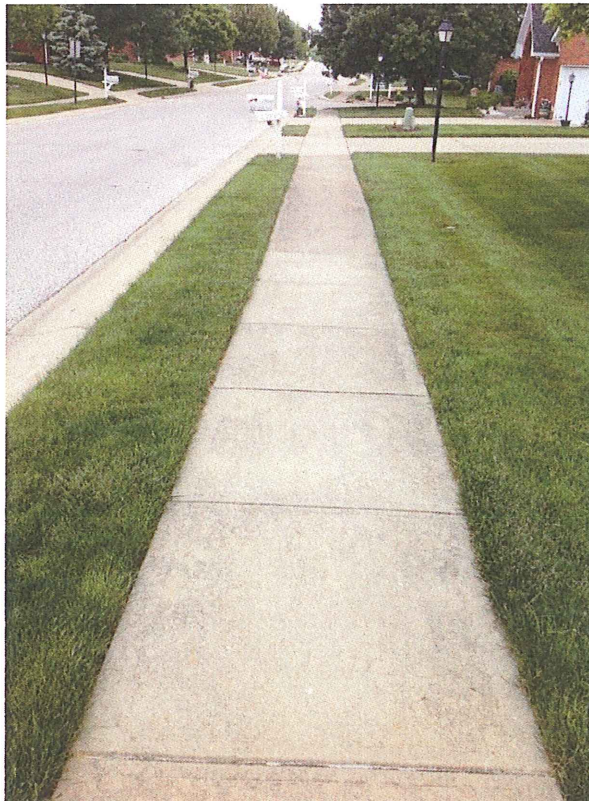
South of clubhouse rd

Sidewalk Cross Slope	less than 2%
Sidewalk Running Slope	1.6
Sidewalk Width Without Curb Feet	4
Sidewalk Width Without Curb Inch	0

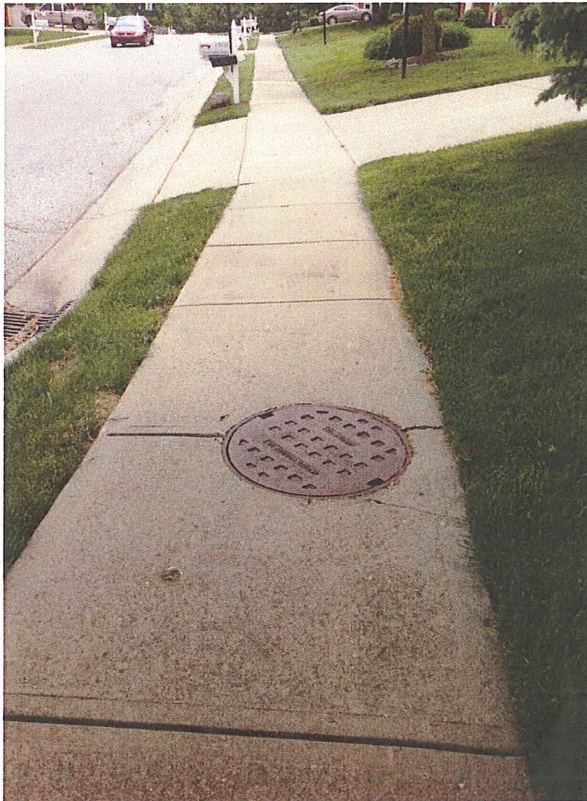
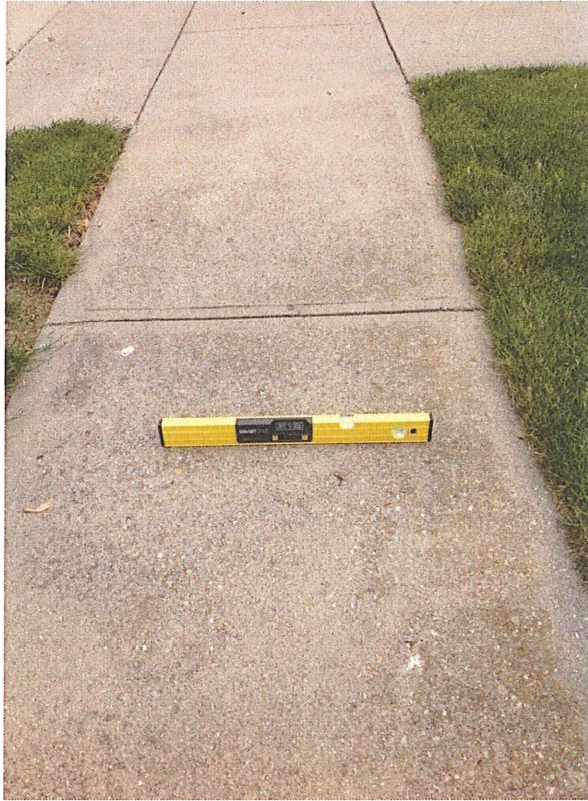
South of clubhouse rd

Sidewalk Cross Slope	greater than 3%
Sidewalk Running Slope	1.4
Sidewalk Width Without Curb Feet	4
Sidewalk Width Without Curb Inch	0
Comments	MH casting. Some x slopes < 2%. Some over 6%

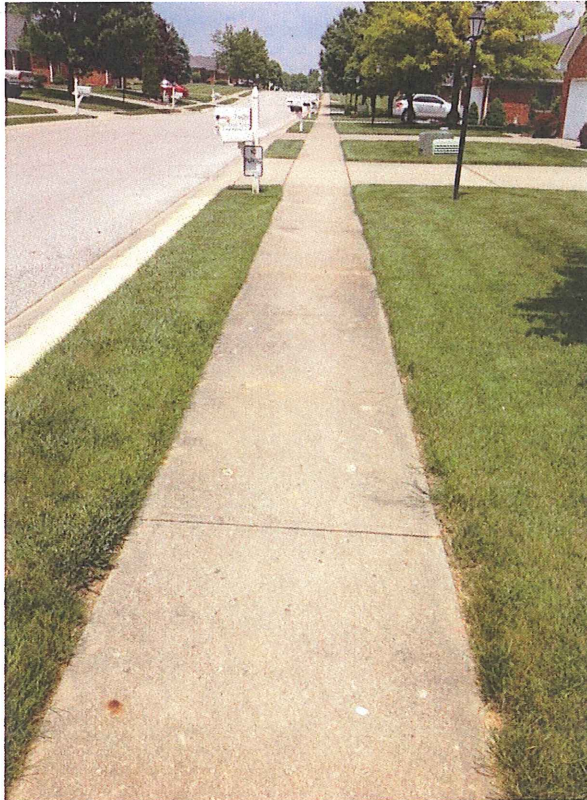
North of clubhouse rd

Sidewalk Cross Slope	less than 2%
Sidewalk Running Slope	2
Sidewalk Passing Space	Yes
Sidewalk Width Without Curb Feet	4
Sidewalk Width Without Curb Inch	0
Comments	4 raised panels 3/4"

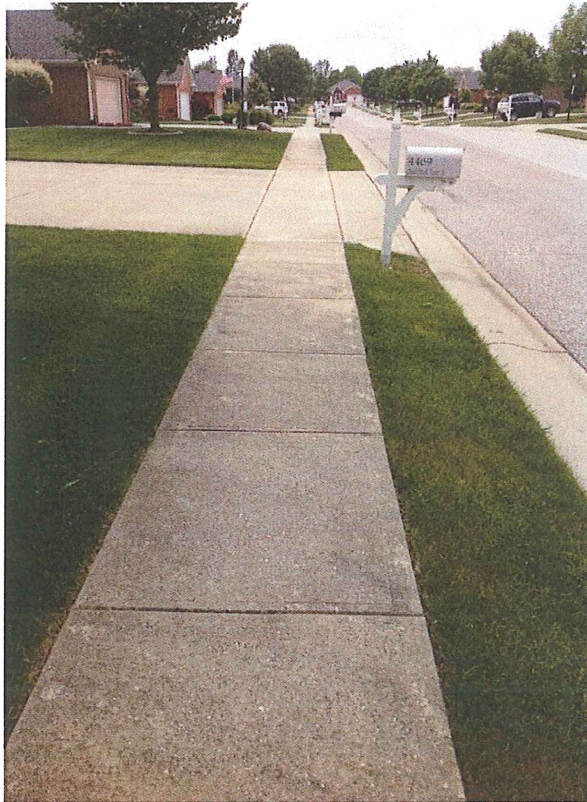
Sidewalk Cross Slope	less than 2%
Sidewalk Running Slope	0.8
Sidewalk Width Without Curb Inch	0
Comments	X slope through 4 drives > 3%

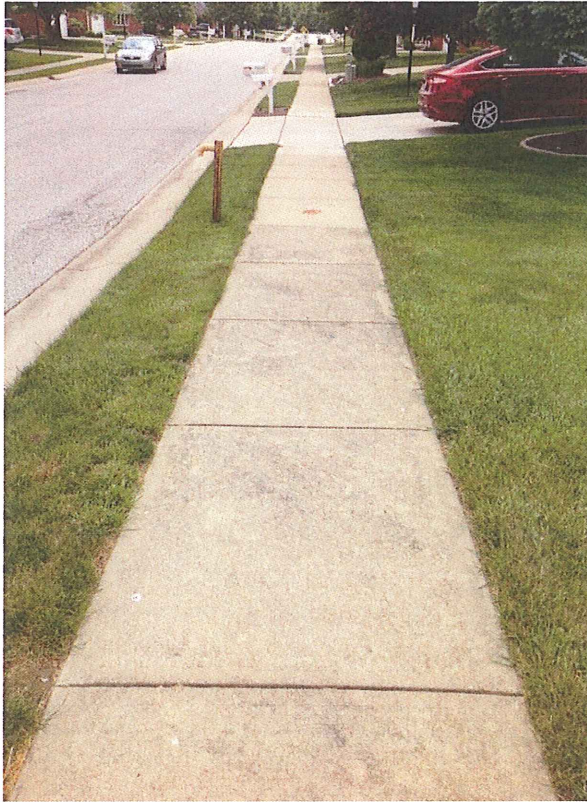
North of clubhouse rd

Sidewalk Cross Slope	2 - 3%
Sidewalk Running Slope	1.2
Sidewalk Vertical Discontinuities	Yes
Sidewalk Width Without Curb Feet	4
Sidewalk Width Without Curb Inch	0
Comments	About half of this area is < 2% x slope. Sidewalk settlement at drives 3/4"

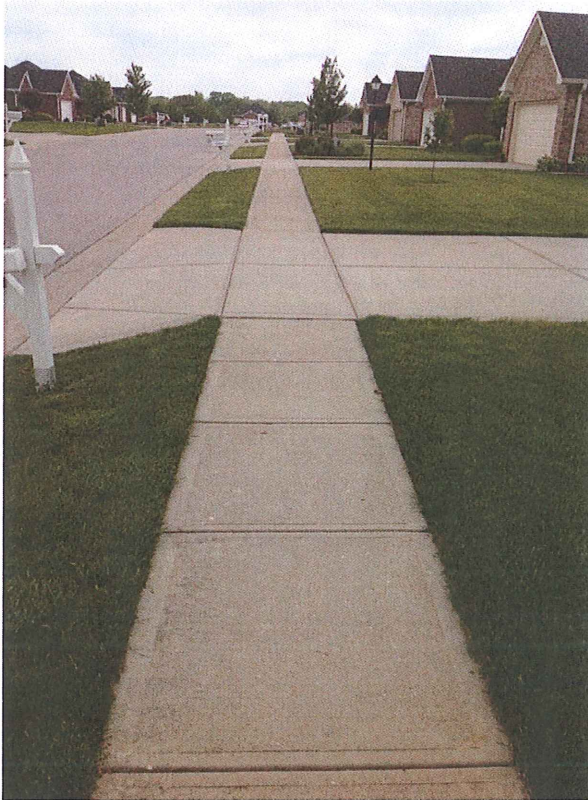
Sidewalk Cross Slope	less than 2%
Sidewalk Running Slope	0.2
Sidewalk Width Without Curb Feet	4
Sidewalk Width Without Curb Inch	0
Comments	Only 50% of lots built on. Walk not in at empty lots

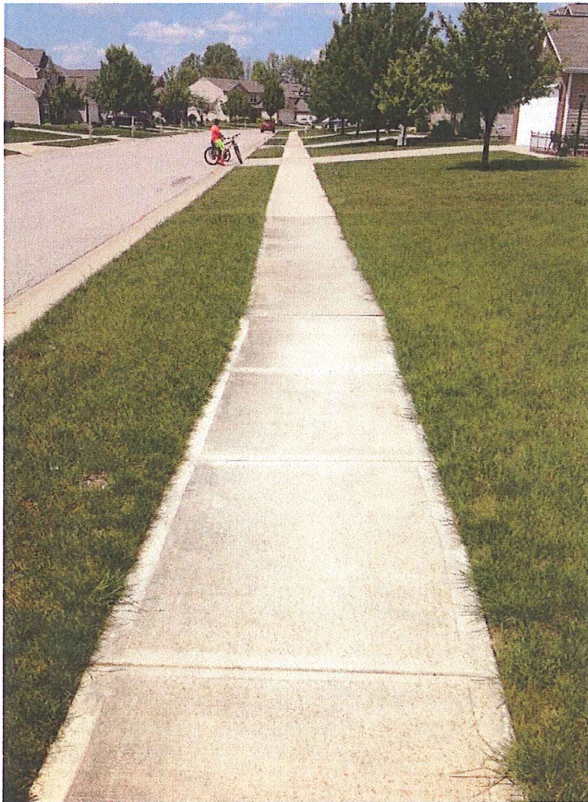
Sidewalk Cross Slope	less than 2%
Sidewalk Running Slope	0.4
Sidewalk Width Without Curb Feet	4
Sidewalk Width Without Curb Inch	0
Comments	Valve box up 3/4"

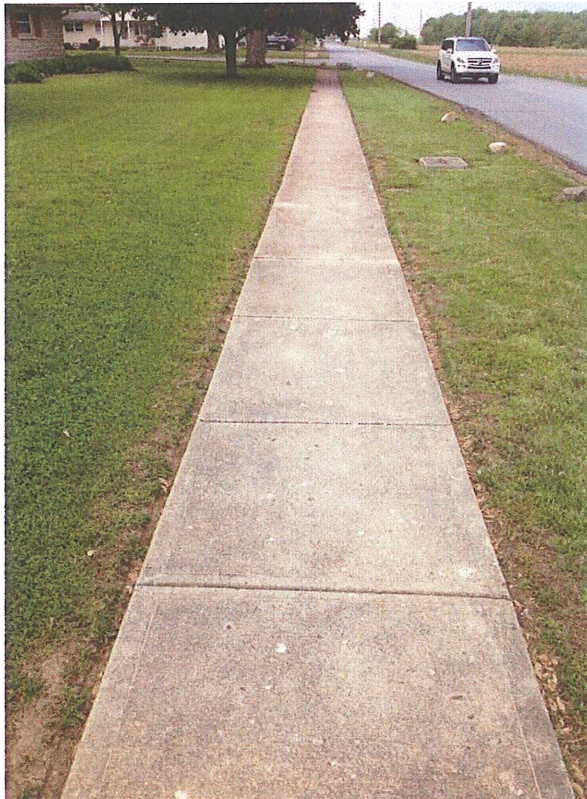
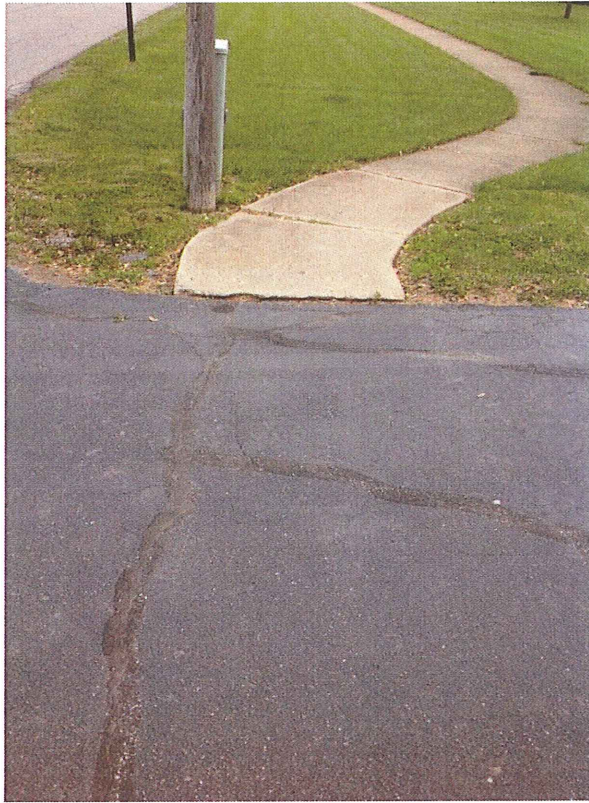
Maple to Karen

Sidewalk Cross Slope	less than 2%
Sidewalk Running Slope	0.5
Sidewalk Width Without Curb Feet	4
Sidewalk Width Without Curb Inch	0
Comments	Walk up 1.5" at drive

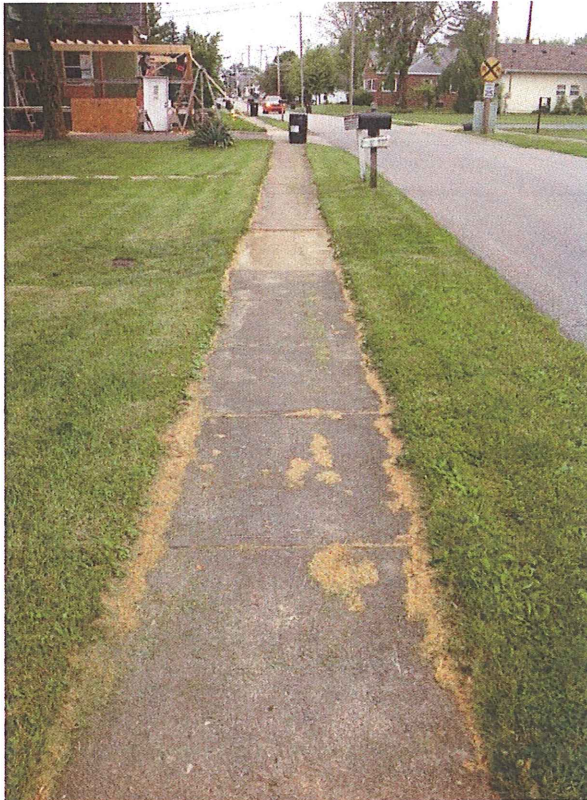
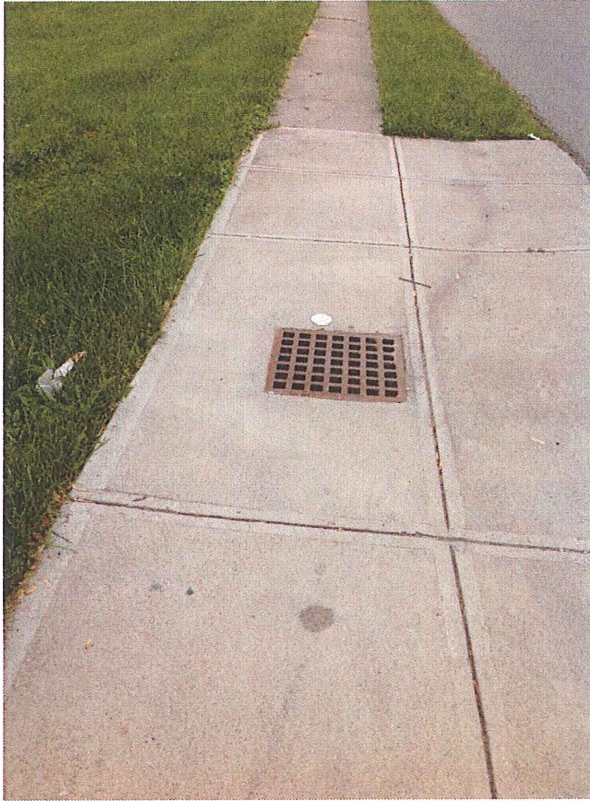
Scott to Poplar

Sidewalk Cross Slope	less than 2%
Sidewalk Running Slope	0.3
Sidewalk Width Without Curb Feet	4
Sidewalk Width Without Curb Inch	0
Comments	4 raised panels 3/4" to 1.5". Casting in walk w 2" openings

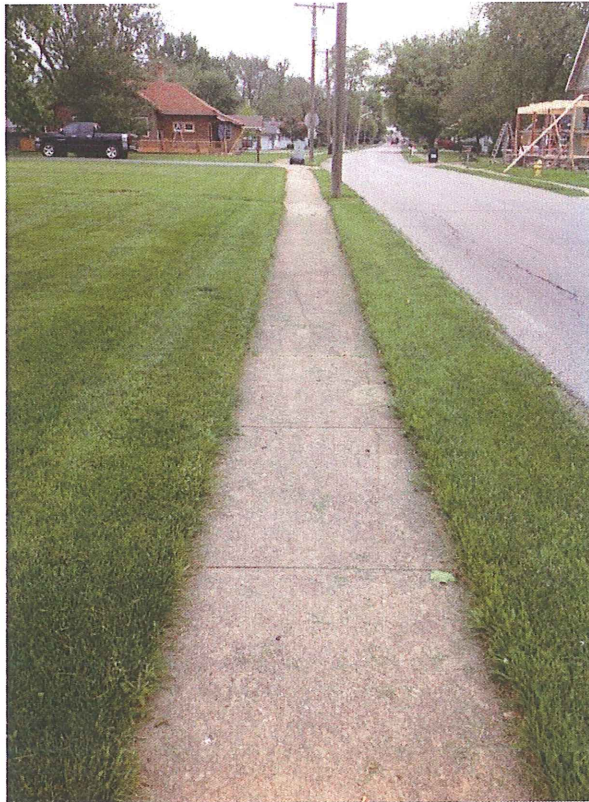
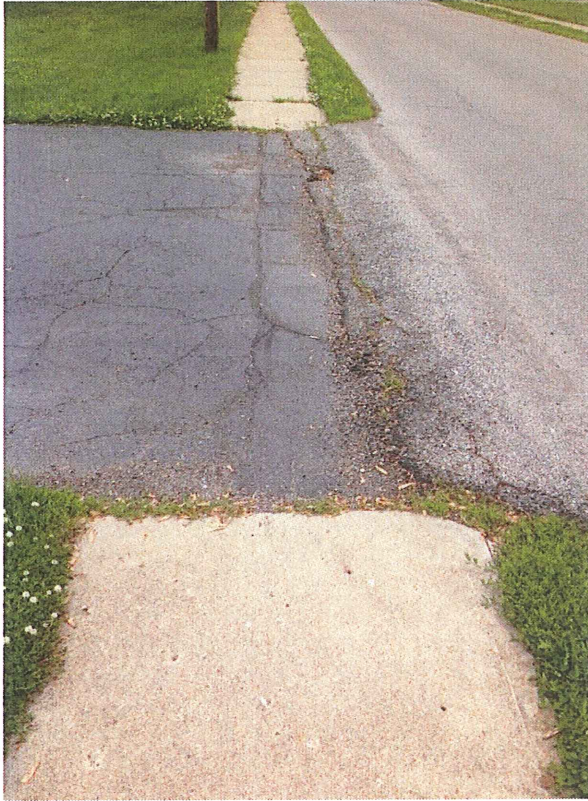
Scott to Poplar

Sidewalk Cross Slope	less than 2%
Sidewalk Running Slope	0.6
Sidewalk Width Without Curb Feet	5
Sidewalk Width Without Curb Inch	0
Comments	Rough driveway

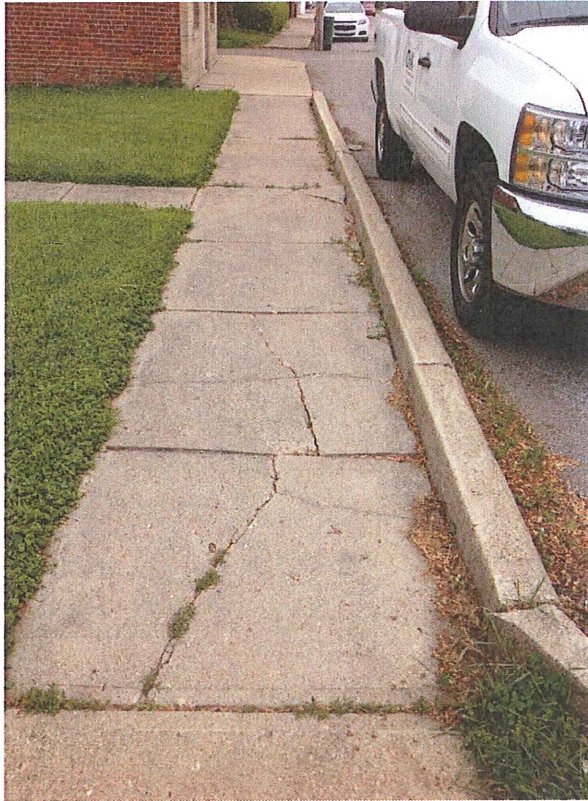
Lodge to church

Sidewalk Cross Slope	less than 2%
Sidewalk Running Slope	0.4
Sidewalk Width Without Curb Feet	4
Sidewalk Width Without Curb Inch	0
Comments	Badly cracked areas and curb up 6" above walk

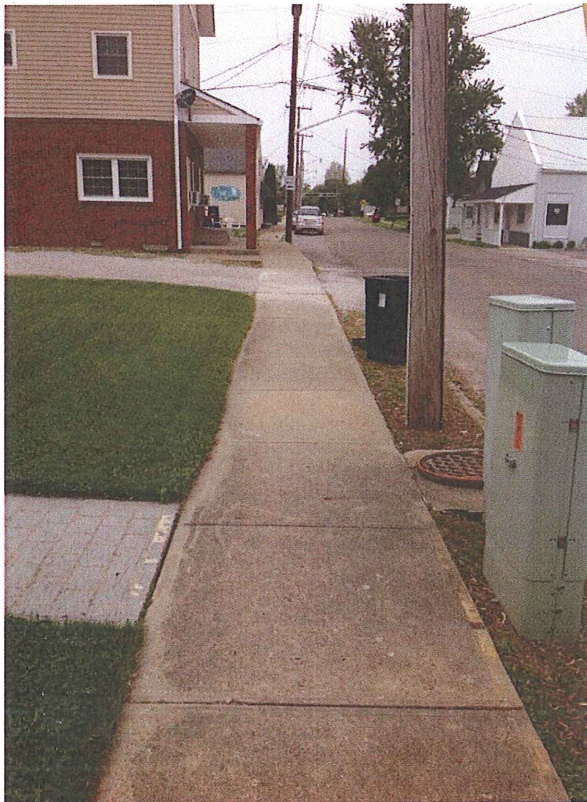
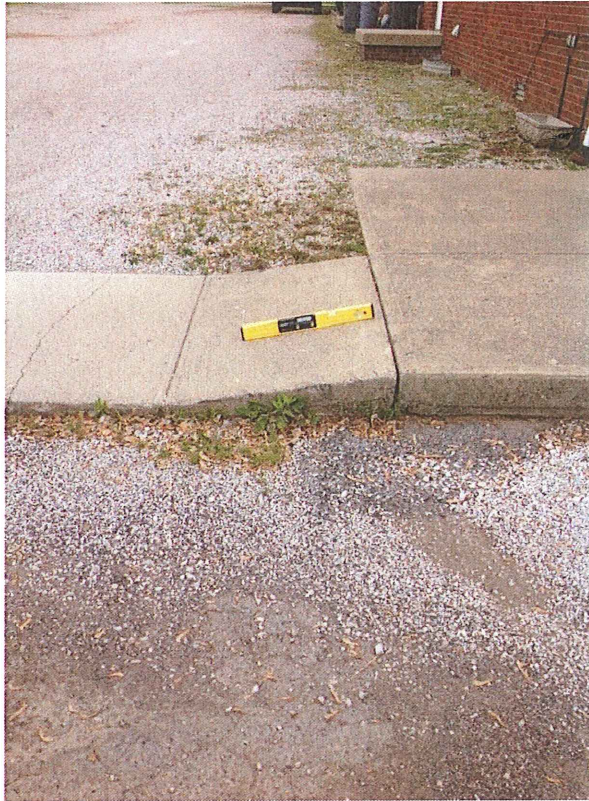
Church to Lodge

Sidewalk Obstructions	Yes
Sidewalk Cross Slope	less than 2%
Sidewalk Running Slope	0.4
Sidewalk Width Without Curb Feet	4
Sidewalk Width Without Curb Inch	0
Comments	Running slope 10 % at alley for 3'

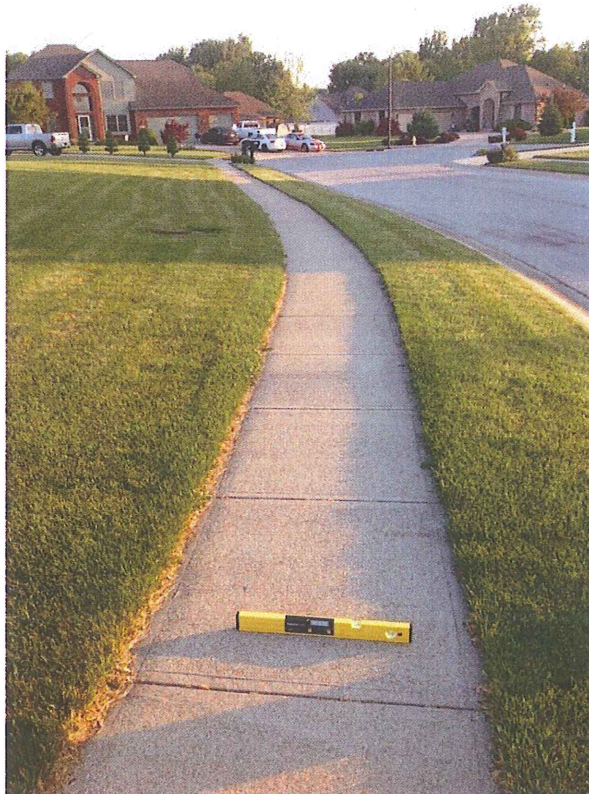
Sidewalk Cross Slope	less than 2%
Sidewalk Running Slope	0.9
Sidewalk Surface Discontinuities	Yes
Sidewalk Width Without Curb Feet	4
Sidewalk Width Without Curb Inch	0
Comments	1 raised panel 3/4". 1 empty lot no walk

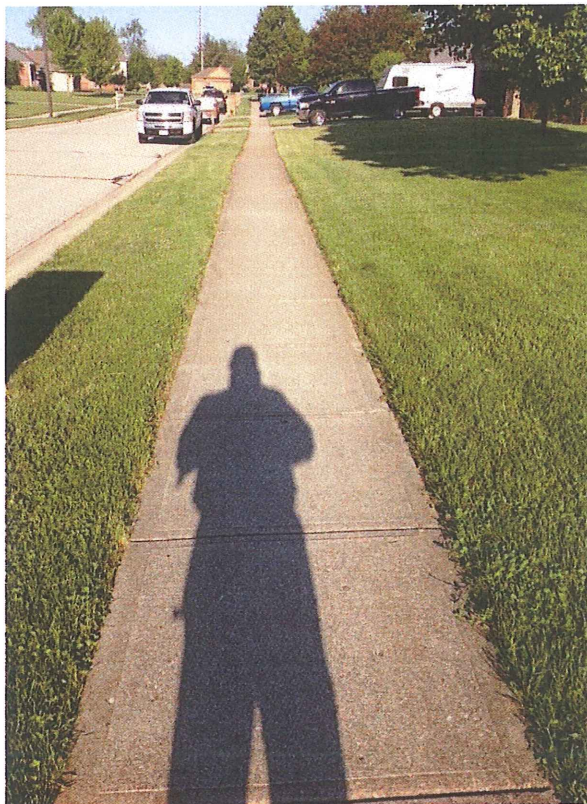
Karen to Edgewood

Sidewalk Cross Slope	2 - 3%
Sidewalk Running Slope	1.6
Sidewalk Vertical Discontinuities	Yes
Sidewalk Width Without Curb Feet	4
Sidewalk Width Without Curb Inch	0
Comments	About half of area < 2%. 2 raised panels 1"

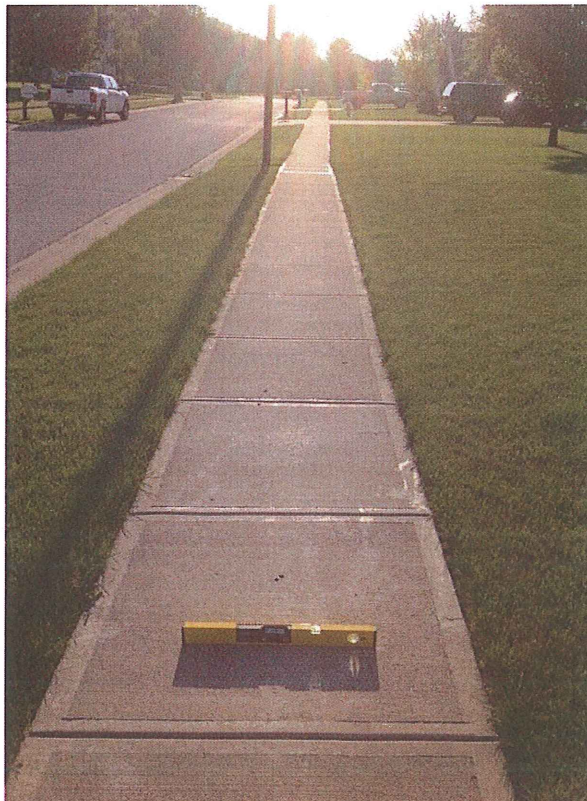
Karen to Edgewood

Sidewalk Cross Slope	greater than 3%
Sidewalk Running Slope	1.6
Sidewalk Vertical Discontinuities	Yes
Sidewalk Width Without Curb Inch	0
Comments	Most of area < 2%. About 200' from curve to Edgewood 3 to 6% x slope 2 raised panels 3/4"

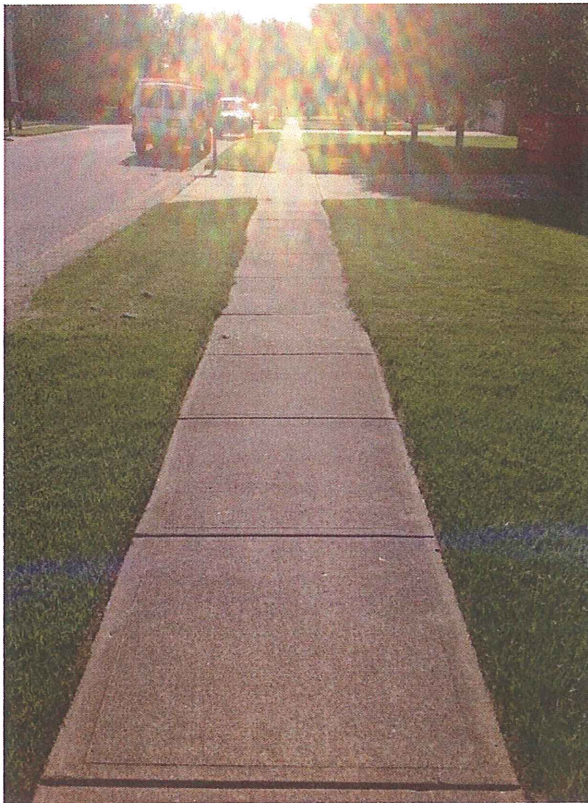
Sidewalk Cross Slope	less than 2%
Sidewalk Running Slope	0.9
Sidewalk Vertical Discontinuities	Yes
Sidewalk Width Without Curb Feet	4
Sidewalk Width Without Curb Inch	0
Comments	2 raised panels 3/4"

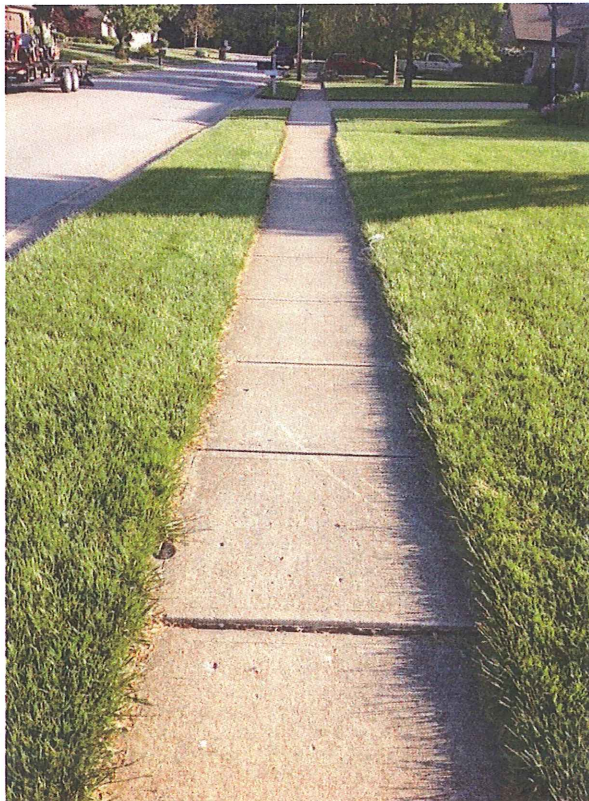
Edgewood to Wall

Sidewalk Cross Slope	less than 2%
Sidewalk Running Slope	0.7
Sidewalk Vertical Discontinuities	Yes
Sidewalk Width Without Curb Feet	4
Sidewalk Width Without Curb Inch	0
Comments	3 raised panels 3/4"

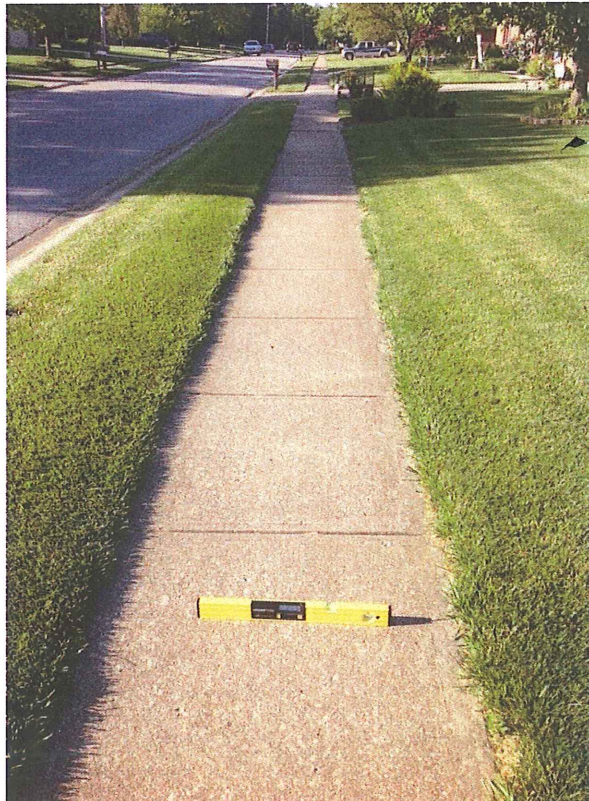
Sidewalk Cross Slope	less than 2%
Sidewalk Running Slope	1.4
Sidewalk Vertical Discontinuities	Yes
Sidewalk Width Without Curb Feet	4
Sidewalk Width Without Curb Inch	0
Comments	4 raised panels 1"

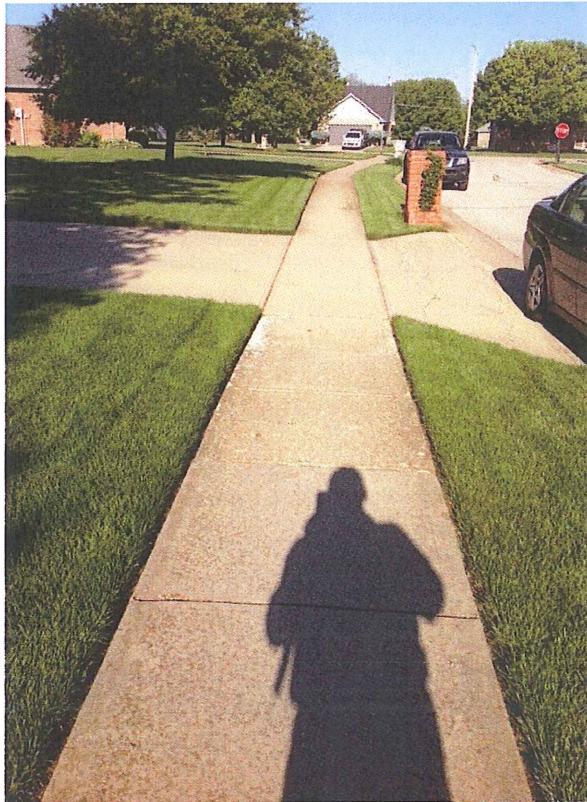
Sidewalk Cross Slope	less than 2%
Sidewalk Running Slope	0.7
Sidewalk Width Without Curb Feet	4
Sidewalk Width Without Curb Inch	0

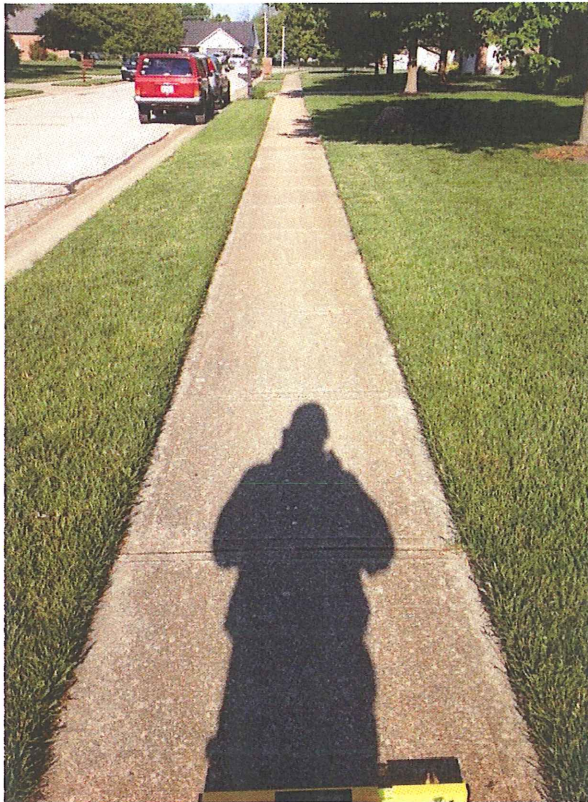
Sidewalk Cross Slope	less than 2%
Sidewalk Running Slope	0.9
Sidewalk Vertical Discontinuities	Yes
Sidewalk Width Without Curb Feet	4
Sidewalk Width Without Curb Inch	0
Comments	2 raised panels 1"

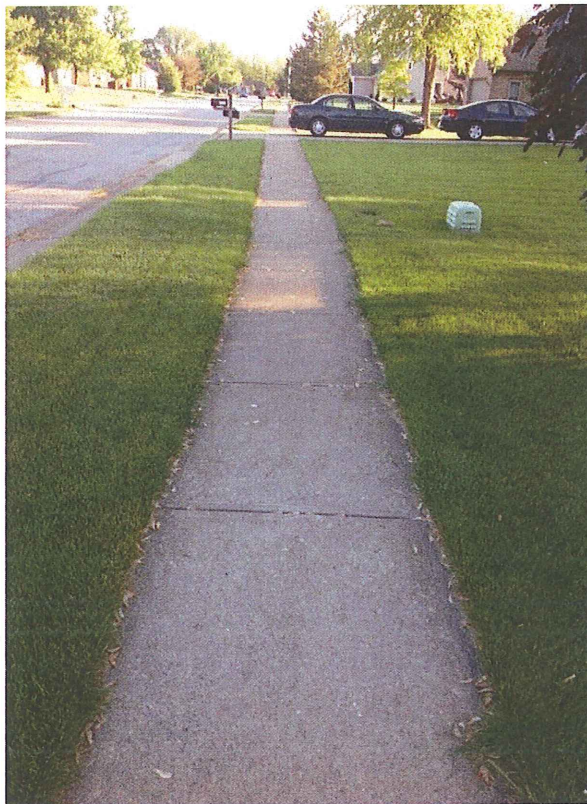
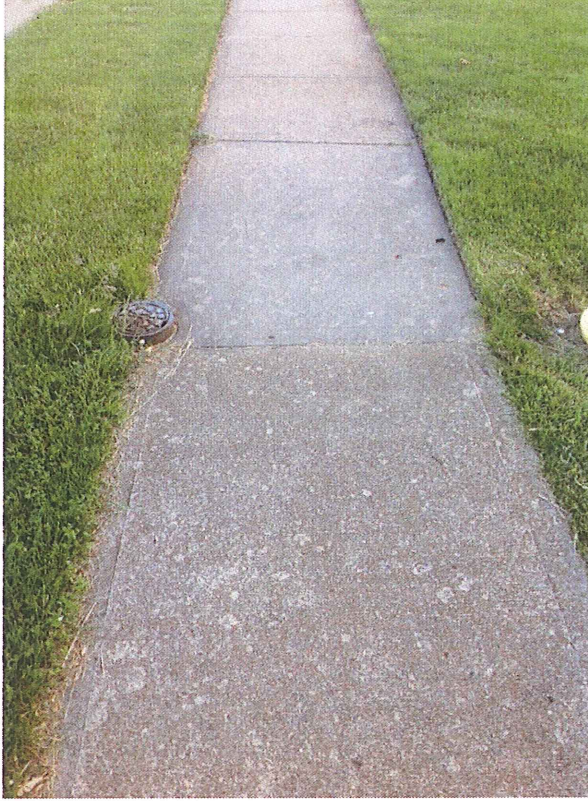
Feet trace to Fawn ct

Sidewalk Cross Slope	less than 2%
Sidewalk Running Slope	0.4
Sidewalk Width Without Curb Feet	4
Sidewalk Width Without Curb Inch	0
Comments	Valve box up 2"

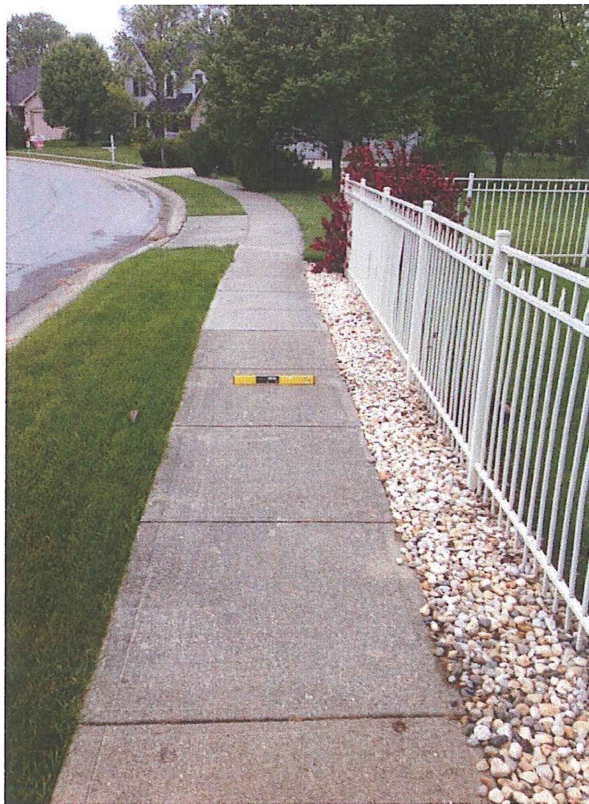
Sidewalk Cross Slope	greater than 3%
Sidewalk Running Slope	0.2
Sidewalk Passing Space	Yes
Sidewalk Width Without Curb Feet	4
Sidewalk Width Without Curb Inch	0

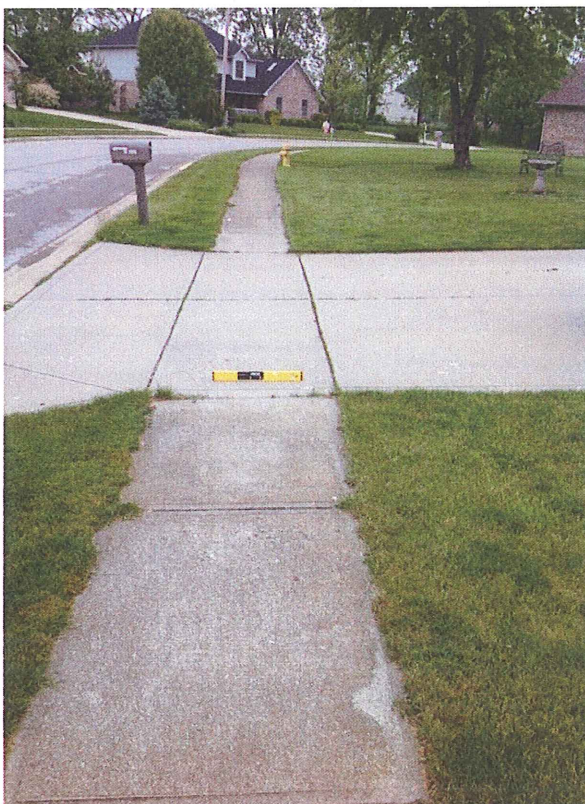
Sidewalk Cross Slope	less than 2%
Sidewalk Running Slope	0.6
Sidewalk Width Without Curb Feet	4
Sidewalk Width Without Curb Inch	0
Comments	X slope 3-4% through drives

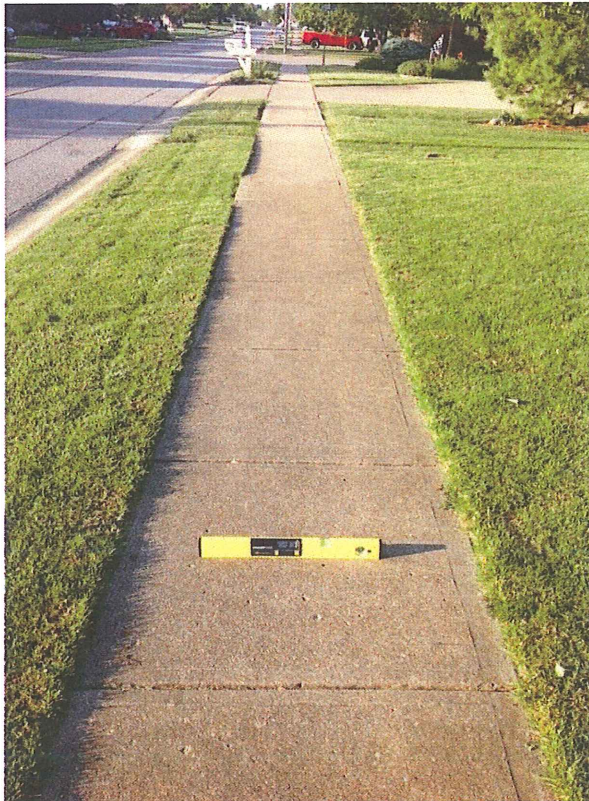
Deer trace to Fawn ct

Sidewalk Cross Slope	less than 2%
Sidewalk Running Slope	0.5
Sidewalk Vertical Discontinuities	Yes
Sidewalk Width Without Curb Feet	4
Sidewalk Width Without Curb Inch	0
Comments	2 raised panels 1"

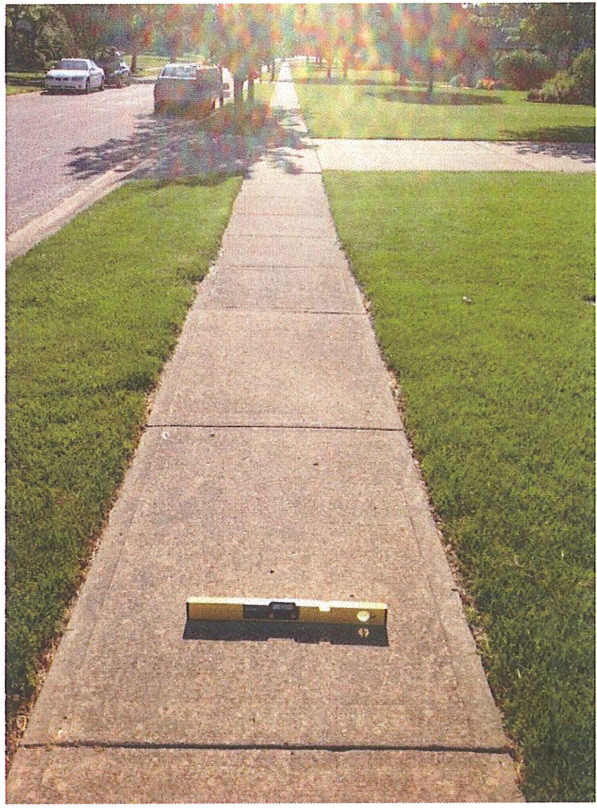
Sidewalk Cross Slope	less than 2%
Sidewalk Running Slope	0.6
Sidewalk Vertical Discontinuities	Yes
Sidewalk Width Without Curb Feet	4
Sidewalk Width Without Curb Inch	0
Comments	2 raised panels 3/4"

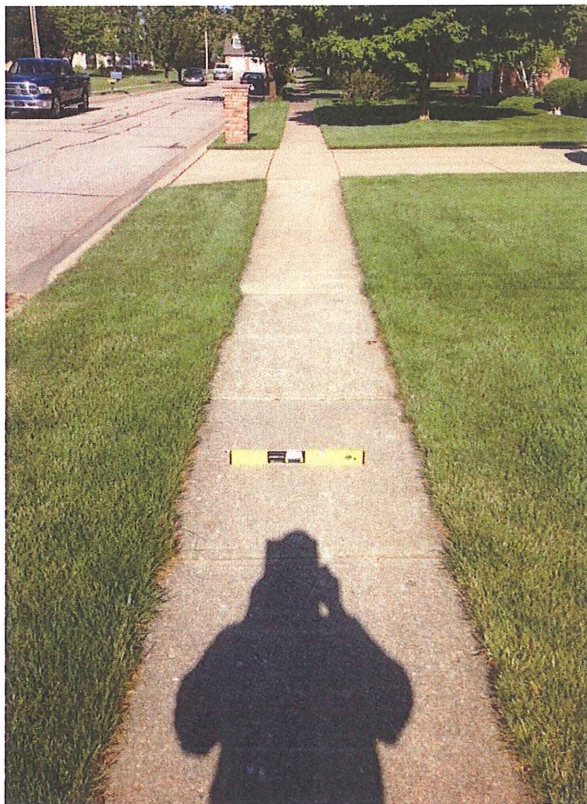
Sidewalk Cross Slope	less than 2%
Sidewalk Running Slope	0.7
Sidewalk Vertical Discontinuities	Yes
Sidewalk Width Without Curb Feet	4
Sidewalk Width Without Curb Inch	0
Comments	4 raised panels 1"

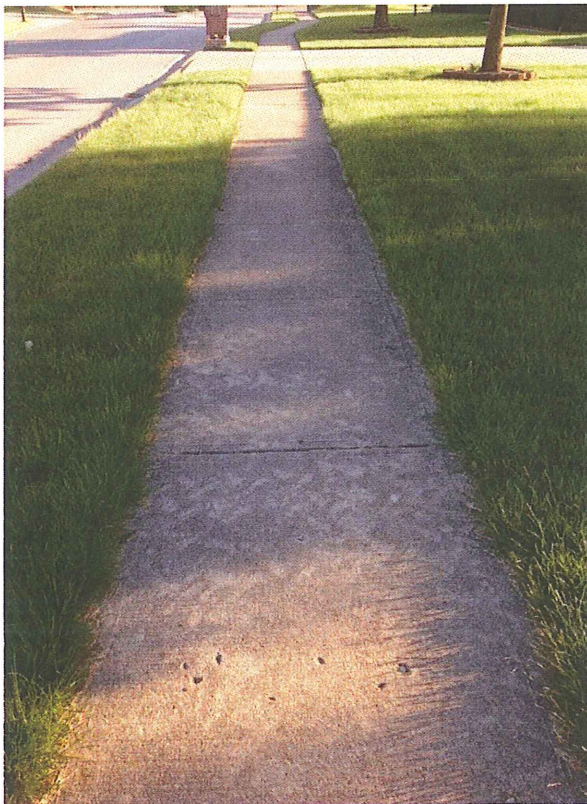
Fawn to Wall st

Sidewalk Cross Slope	less than 2%
Sidewalk Running Slope	0.2
Sidewalk Width Without Curb Inch	0
Comments	1 raised panel 1"

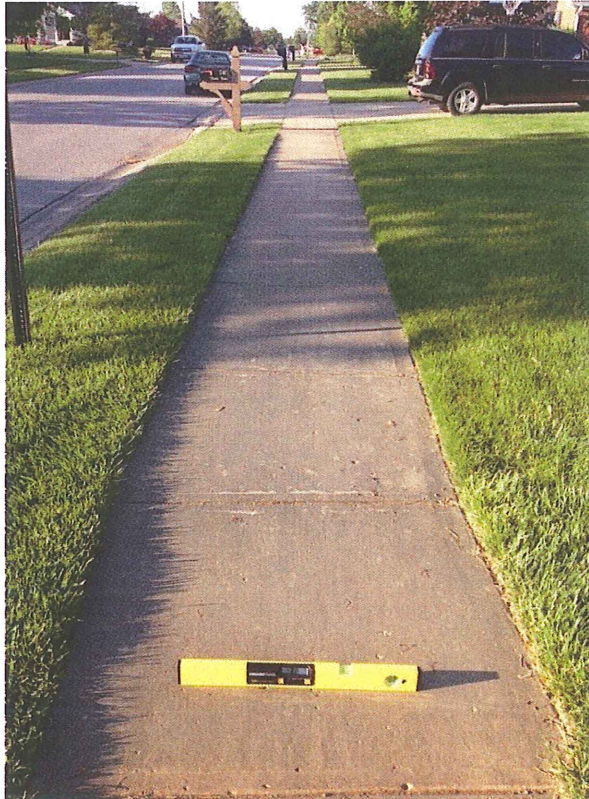
Fawn to Wall st

Sidewalk Cross Slope	less than 2%
Sidewalk Running Slope	0.2
Sidewalk Width Without Curb Feet	4
Sidewalk Width Without Curb Inch	0
Comments	1 raised panel 3/4"

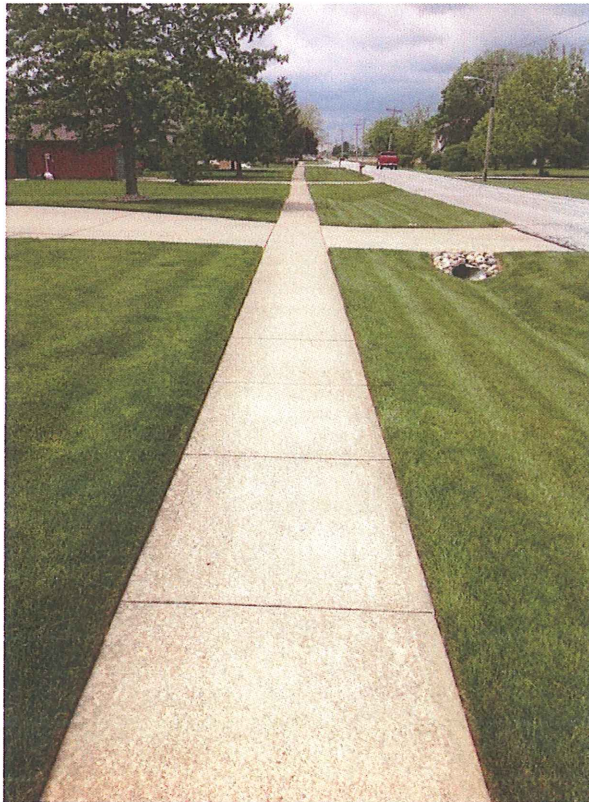
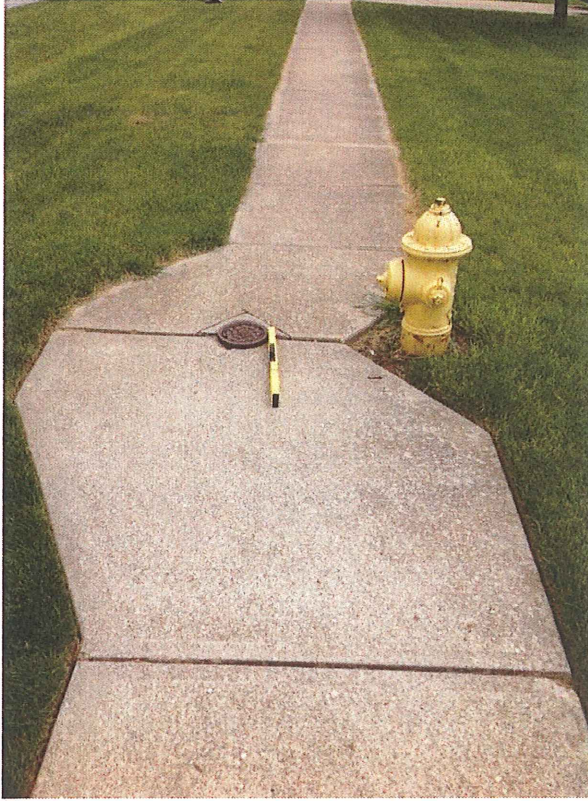
Karen to Woodland pl

Sidewalk Obstructions	Yes
Sidewalk Cross Slope	less than 2%
Sidewalk Running Slope	0.5
Sidewalk Passing Space	Yes
Sidewalk Width Without Curb Feet	4
Sidewalk Width Without Curb Inch	0
Comments	Valve box up 1". 4 raised panels 3/4"

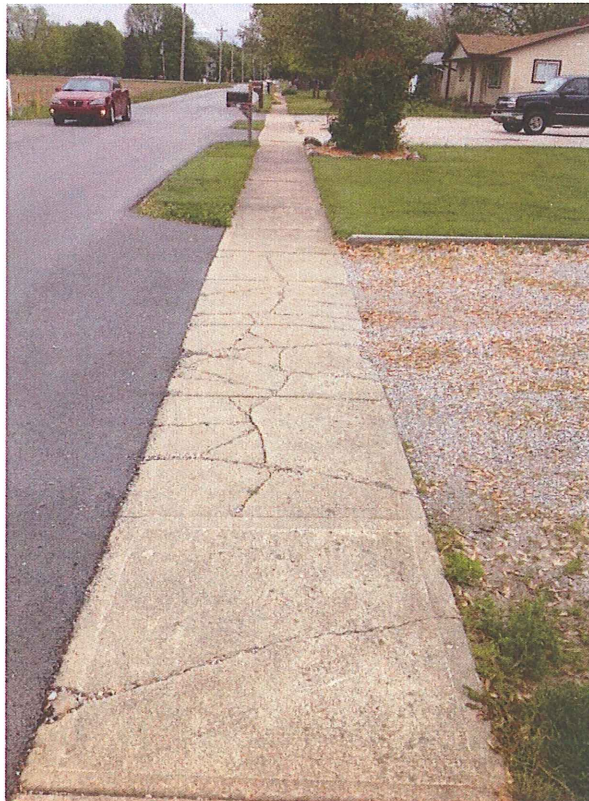
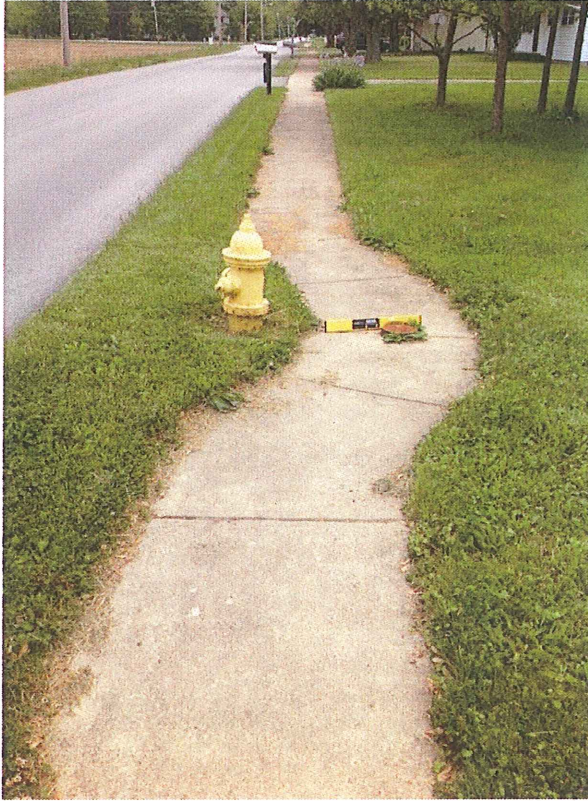
Poplar to Maple

Sidewalk Cross Slope	less than 2%
Sidewalk Running Slope	0.4
Sidewalk Width Without Curb Feet	4
Sidewalk Width Without Curb Inch	0
Comments	Water v box up 2" 3 raised panels 3/4"

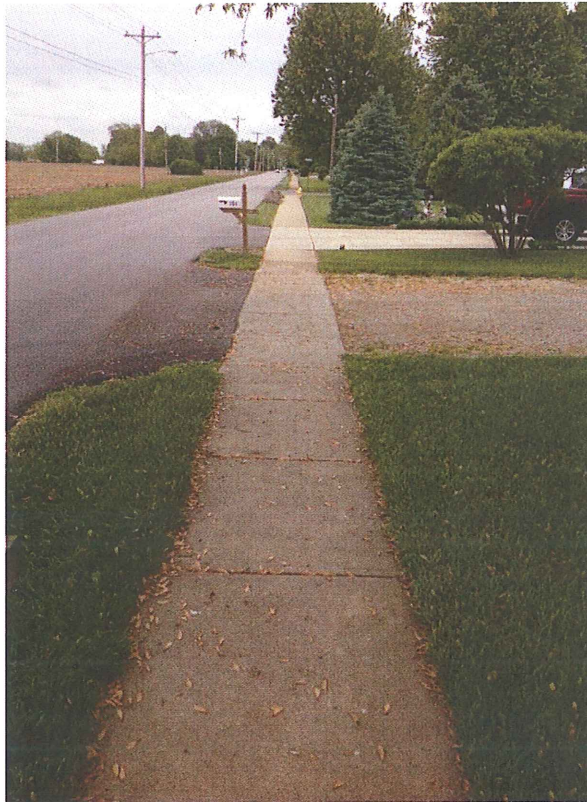
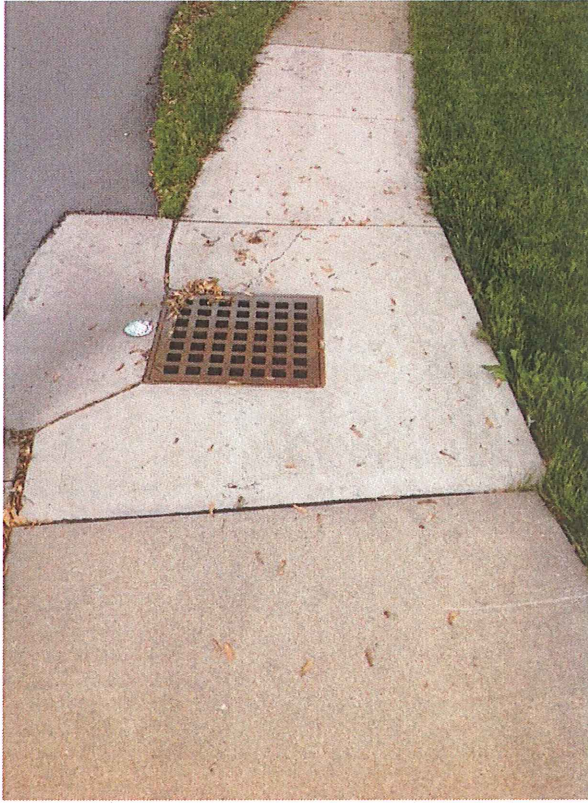
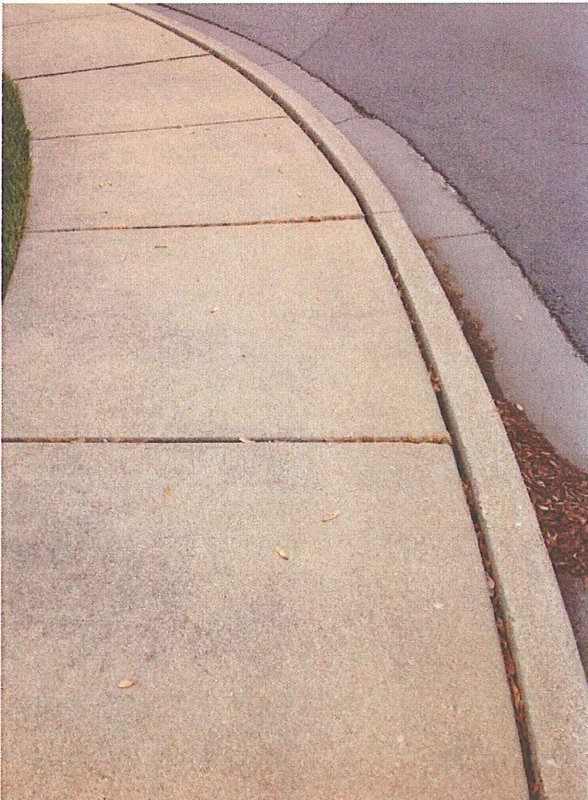
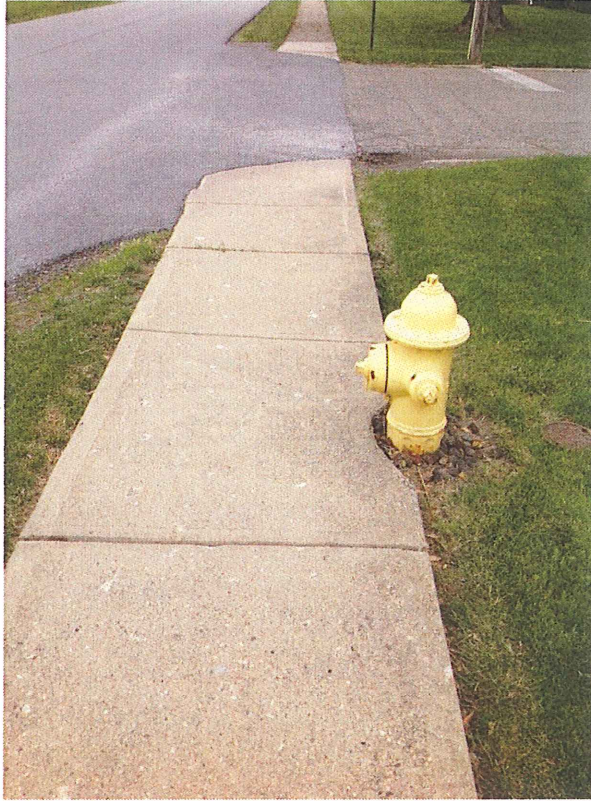
Meridian to Poplar

Comments Walk settlement 1" at Meridian st and 1.5" gap away from curb. Casting w 2" openings
