CITY OF PITTSBORO, INDIANA

SIDEWALK INVENTORY

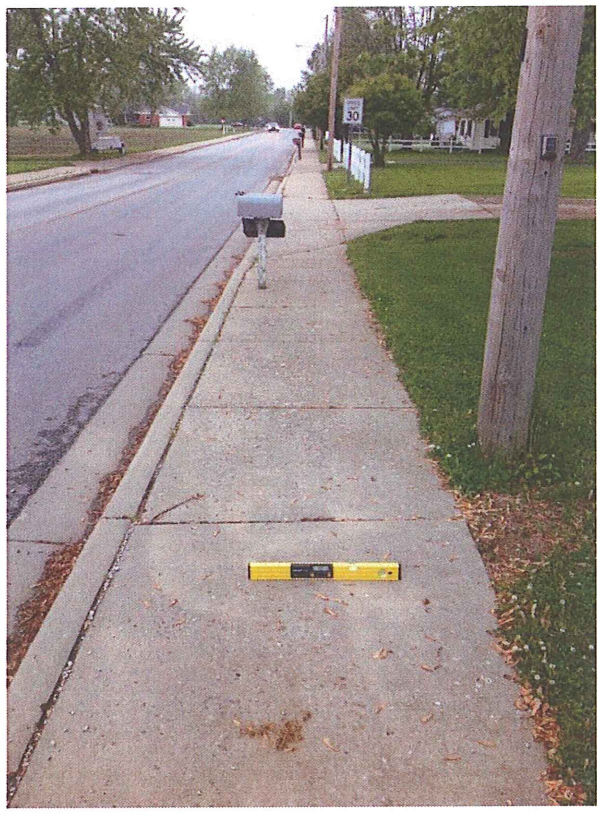
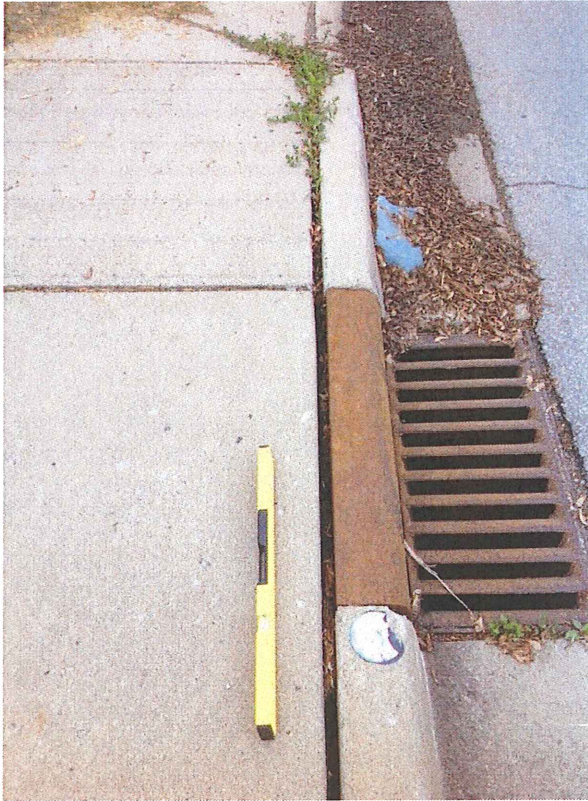
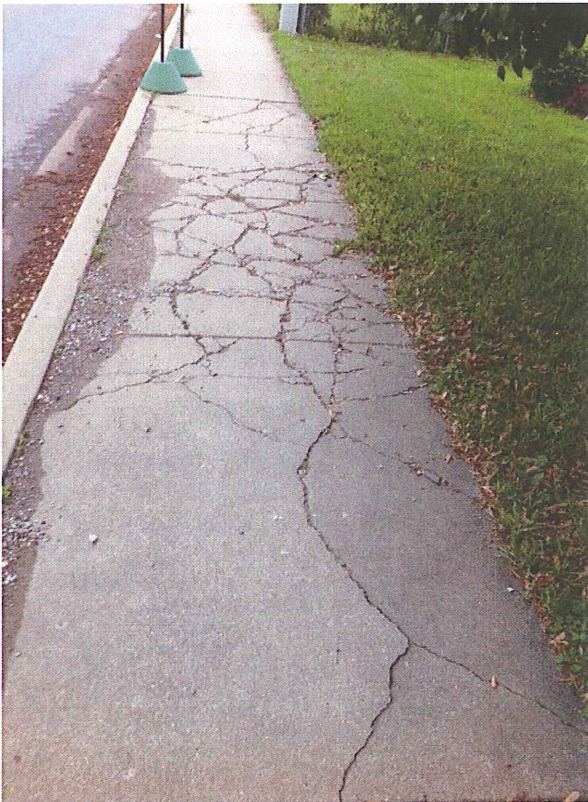
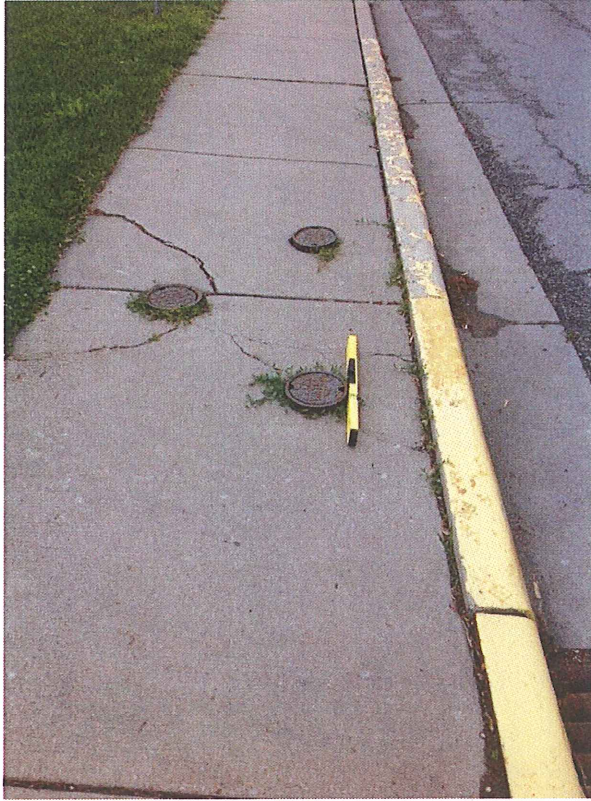
Sidewalk Cross Slope	2 - 3%
Sidewalk Running Slope	2.5
Sidewalk Width Without Curb Feet	5
Sidewalk Width Without Curb Inch	0
Comments	Mailboxes Gap at curb 1" in spots. Water valve boxes up 1.5"

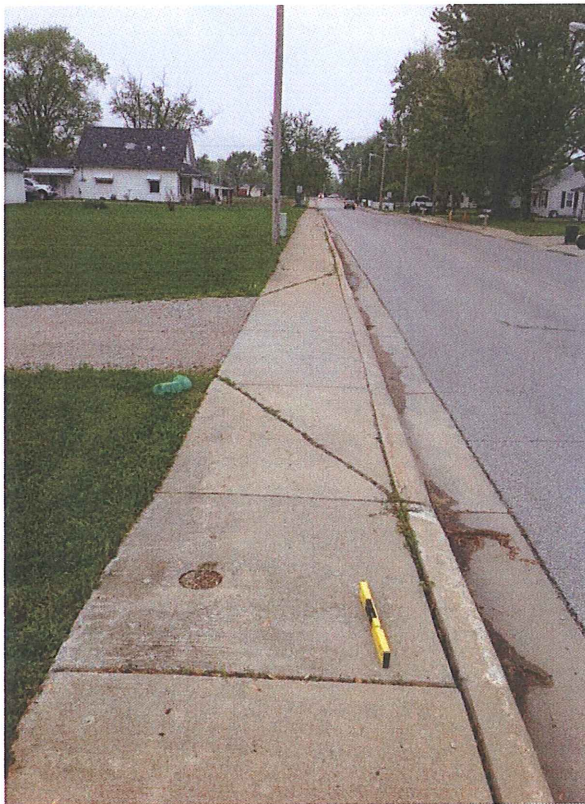
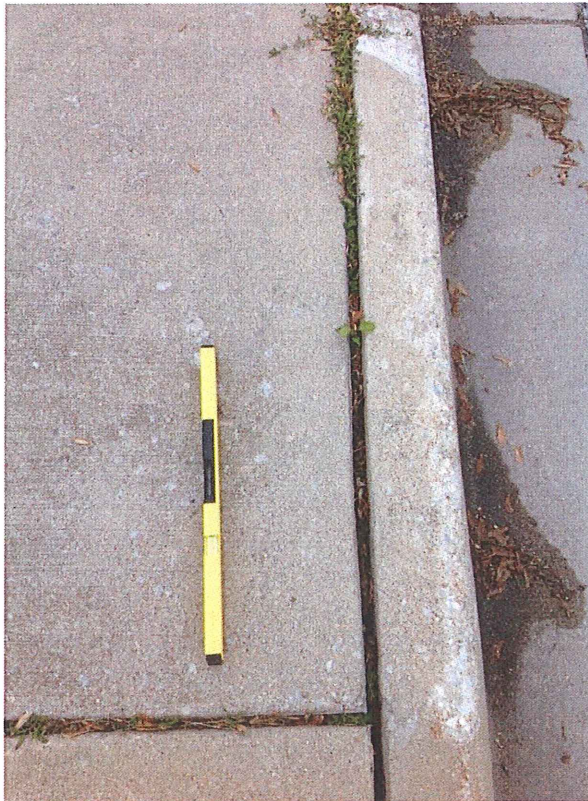
Sidewalk Cross Slope	2 - 3%
Sidewalk Running Slope	3
Sidewalk Width Without Curb Feet	5
Sidewalk Width Without Curb Inch	0
Comments	1" gap in spots between curb. About half of block is < 2% x slope

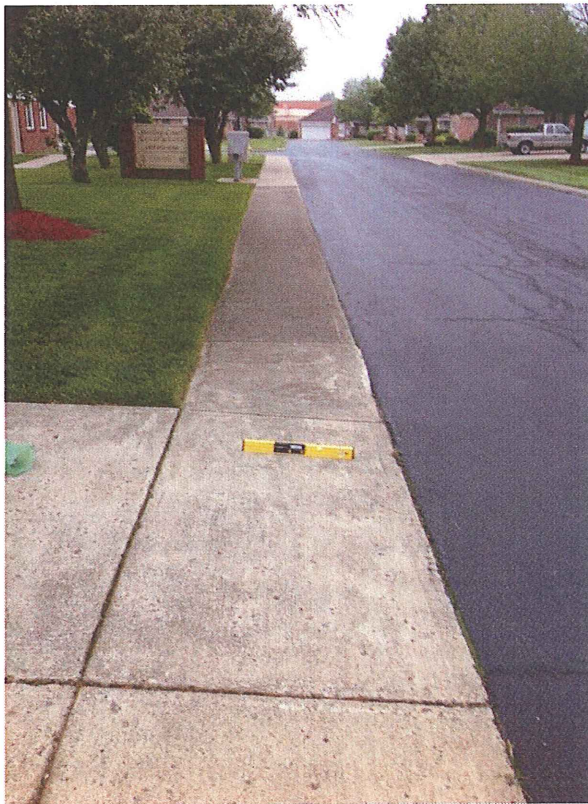
Sidewalk Cross Slope	greater than 3%
Sidewalk Running Slope	0.5
Sidewalk Width Without Curb Feet	4
Sidewalk Width Without Curb Inch	0
Comments	Slope 5% through driveway Sterling dr is private drive

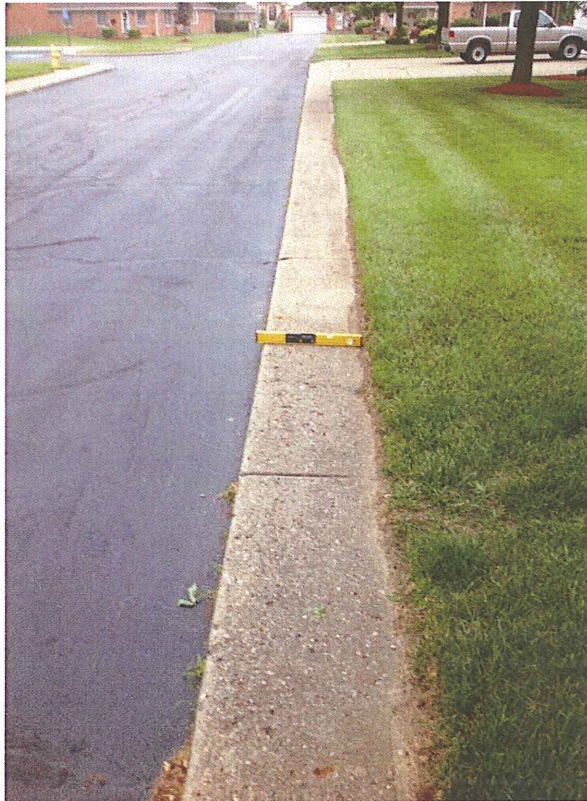
Sidewalk Cross Slope	greater than 3%
Sidewalk Running Slope	0.6
Sidewalk Width Without Curb Feet	2
Sidewalk Width Without Curb Inch	0
Comments	Sterling dr is a private entrance for apartments

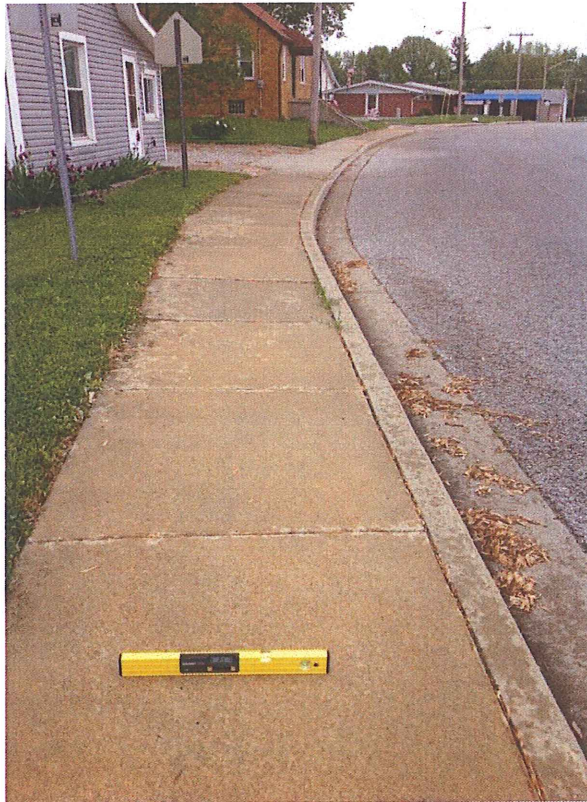
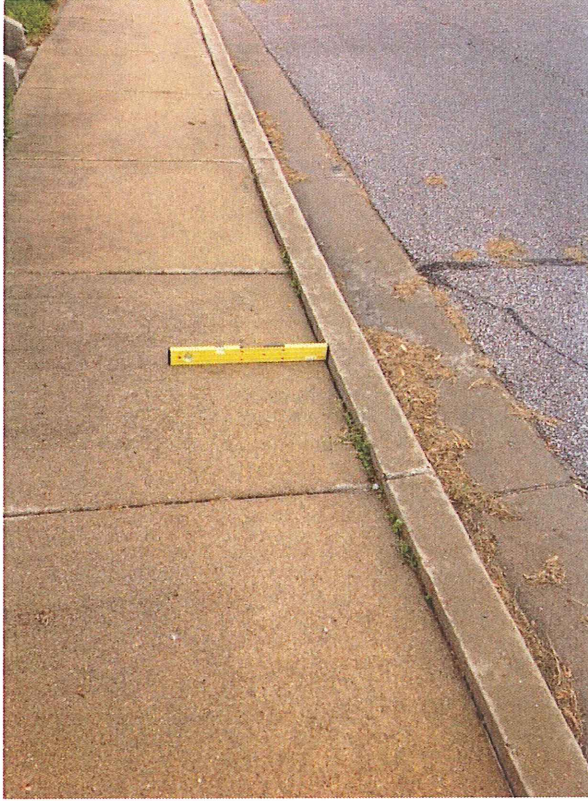
Lodge to Church

Sidewalk Obstructions	Yes
Sidewalk Cross Slope	2 - 3%
Sidewalk Running Slope	0.4
Sidewalk Width Without Curb Inch	0
Comments	Walk settlement 2" below curb

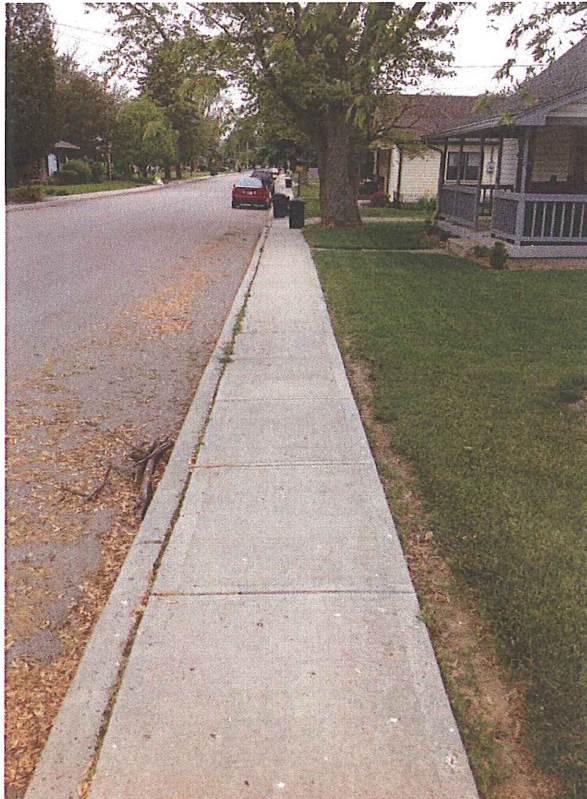
McCord to Sparks

Sidewalk Cross Slope	greater than 3%
Sidewalk Running Slope	0.4
Sidewalk Passing Space	Yes
Sidewalk Width Without Curb Feet	3
Sidewalk Width Without Curb Inch	6
Comments	Some areas < 2%

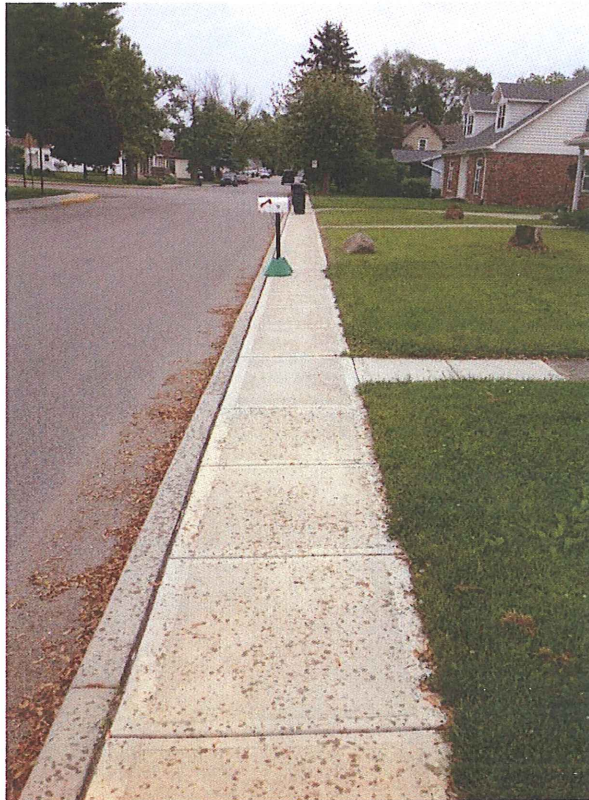
Sidewalk Obstructions	Yes
Sidewalk Cross Slope	greater than 3%
Sidewalk Running Slope	0.6
Sidewalk Width Without Curb Feet	3
Sidewalk Width Without Curb Inch	6
Comments	Mailboxes

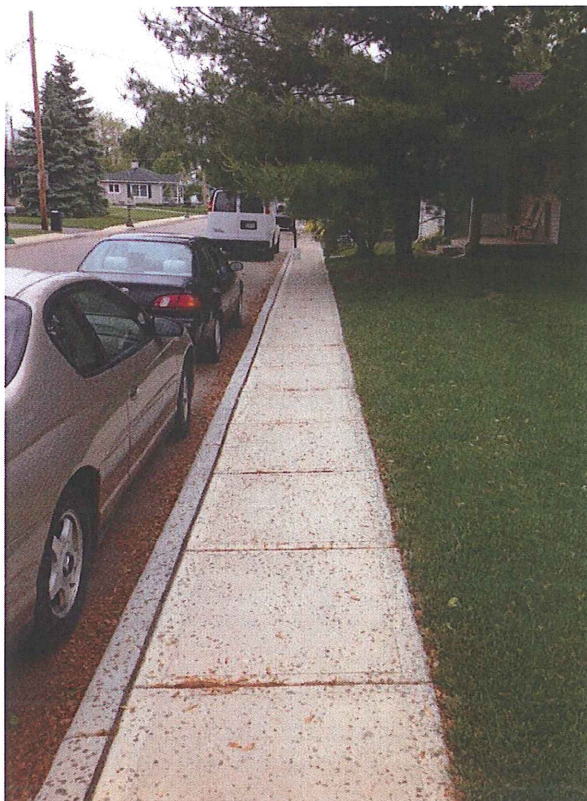
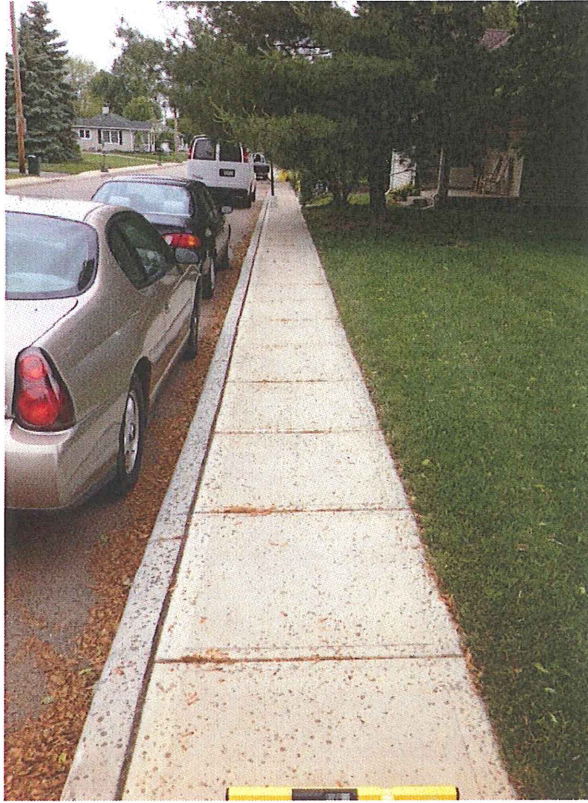
Fisher to Hamilton

Sidewalk Cross Slope	less than 2%
Sidewalk Running Slope	0.4
Sidewalk Width Without Curb Feet	3
Sidewalk Width Without Curb Inch	6

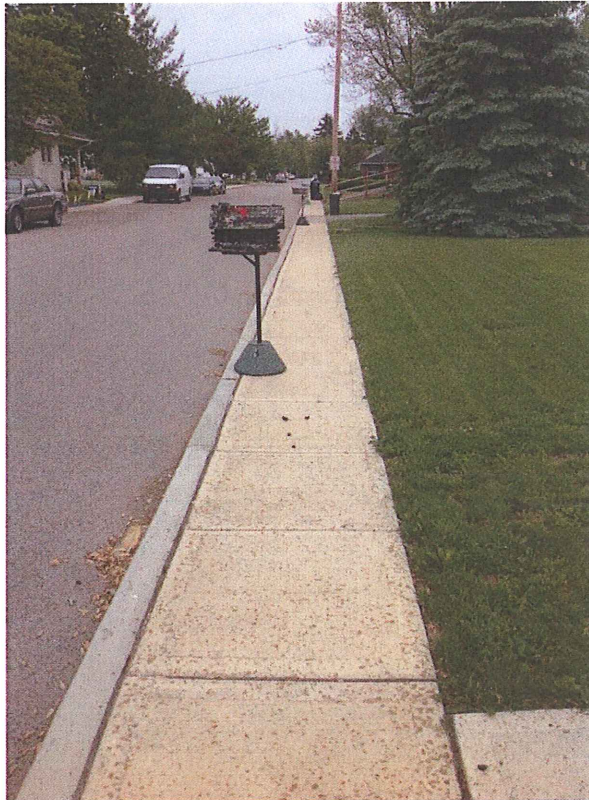
Hamilton to Fisher

Sidewalk Obstructions	Yes
Sidewalk Cross Slope	less than 2%
Sidewalk Running Slope	0.3
Sidewalk Width Without Curb Feet	3
Sidewalk Width Without Curb Inch	6
Comments	Mailboxes

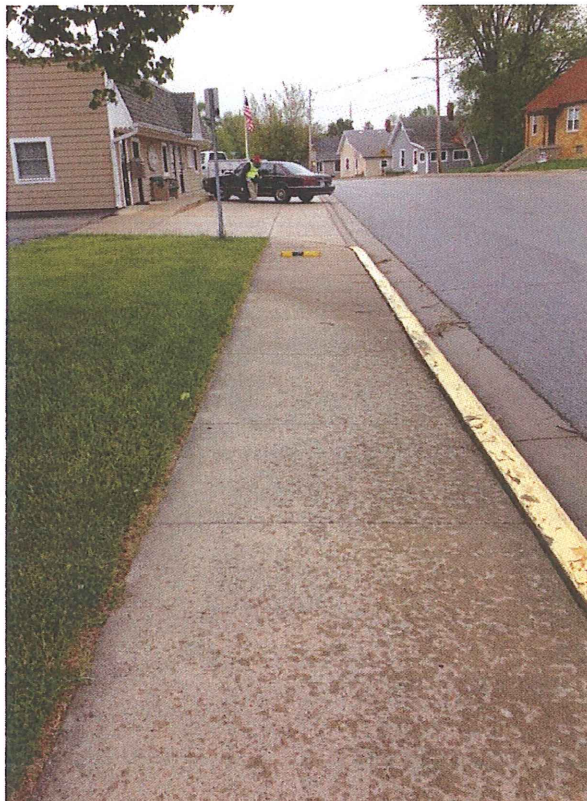
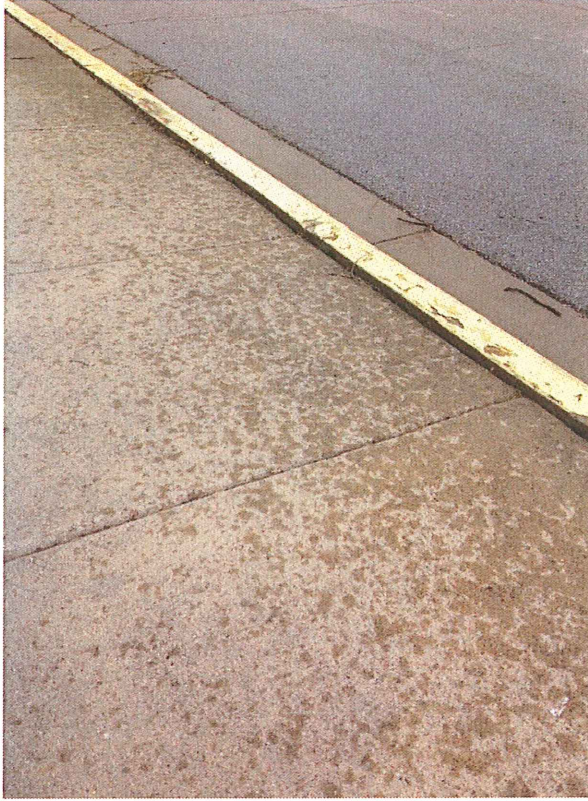
Main to Osborne

Sidewalk Cross Slope	2 - 3%
Sidewalk Running Slope	0.5
Sidewalk Width Without Curb Feet	5
Sidewalk Width Without Curb Inch	0
Comments	Sidewalk settlement 1" below curb

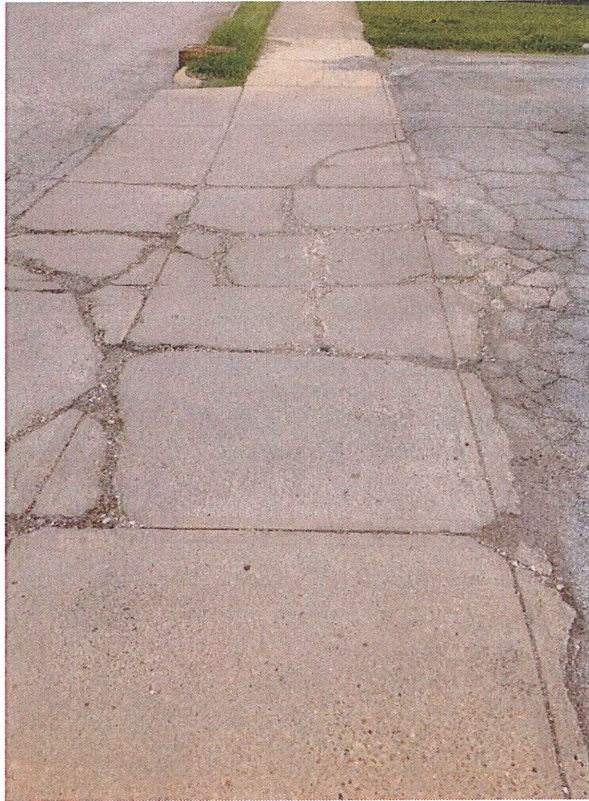
Olsen to Main st

Sidewalk Cross Slope	greater than 3%
Sidewalk Running Slope	1.3
Sidewalk Width Without Curb Inch	0
Comments	Half of block is < 2%. Badly cracked in areas

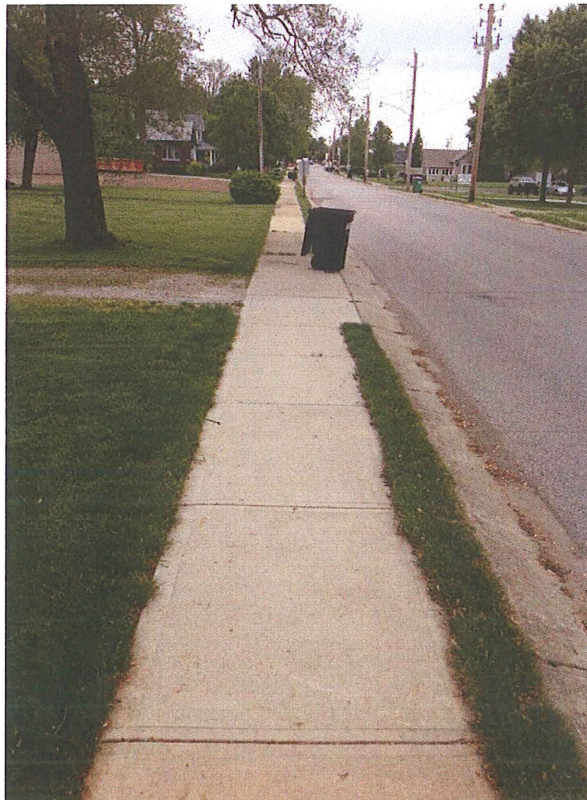
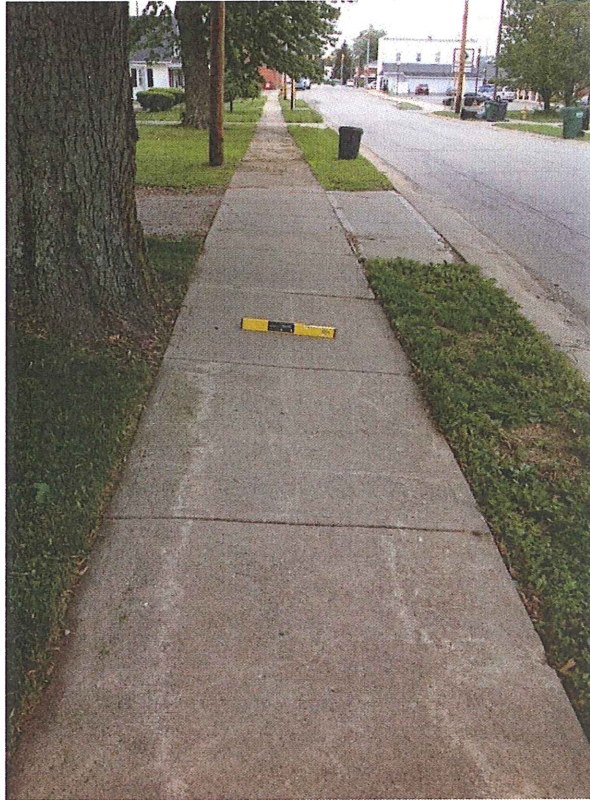
Woodridge dr to Olsen st

Sidewalk Cross Slope	less than 2%
Sidewalk Running Slope	0.7
Sidewalk Passing Space	Yes
Sidewalk Surface Discontinuities	No
Sidewalk Width Without Curb Feet	4
Sidewalk Width Without Curb Inch	0
Comments	30' area at tree 5% x slope. Width is 4' to 5'

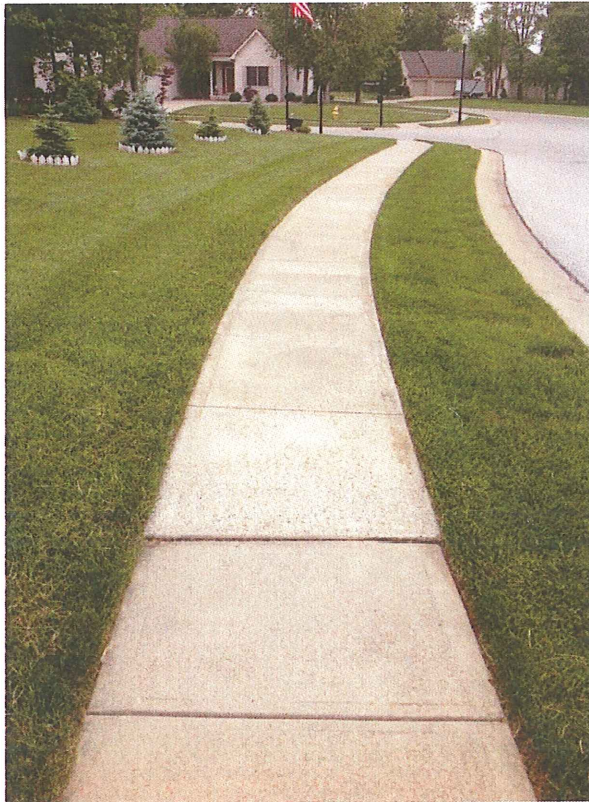
West end of sub

Sidewalk Cross Slope	less than 2%
Sidewalk Running Slope	0.6
Sidewalk Passing Space	Yes
Sidewalk Vertical Discontinuities	Yes
Sidewalk Width Without Curb Inch	0
Comments	1 raised panel 3/4"

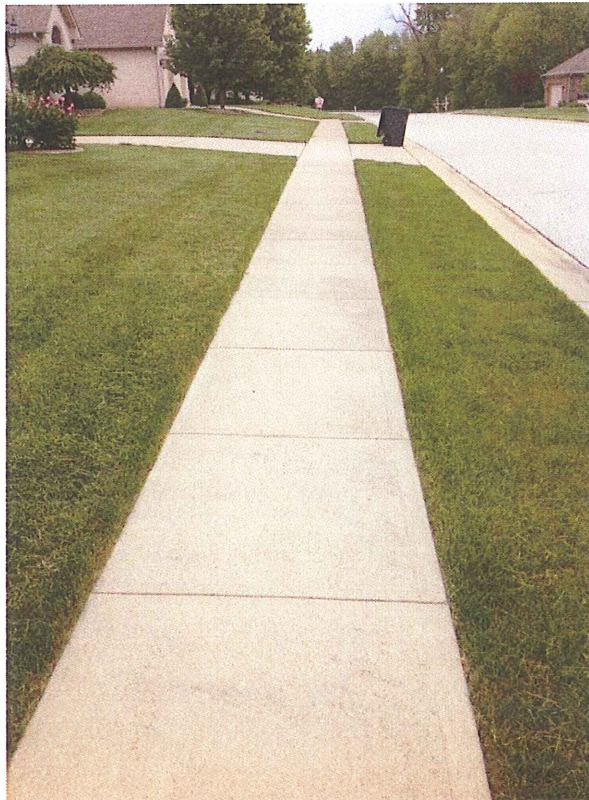
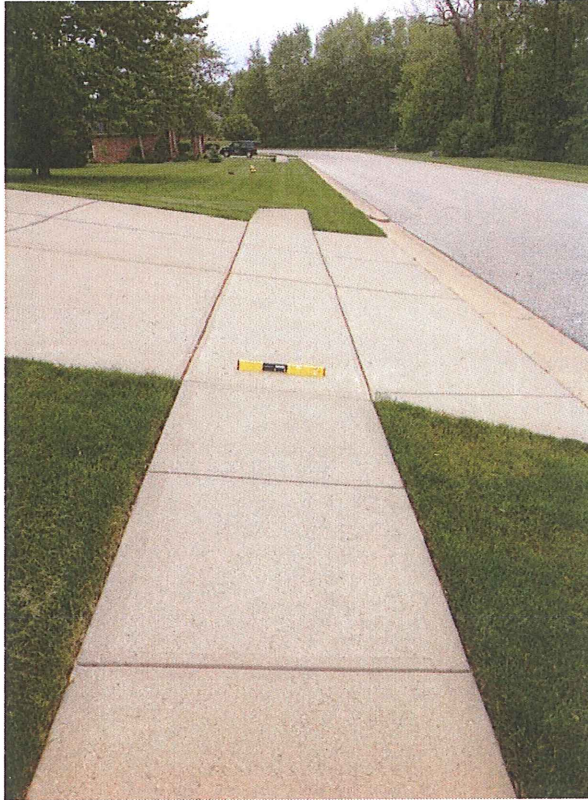
NE corner of sub

Sidewalk Cross Slope	less than 2%
Sidewalk Running Slope	0.4
Sidewalk Passing Space	Yes
Sidewalk Surface Discontinuities	Yes
Sidewalk Width Without Curb Feet	4
Sidewalk Width Without Curb Inch	0
Comments	X slope 8.2 through 1 driveway

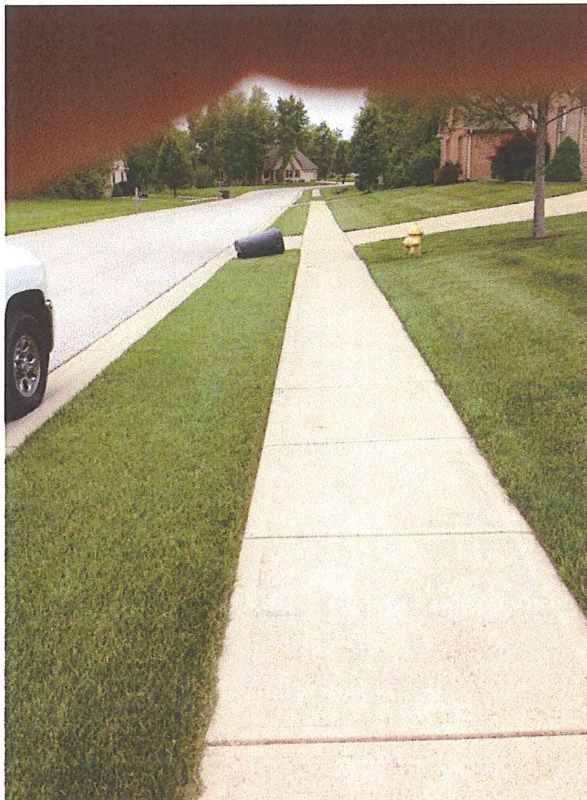
SE section of sub

Sidewalk Cross Slope	less than 2%
Sidewalk Running Slope	0.4
Sidewalk Passing Space	Yes
Sidewalk Surface Discontinuities	Yes
Sidewalk Width Without Curb Feet	4
Sidewalk Width Without Curb Inch	0
Comments	2 raised panels 1"

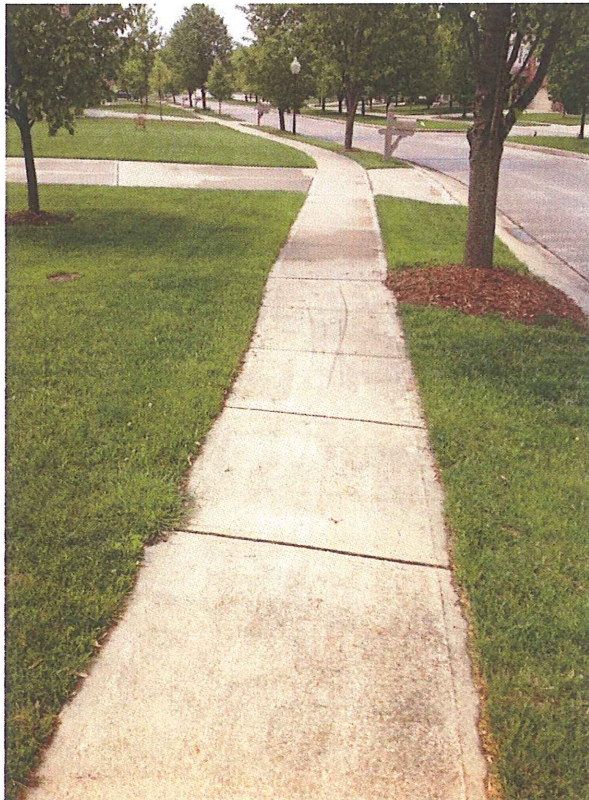
Stamford dr to Main st

Sidewalk Cross Slope	less than 2%
Sidewalk Running Slope	1
Sidewalk Surface Discontinuities	Yes
Sidewalk Vertical Discontinuities	Yes
Sidewalk Width Without Curb Feet	4
Sidewalk Width Without Curb Inch	0
Comments	3 raised panels 3/4". Walks ends at pond

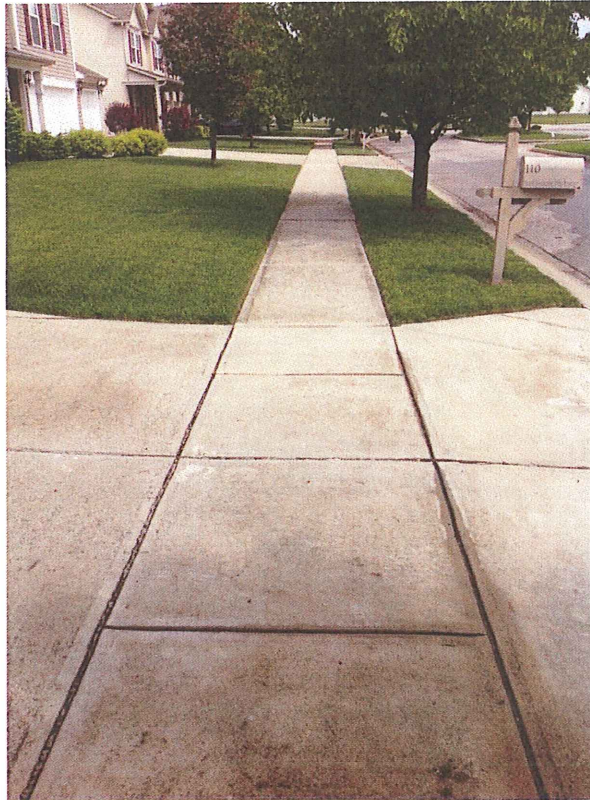
Stamford dr to Main st

Sidewalk Cross Slope	less than 2%
Sidewalk Running Slope	0.7
Sidewalk Passing Space	Yes
Sidewalk Surface Discontinuities	No
Sidewalk Vertical Discontinuities	Yes
Sidewalk Width Without Curb Inch	0
Comments	2 raised panels 3/4"

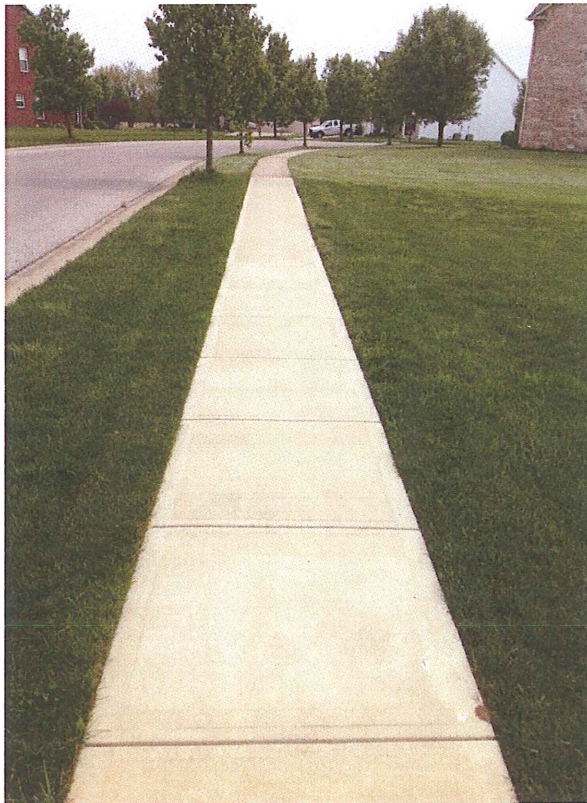
East end of loop

Sidewalk Cross Slope	less than 2%
Sidewalk Surface Discontinuities	Yes
Sidewalk Width Without Curb Inch	0
Comments	No walk on east side

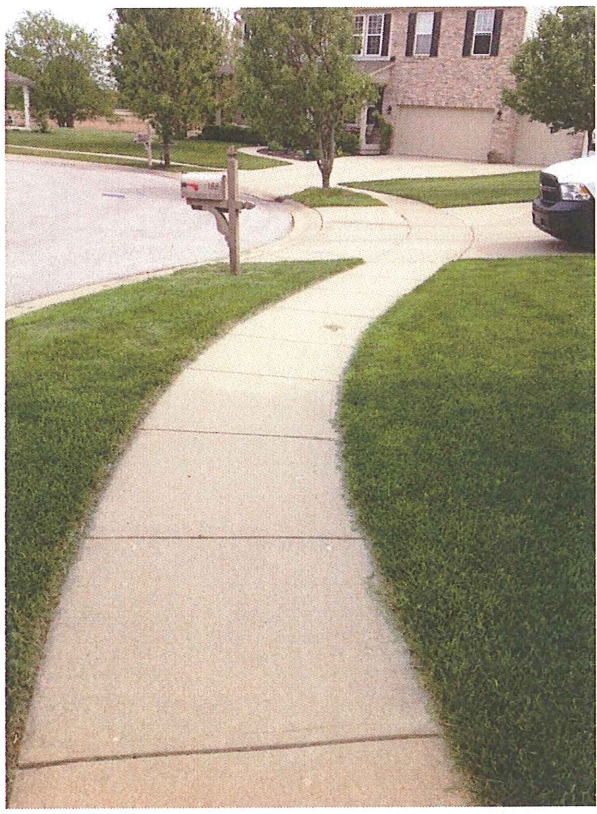
Sidewalk Cross Slope	less than 2%
Sidewalk Running Slope	1.3
Sidewalk Vertical Discontinuities	Yes
Sidewalk Width Without Curb Inch	0
Comments	1 raised panel. 1"

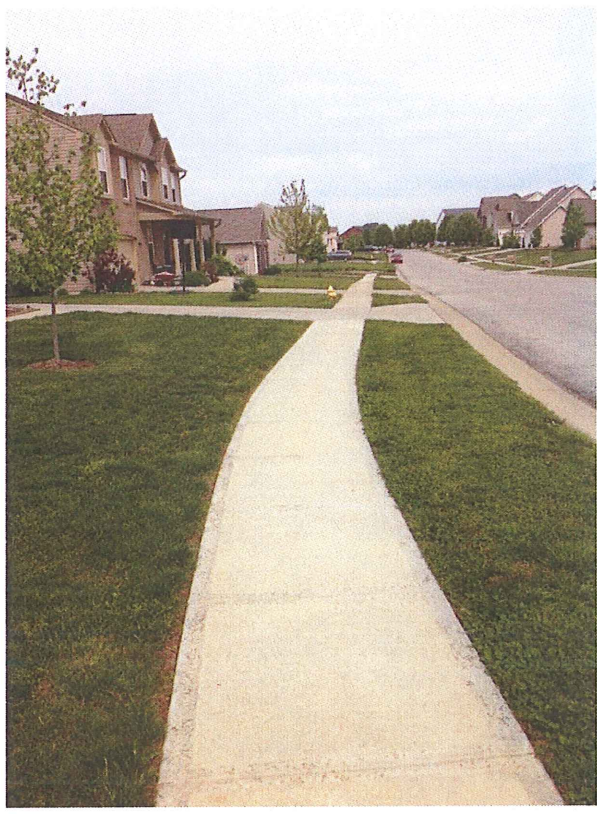
Sidewalk Cross Slope	less than 2%
Sidewalk Running Slope	0.8
Sidewalk Passing Space	Yes
Sidewalk Vertical Discontinuities	Yes
Sidewalk Width Without Curb Inch	0
Comments	2 lots w no walks

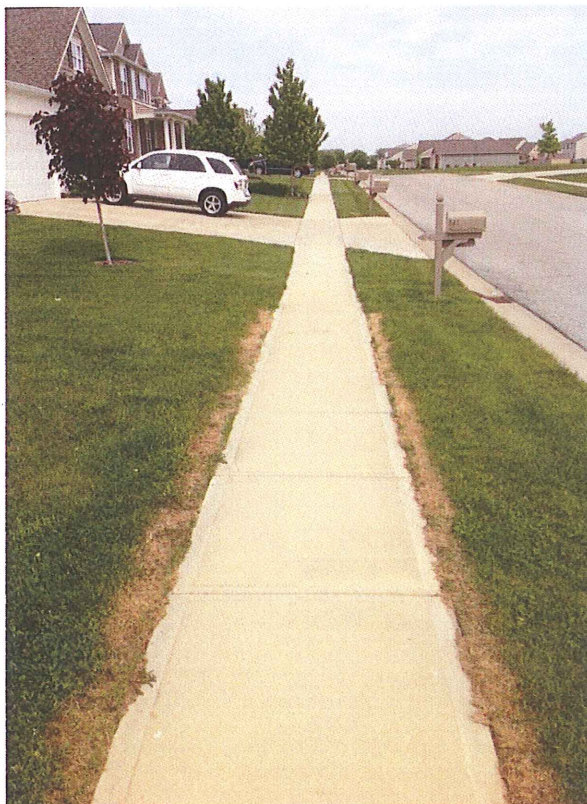
Sidewalk Cross Slope	less than 2%
Sidewalk Running Slope	1.3
Sidewalk Passing Space	Yes
Sidewalk Width Without Curb Inch	0
Comments	Few areas < 200' over 2%

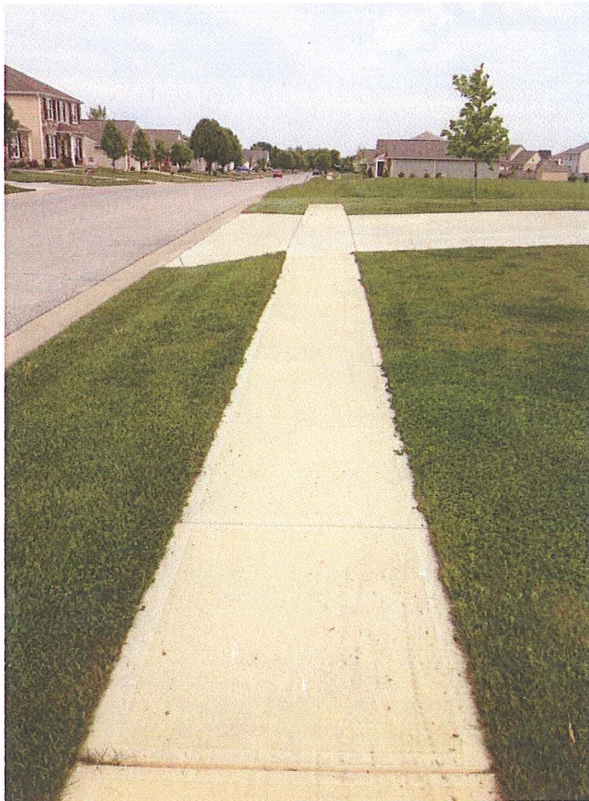
Sidewalk Cross Slope	less than 2%
Sidewalk Running Slope	1
Sidewalk Passing Space	Yes
Sidewalk Surface Discontinuities	Yes
Sidewalk Width Without Curb Inch	0
Comments	7 lots w no walks

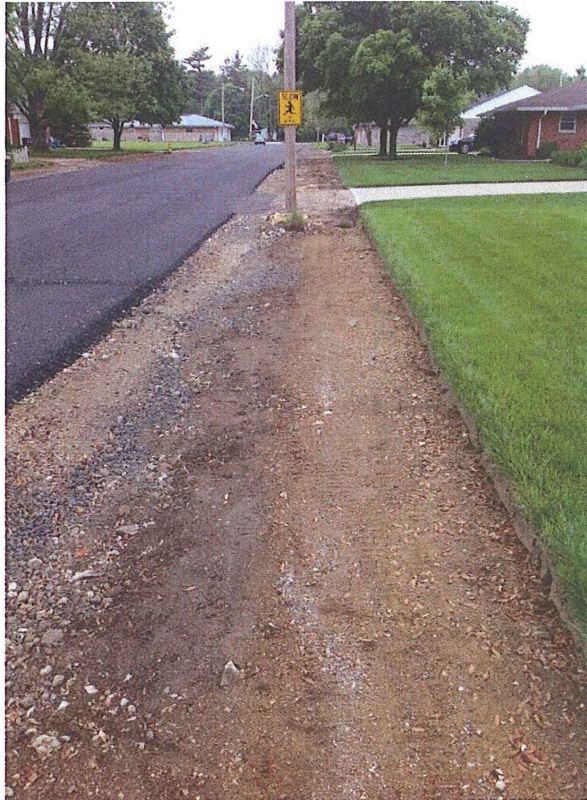
Noyes to Main

Sidewalk Width Without Curb Inch	0
Comments	Both sides under construction. Walk removed

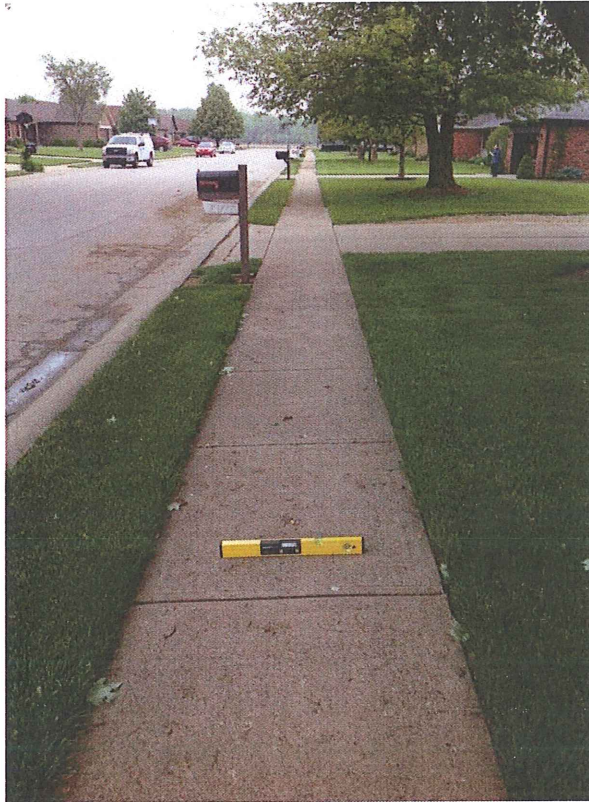
South of Noyes

Sidewalk Cross Slope	2 - 3%
Sidewalk Running Slope	0.3
Sidewalk Passing Space	Yes
Sidewalk Width Without Curb Feet	4
Sidewalk Width Without Curb Inch	0
Comments	About half of block is < 2% x slope

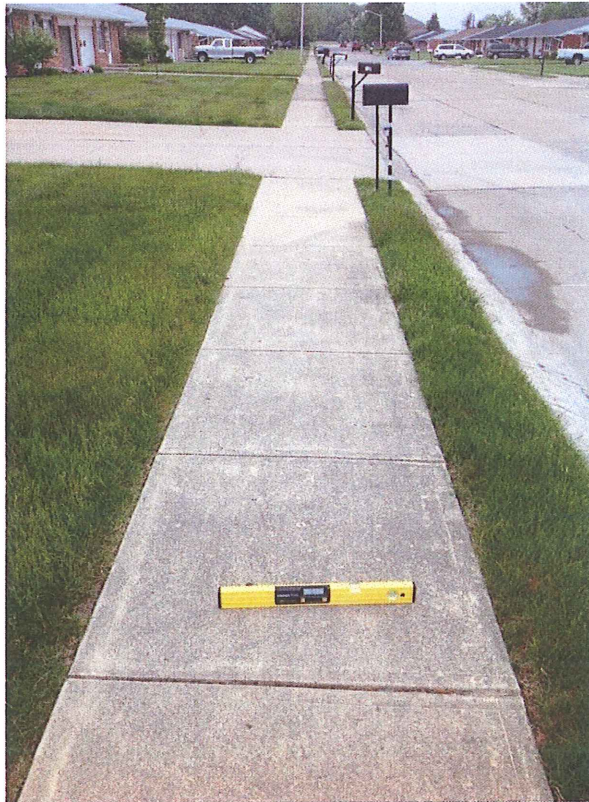
South of Noyes

Sidewalk Cross Slope	less than 2%
Sidewalk Running Slope	0.2
Sidewalk Passing Space	Yes
Sidewalk Width Without Curb Feet	4
Sidewalk Width Without Curb Inch	0
Comments	1 raised panel 1"

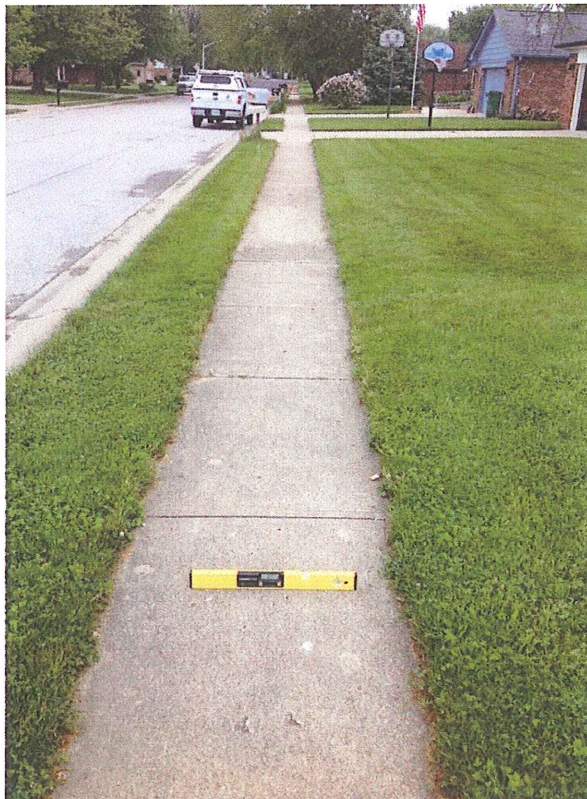
South of Noyes

Sidewalk Cross Slope	less than 2%
Sidewalk Running Slope	0.2
Sidewalk Width Without Curb Feet	4
Sidewalk Width Without Curb Inch	0
Comments	20' at tree raised 4% x slope. 4 raised panels 3/4"

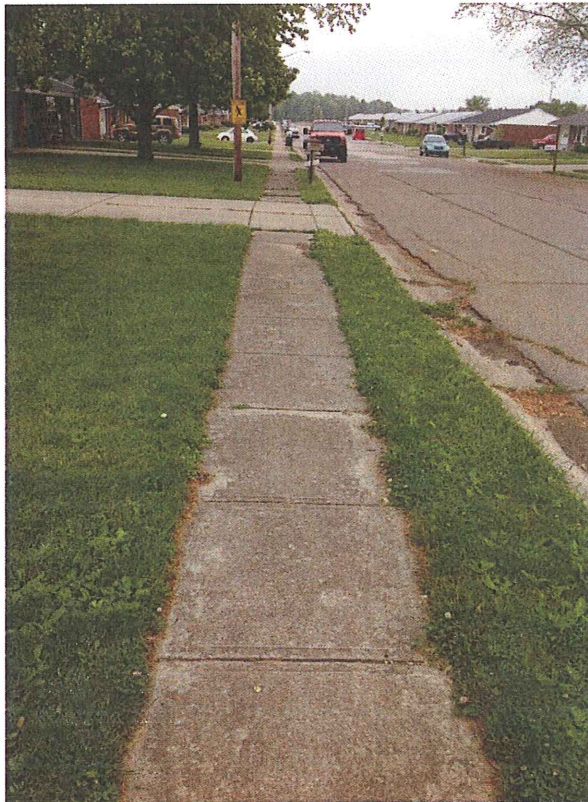
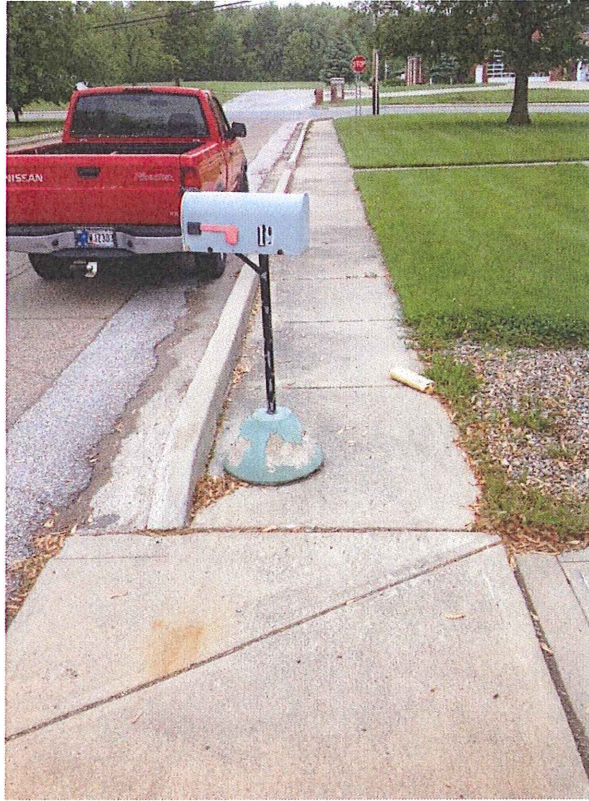
Noyes to Main

Sidewalk Cross Slope	less than 2%
Sidewalk Running Slope	0.1
Sidewalk Passing Space	Yes
Sidewalk Vertical Discontinuities	Yes
Sidewalk Width Without Curb Feet	4
Sidewalk Width Without Curb Inch	0
Comments	1 raised panel 2". 6" curb next to walk at Main st

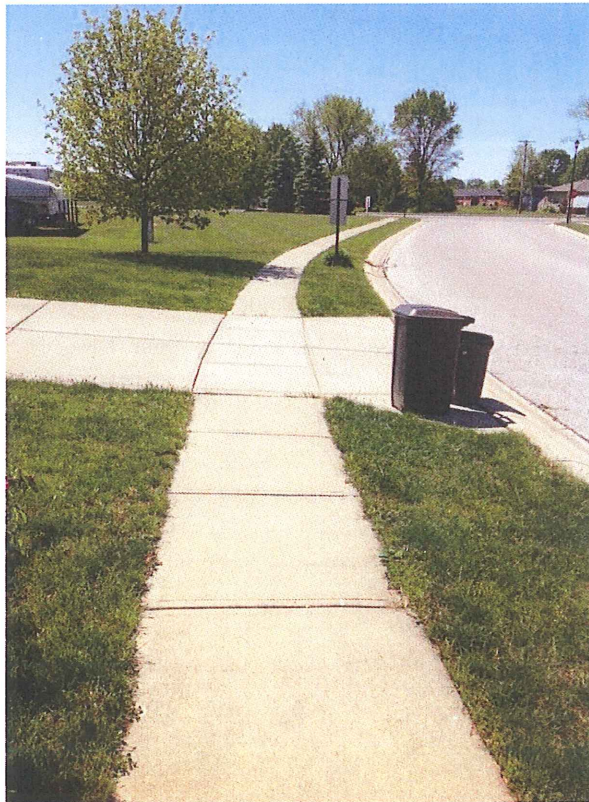
So of broadmoor bend

Sidewalk Cross Slope	greater than 3%
Sidewalk Running Slope	1.4
Sidewalk Passing Space	Yes
Sidewalk Vertical Discontinuities	Yes
Sidewalk Width Without Curb Inch	0
Comments	1 raised panel 1"

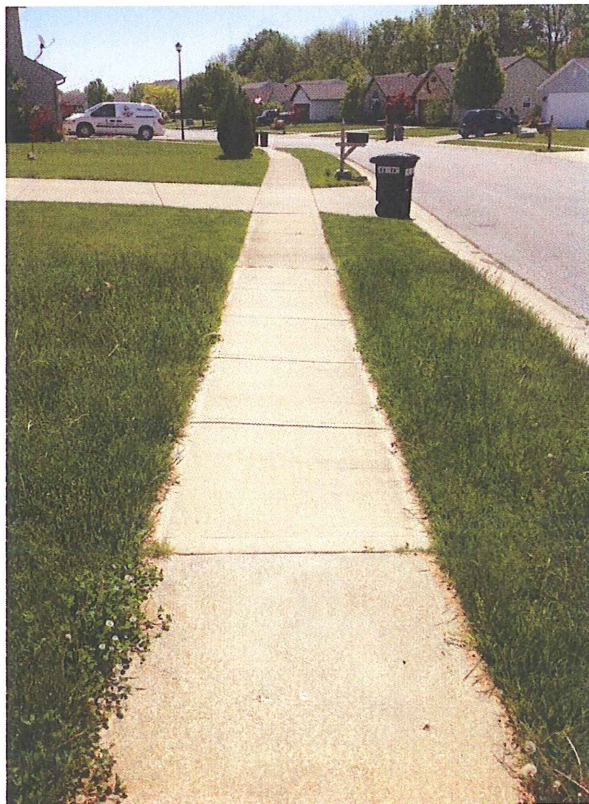
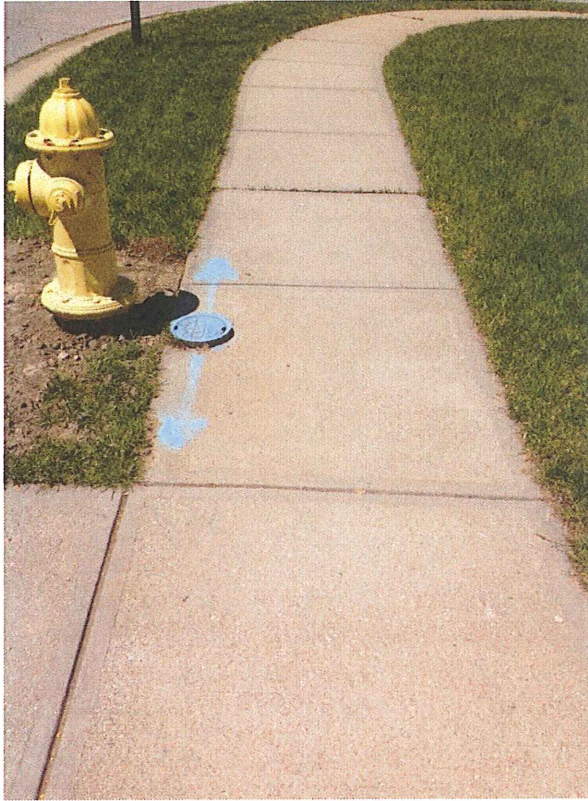
Lasalle to brooks way

Sidewalk Obstructions	Yes
Sidewalk Cross Slope	greater than 3%
Sidewalk Running Slope	2
Sidewalk Passing Space	Yes
Sidewalk Width Without Curb Inch	0
Comments	Water valve box up 1"

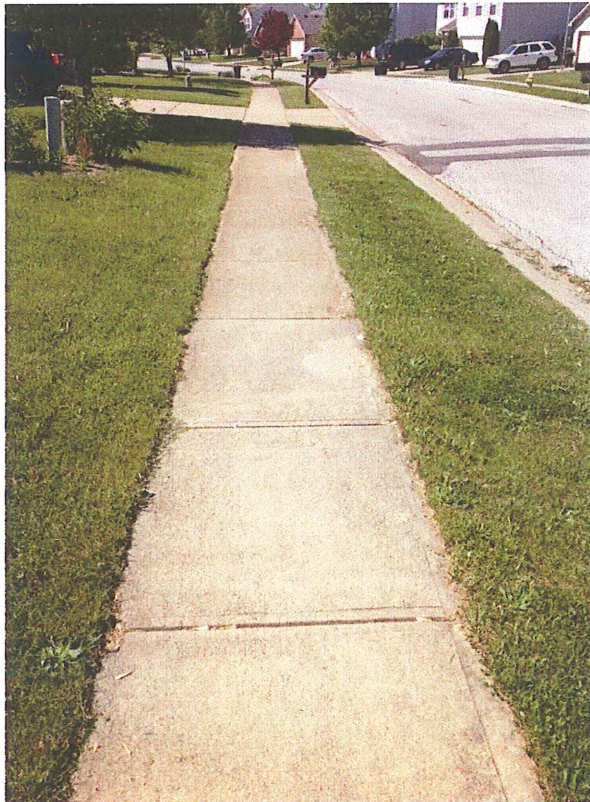
Lockerbie to Lasalle In

Sidewalk Cross Slope	greater than 3%
Sidewalk Running Slope	1.2
Sidewalk Passing Space	Yes
Sidewalk Vertical Discontinuities	Yes
Sidewalk Accessibility Obstacles	No
Sidewalk Width Without Curb Feet	4
Sidewalk Width Without Curb Inch	0
Comments	4 raised panels .5 to 1"

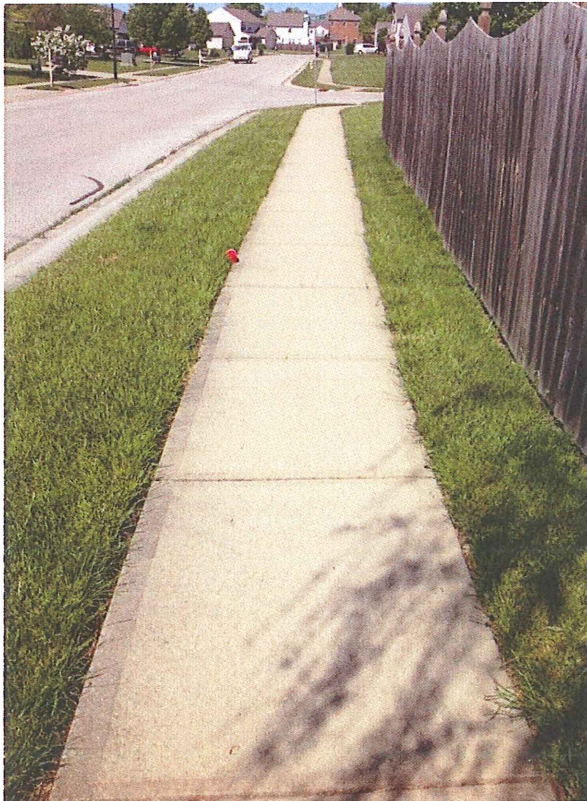
Lockerbie to Lasalle In

Sidewalk Cross Slope	greater than 3%
Sidewalk Running Slope	1.8
Sidewalk Vertical Discontinuities	Yes
Sidewalk Width Without Curb Feet	4
Sidewalk Width Without Curb Inch	0
Comments	2 raised panels.5"

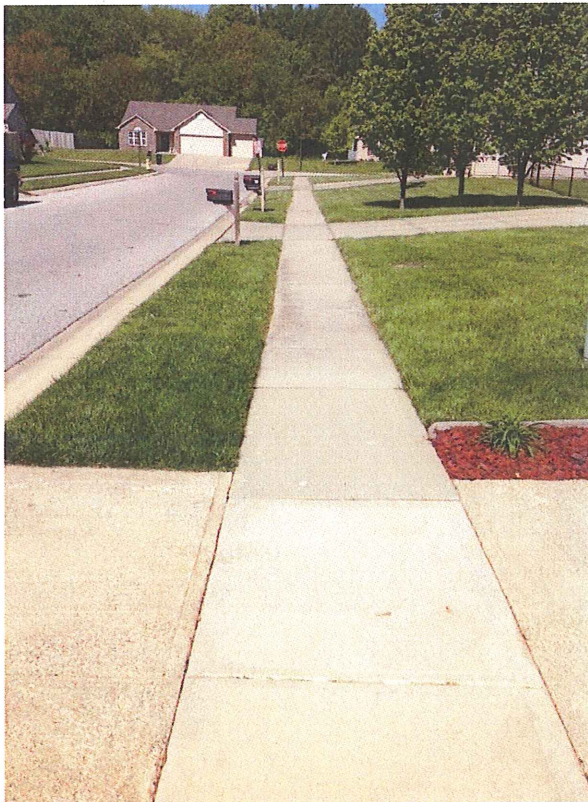
Broadmoor bend to brooks way

Sidewalk Obstructions	No
Sidewalk Cross Slope	2 - 3%
Sidewalk Running Slope	1.9
Sidewalk Passing Space	Yes
Sidewalk Vertical Discontinuities	Yes
Sidewalk Width Without Curb Feet	4
Sidewalk Width Without Curb Inch	0
Comments	4 raised panels.5"

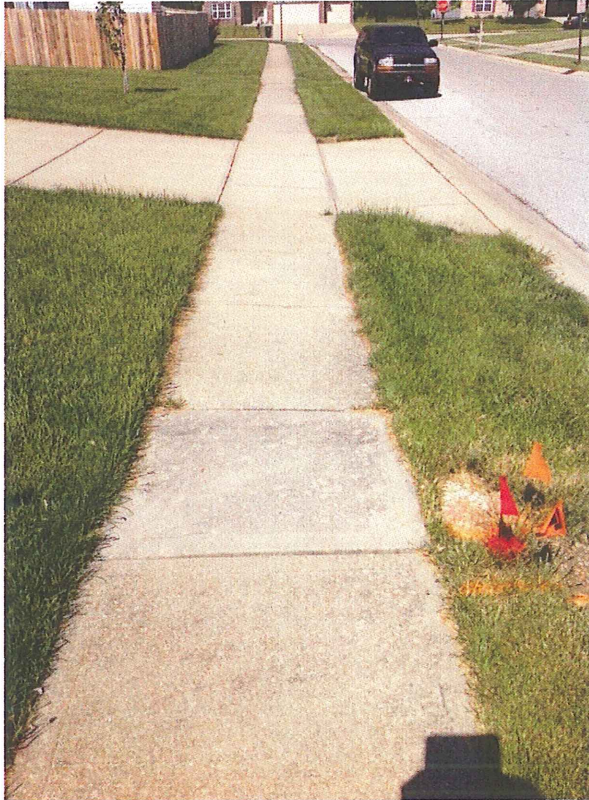
Sidewalk Cross Slope	greater than 3%
Sidewalk Running Slope	1.5
Sidewalk Passing Space	Yes
Sidewalk Vertical Discontinuities	Yes
Sidewalk Width Without Curb Feet	4
Sidewalk Width Without Curb Inch	0
Comments	5 raised panels 1" to .5"

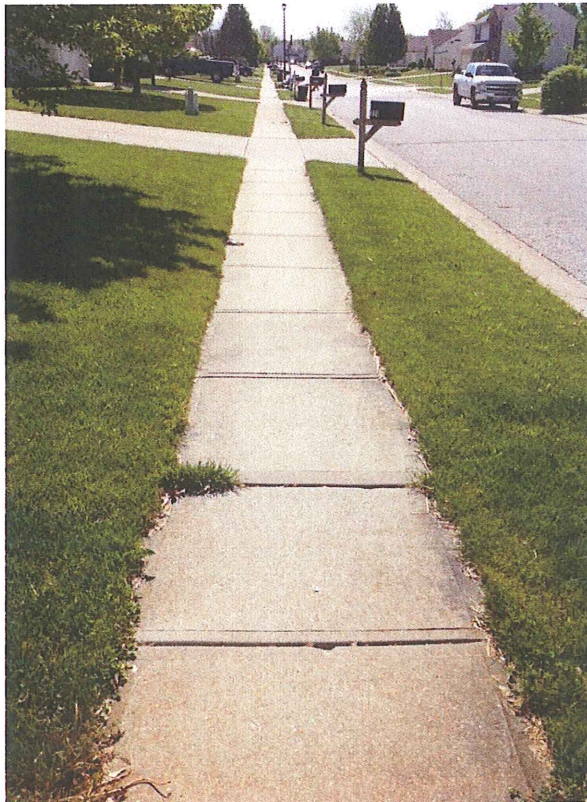
Brixton w to broadmoor bend

Sidewalk Cross Slope	2 - 3%
Sidewalk Running Slope	3.5
Sidewalk Passing Space	Yes
Sidewalk Vertical Discontinuities	Yes
Sidewalk Width Without Curb Inch	0
Comments	Panel raised 1"
