CITY OF PITTSBORO, INDIANA

SIDEWALK INVENTORY

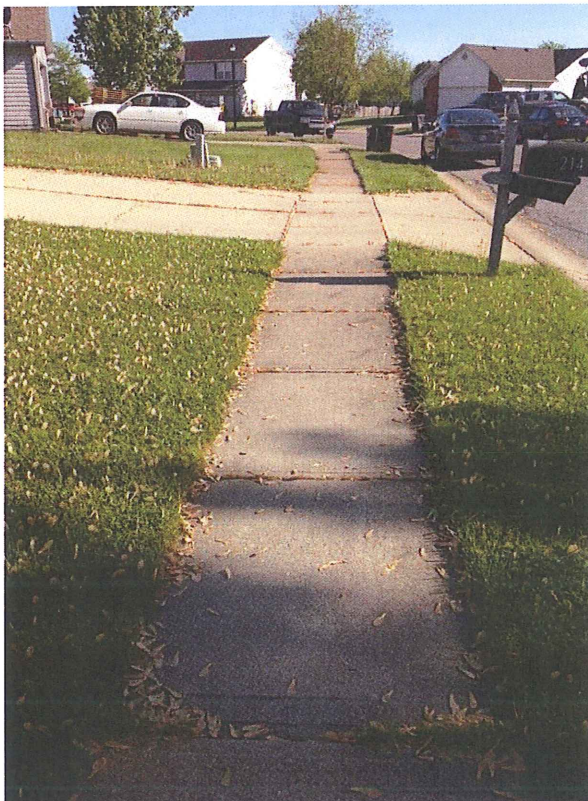
Lockerbie to morse ct

Sidewalk Cross Slope	less than 2%
Sidewalk Running Slope	1.5
Sidewalk Passing Space	Yes
Sidewalk Width Without Curb Inch	0
Comments	100' x slope 4%

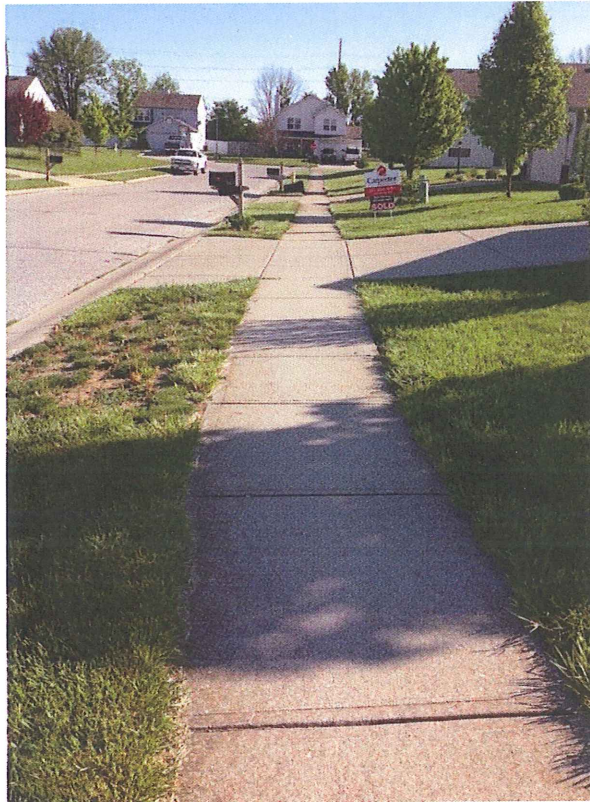
Lockerbie to morse ct

Sidewalk Cross Slope	2 - 3%
Sidewalk Running Slope	1.5
Sidewalk Passing Space	Yes
Sidewalk Vertical Discontinuities	Yes
Sidewalk Width Without Curb Inch	0
Comments	Raised panel 1"

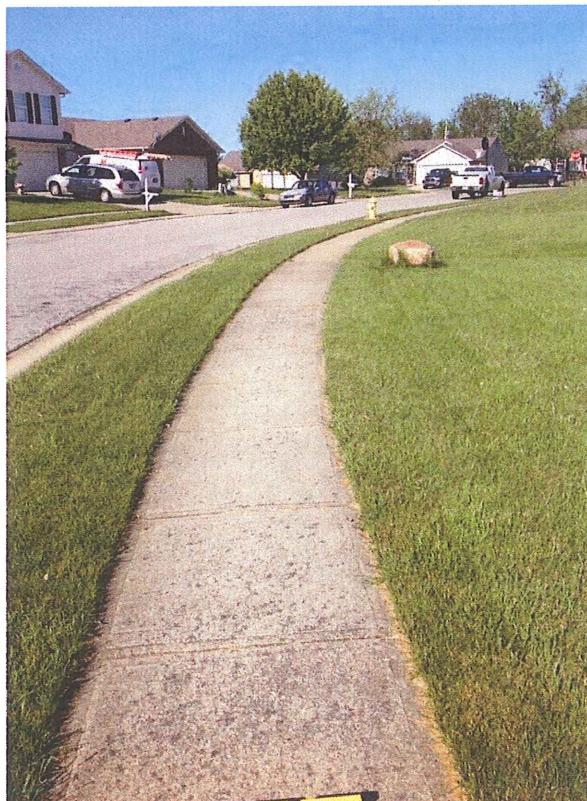
Sidewalk Cross Slope	less than 2%
Sidewalk Running Slope	2
Sidewalk Passing Space	Yes
Sidewalk Vertical Discontinuities	Yes
Sidewalk Width Without Curb Feet	4
Sidewalk Width Without Curb Inch	0
Comments	25% of x slope 2-4%. 2 raised panels. .75"

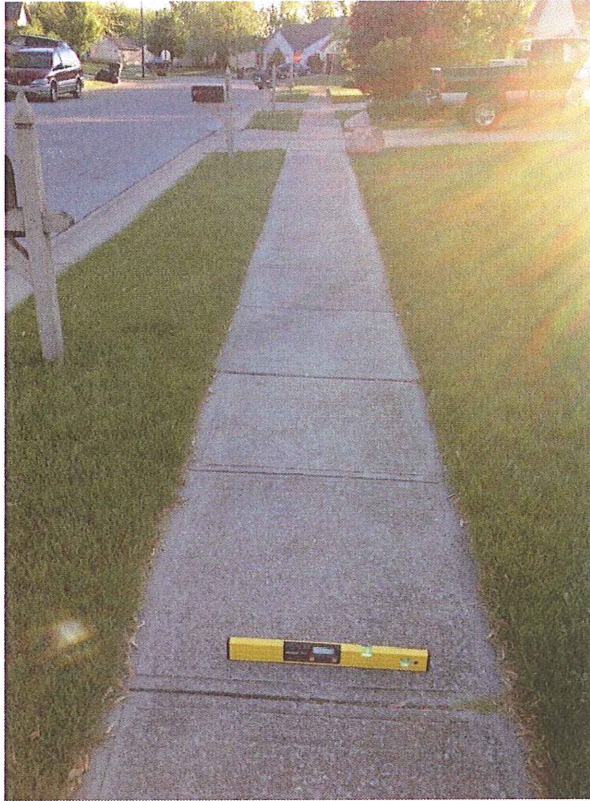
Castlegate to brookland In

Sidewalk Obstructions	No
Sidewalk Status	Active
Sidewalk Cross Slope	2 - 3%
Sidewalk Running Slope	1
Sidewalk Passing Space	Yes
Sidewalk Surface Discontinuities	No
Sidewalk Vertical Discontinuities	No
Sidewalk Accessibility Obstacles	No
Paving Obstructions (greater than 1/2")	Yes
Sidewalk Width Without Curb Feet	4
Sidewalk Width Without Curb Inch	0
Comments	1 raised panel .5"

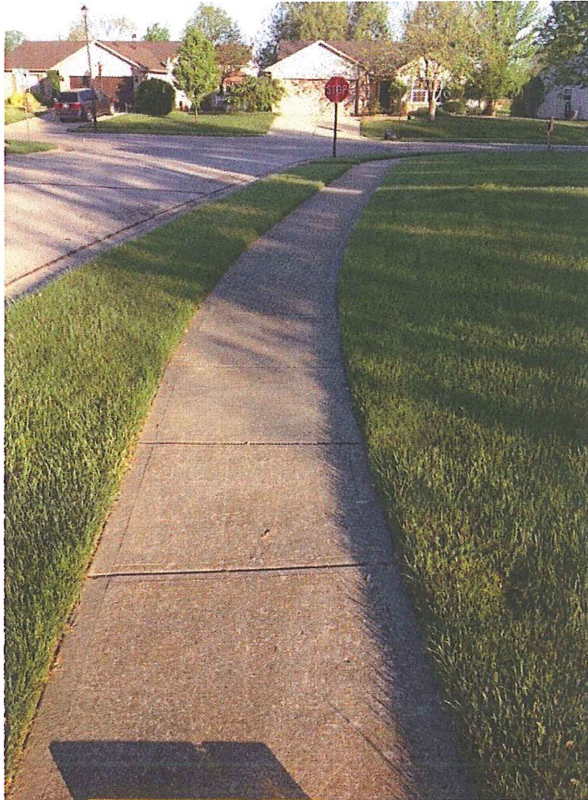
Sidewalk Obstructions	No
Sidewalk Status	Active
Sidewalk Cross Slope	greater than 3%
Sidewalk Running Slope	1.5
Sidewalk Passing Space	Yes
Sidewalk Surface Discontinuities	No
Paving Obstructions (greater than 1/2")	Yes
Sidewalk Width Without Curb Feet	4
Sidewalk Width Without Curb Inch	0
Comments	2 raised panels .5"

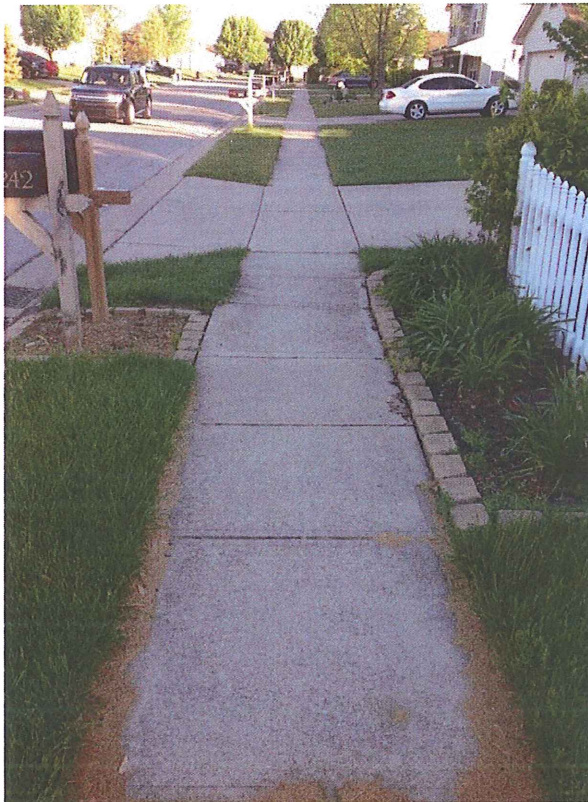
South of Lockerbie

Sidewalk Cross Slope	greater than 3%
Sidewalk Running Slope	2.3
Sidewalk Passing Space	Yes
Paving Obstructions (greater than 1/2")	Yes
Sidewalk Width Without Curb Feet	4
Sidewalk Width Without Curb Inch	0
Comments	3 raised panels .5"

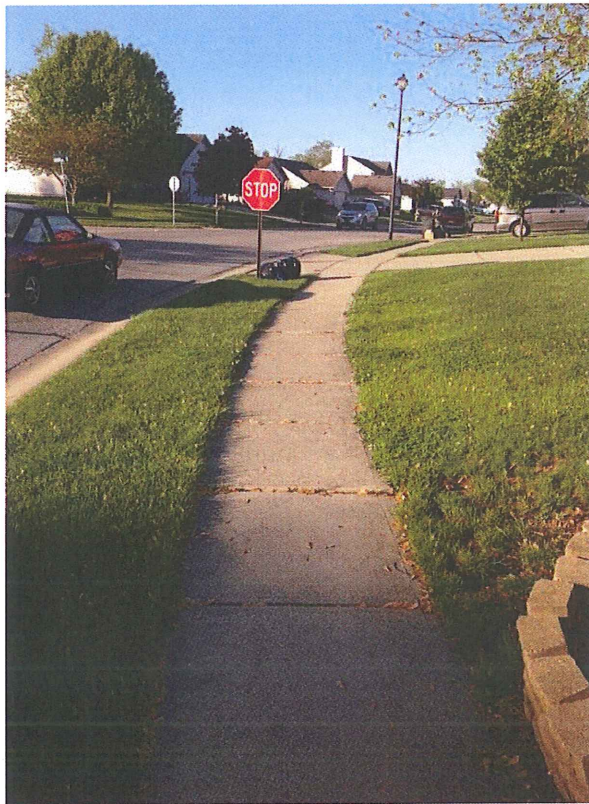
Lockerbie to brixton woods dr

Sidewalk Obstructions	No
Sidewalk Cross Slope	greater than 3%
Sidewalk Running Slope	3
Sidewalk Passing Space	Yes
Sidewalk Vertical Discontinuities	Yes
Sidewalk Width Without Curb Feet	4
Sidewalk Width Without Curb Inch	0
Comments	5 raised panels. .5 to 1"

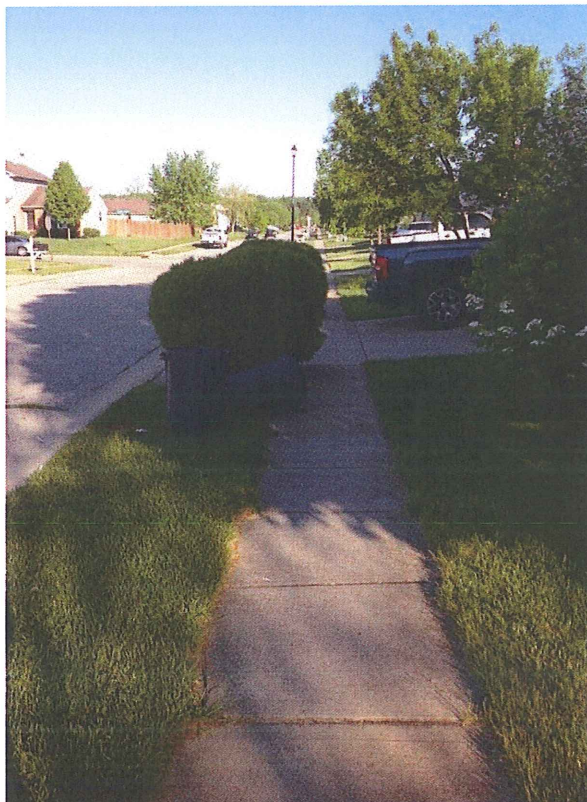
E of e brixton woods dr

Sidewalk Obstructions	Yes
Sidewalk Cross Slope	2 - 3%
Sidewalk Running Slope	2
Sidewalk Passing Space	Yes
Sidewalk Vertical Discontinuities	Yes
Sidewalk Width Without Curb Feet	4
Sidewalk Width Without Curb Inch	0
Comments	Raised panel .5". Pinned location is wrong. See segment

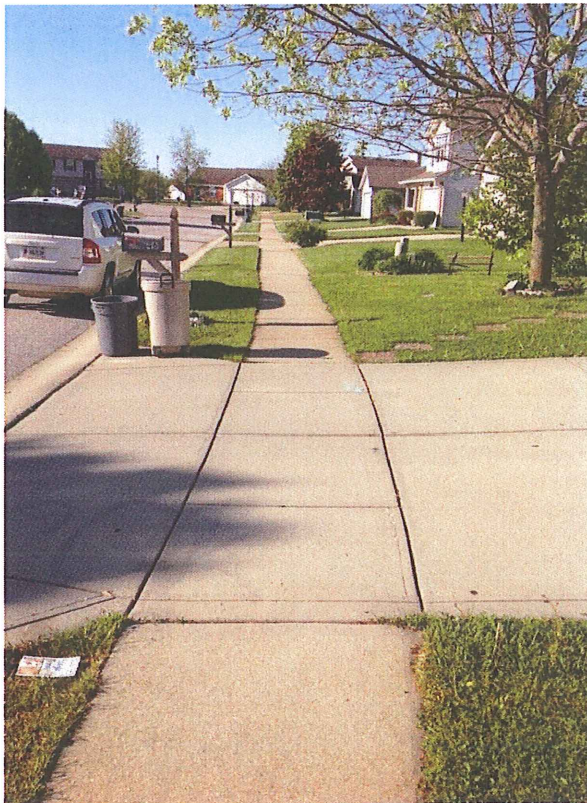
Sidewalk Cross Slope	greater than 3%
Sidewalk Running Slope	2
Sidewalk Passing Space	Yes
Sidewalk Width Without Curb Feet	4
Sidewalk Width Without Curb Inch	0
Comments	50% of east side x slope is < 2%

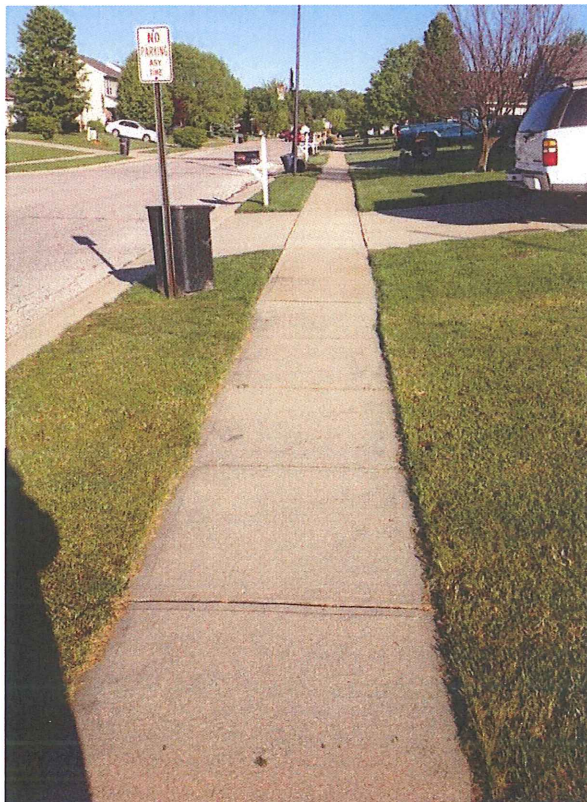
Brixton woods w to brixton woods e dr

Sidewalk Obstructions	No
Sidewalk Cross Slope	2 - 3%
Sidewalk Running Slope	1
Sidewalk Passing Space	Yes
Sidewalk Vertical Discontinuities	Yes
Sidewalk Width Without Curb Feet	4
Sidewalk Width Without Curb Inch	0
Comments	3 raised panels,5"

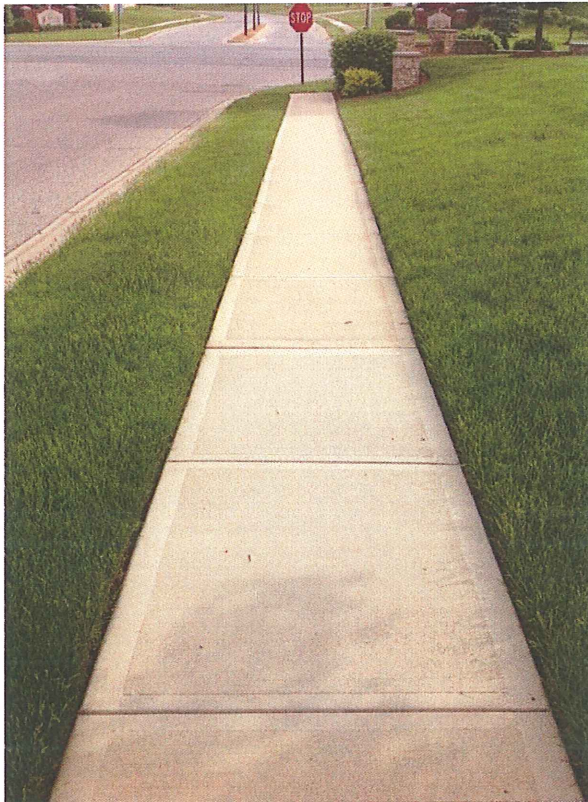
North of Ridgeway ct

Sidewalk Cross Slope	less than 2%
Sidewalk Running Slope	2.3
Sidewalk Passing Space	Yes
Sidewalk Surface Discontinuities	Yes
Sidewalk Width Without Curb Inch	0
Comments	West side under construction

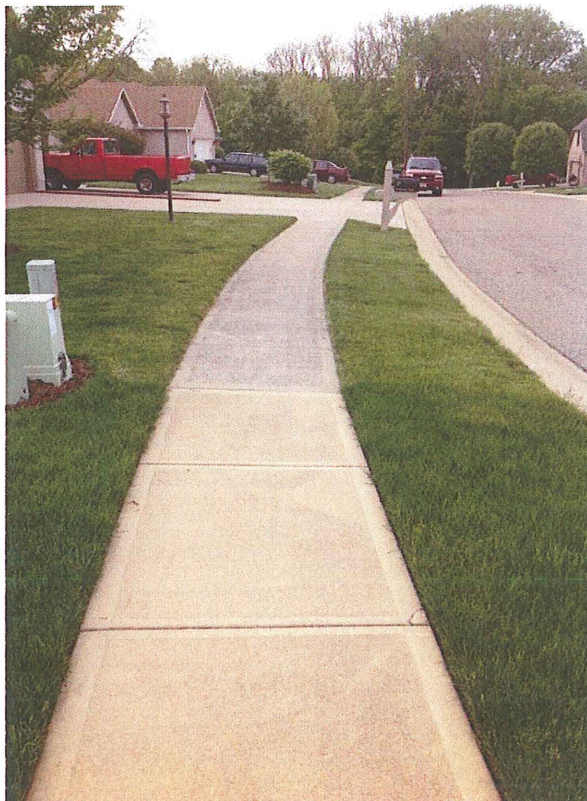
Sidewalk Cross Slope	less than 2%
Sidewalk Running Slope	3
Sidewalk Passing Space	Yes
Sidewalk Vertical Discontinuities	Yes
Sidewalk Width Without Curb Feet	4
Sidewalk Width Without Curb Inch	0
Comments	Short area in cul de sac 3% x slope. 3 raised panels .5"

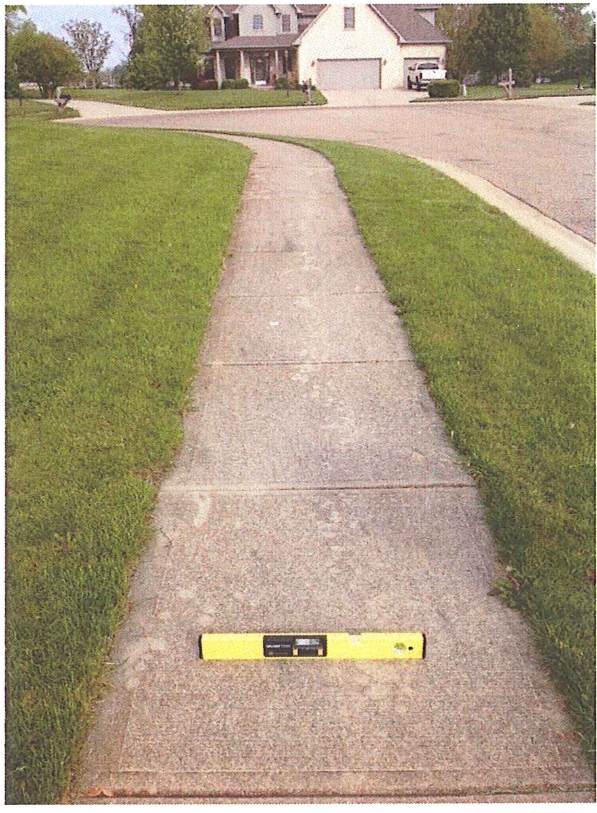
Sidewalk Cross Slope	less than 2%
Sidewalk Running Slope	1
Sidewalk Passing Space	Yes
Sidewalk Surface Discontinuities	Yes
Sidewalk Width Without Curb Feet	4
Sidewalk Width Without Curb Inch	0
Comments	North side under construction

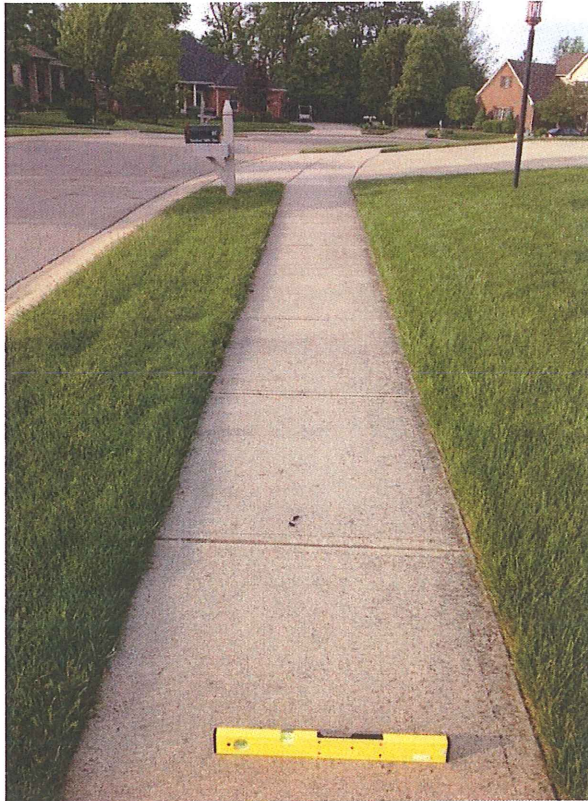
Sidewalk Cross Slope	greater than 3%
Sidewalk Running Slope	4
Sidewalk Passing Space	Yes
Sidewalk Width Without Curb Feet	4
Sidewalk Width Without Curb Inch	0
Comments	Few short areas < 2%

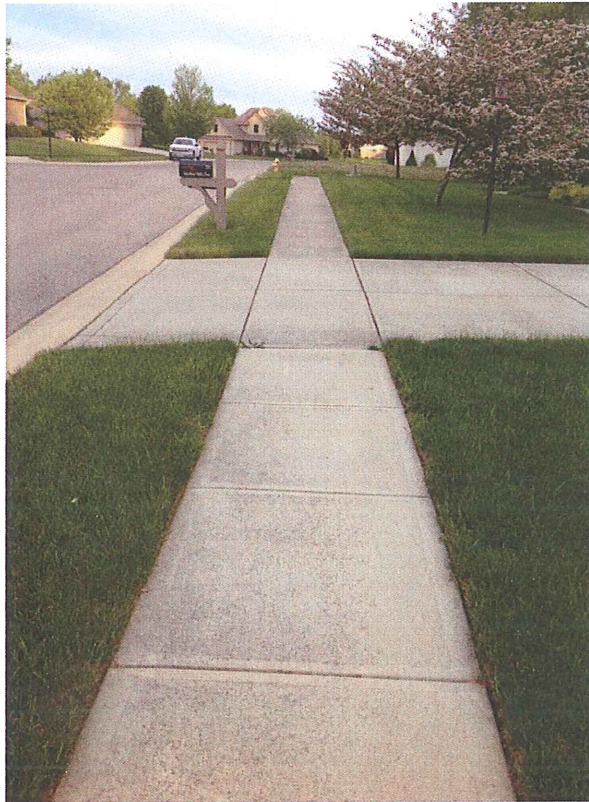
Woodview dr to end

Sidewalk Cross Slope	less than 2%
Sidewalk Running Slope	3
Sidewalk Passing Space	Yes
Sidewalk Surface Discontinuities	Yes
Sidewalk Width Without Curb Feet	4
Sidewalk Width Without Curb Inch	0
Comments	1 lot w no walks

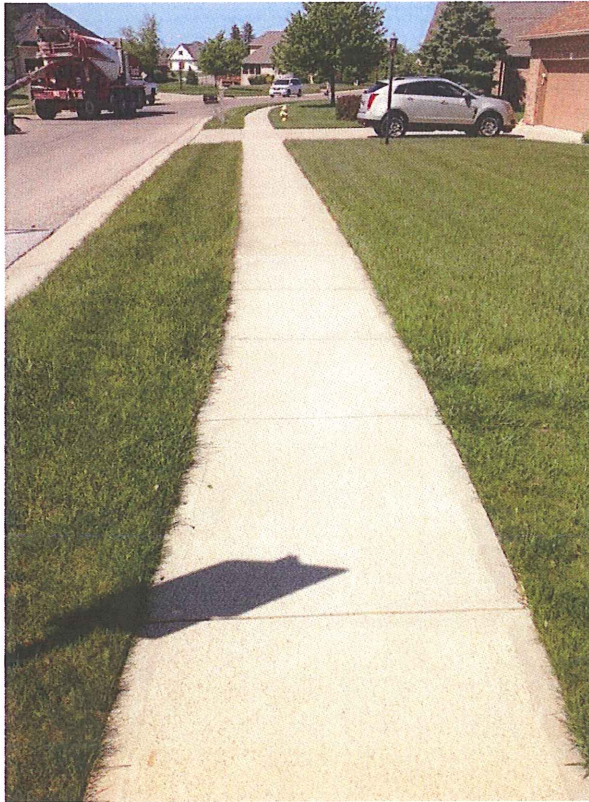
North of Hawthorne

Sidewalk Cross Slope	2 - 3%
Sidewalk Running Slope	1.8
Sidewalk Passing Space	Yes
Sidewalk Surface Discontinuities	Yes
Sidewalk Width Without Curb Inch	0
Comments	One lot w no walks

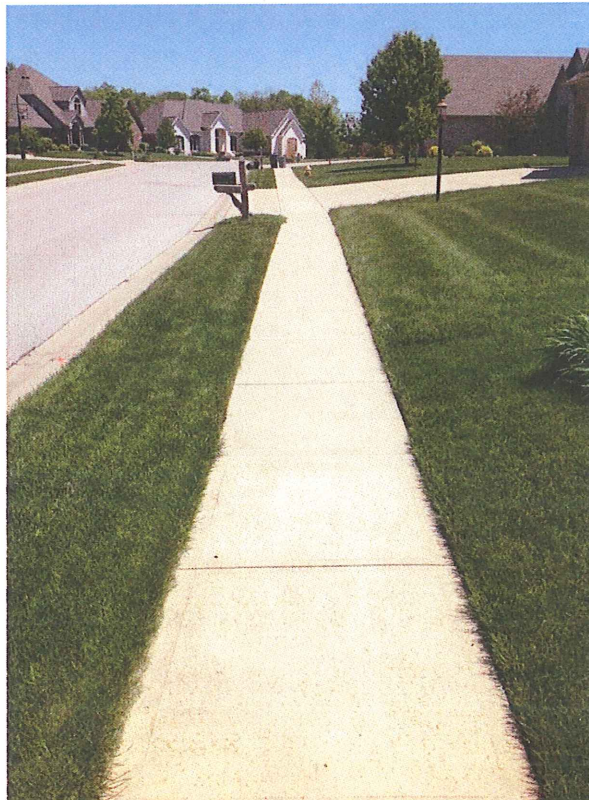
Photo of Block

Sidewalk Cross Slope	2 - 3%
Sidewalk Running Slope	0.5
Sidewalk Passing Space	Yes
Sidewalk Surface Discontinuities	Yes
Sidewalk Width Without Curb Feet	4
Sidewalk Width Without Curb Inch	0
Comments	2 empty lots w/no walks

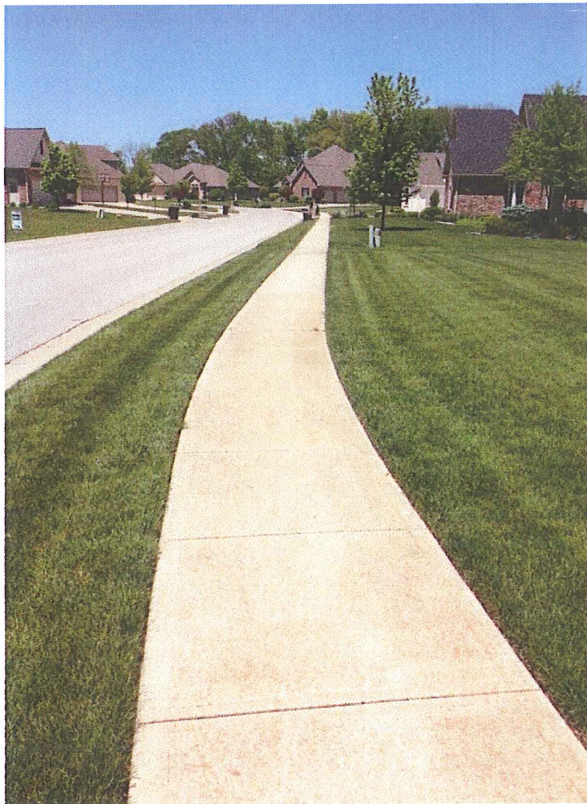
Segment	Fox tr to woodview dr
Side	N
Date	2015-05-13
Surveyor	Jack
Street	Hawthorne dr

Sidewalk Cross Slope	less than 2%
Sidewalk Running Slope	0.6
Sidewalk Passing Space	Yes
Sidewalk Width Without Curb Feet	4
Sidewalk Width Without Curb Inch	0
Comments	Several short areas <100' total over 2%

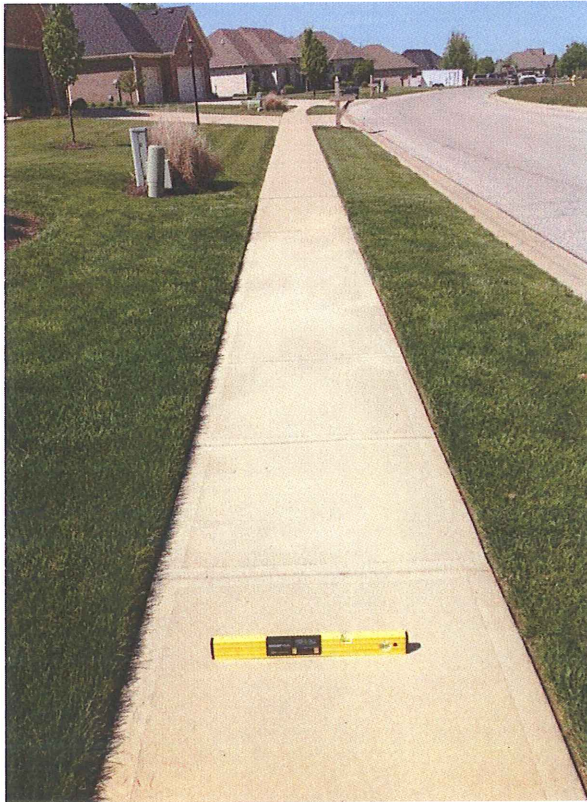
Segment	South of Hawthorne dr
Side	Both
Date	2015-05-13
Surveyor	Jack
Street	Woodview dr

Sidewalk Cross Slope	less than 2%
Sidewalk Running Slope	1.7
Sidewalk Passing Space	Yes
Sidewalk Surface Discontinuities	Yes
Sidewalk Width Without Curb Inch	0
Comments	One lot w no walks.

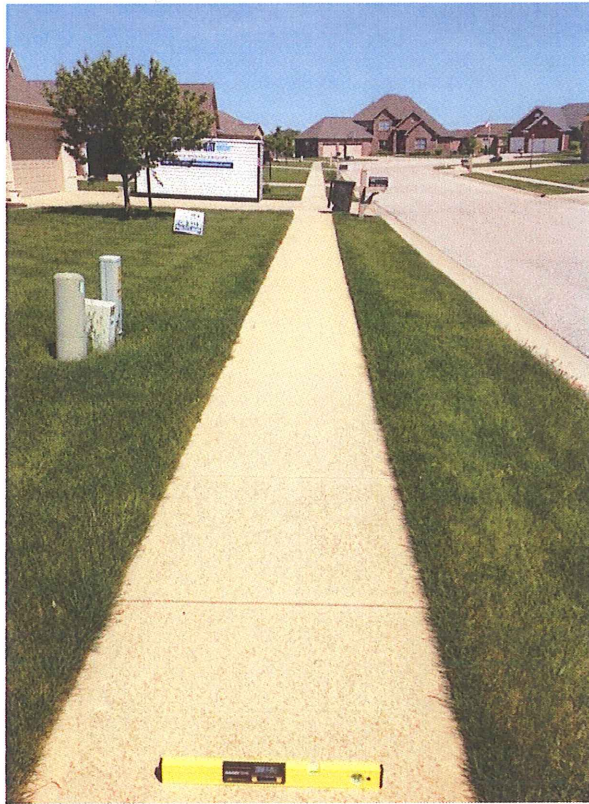
Side	Both
Date	2015-05-13
Surveyor	Jack
Street	Wind drift ct

Sidewalk Cross Slope	2 - 3%
Sidewalk Running Slope	1.5
Sidewalk Passing Space	Yes
Sidewalk Width Without Curb Feet	4
Sidewalk Width Without Curb Inch	0

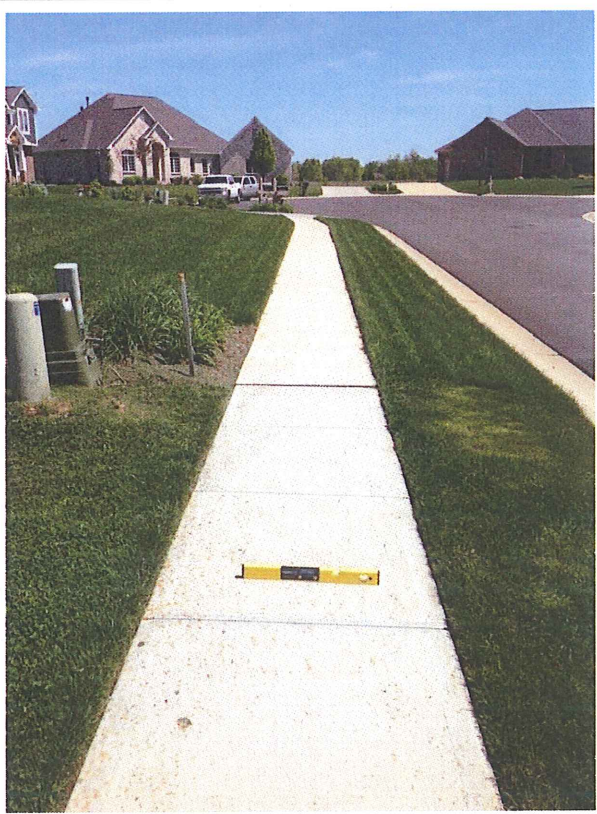
Side	Both
Date	2015-05-13
Surveyor	Jack
Street	Lakeside ct

Sidewalk Cross Slope	2 - 3%
Sidewalk Running Slope	1.2
Sidewalk Passing Space	Yes
Sidewalk Surface Discontinuities	Yes
Sidewalk Width Without Curb Feet	4
Sidewalk Width Without Curb Inch	0
Comments	50% of area is < 2%. One lot w no walks

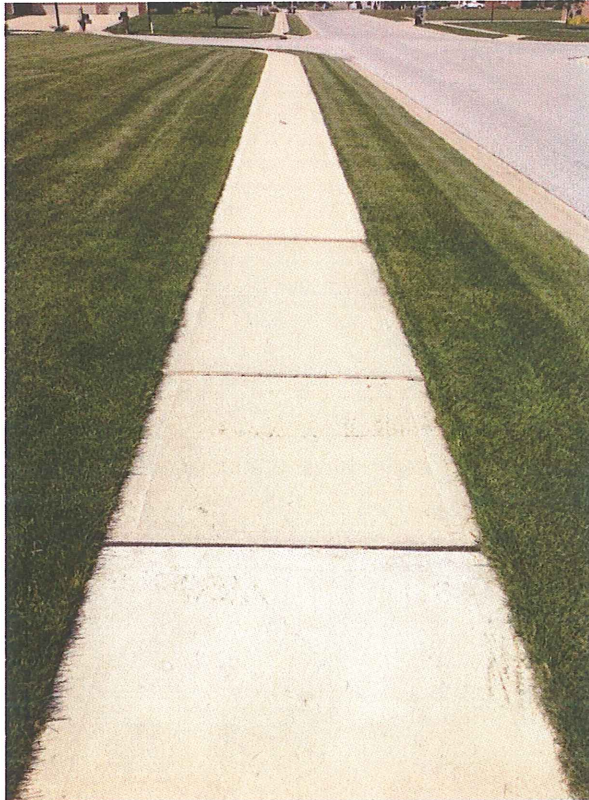
Segment	So of windrift ct
Side	Both
Date	2015-05-13
Surveyor	Jack
Street	Woodview dr

Sidewalk Cross Slope	2 - 3%
Sidewalk Running Slope	1.2
Sidewalk Passing Space	Yes
Sidewalk Surface Discontinuities	Yes
Sidewalk Width Without Curb Feet	4
Sidewalk Width Without Curb Inch	0
Comments	2 lots w no walks. Pinned location wrong

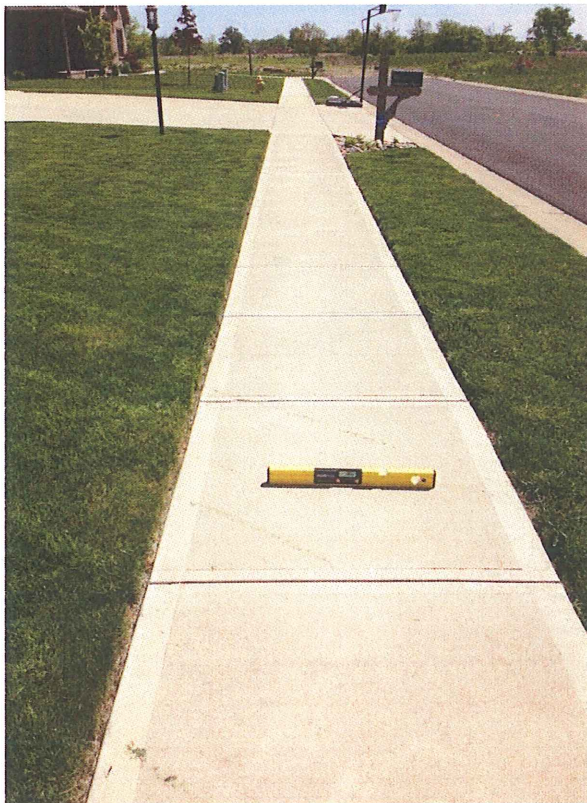
Side	Both
Date	2015-05-13
Surveyor	Jack
Street	Lakeside dr

Sidewalk Cross Slope	less than 2%
Sidewalk Running Slope	2
Sidewalk Surface Discontinuities	Yes
Sidewalk Width Without Curb Feet	4
Sidewalk Width Without Curb Inch	0
Comments	3 lots w/ no walks

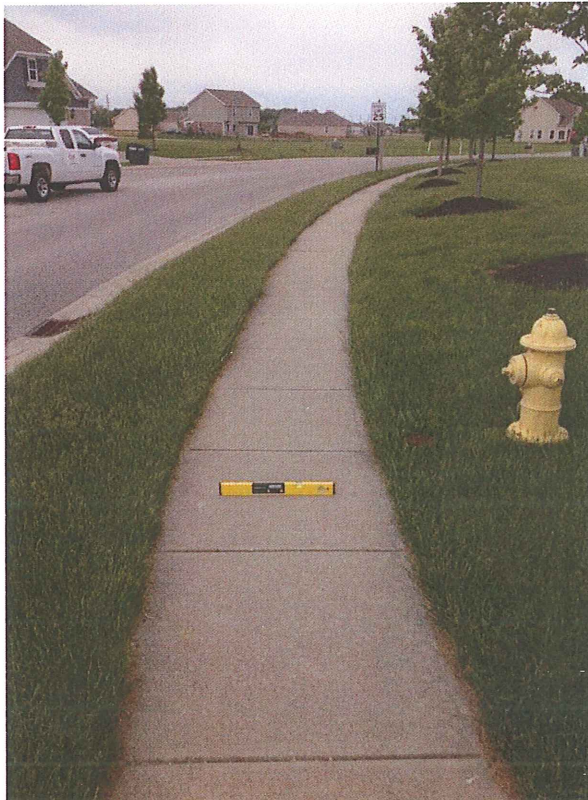
Segment	Entrance to sub
Side	Both
Date	2015-05-20
Surveyor	Jack
Street	Jefferson Park dr

Sidewalk Cross Slope	less than 2%
Sidewalk Running Slope	1.6
Sidewalk Passing Space	Yes
Sidewalk Surface Discontinuities	Yes
Sidewalk Vertical Discontinuities	Yes
Sidewalk Width Without Curb Inch	0
Comments	2 raised panels 3/4". Subdivision with < 50% of lots built on.

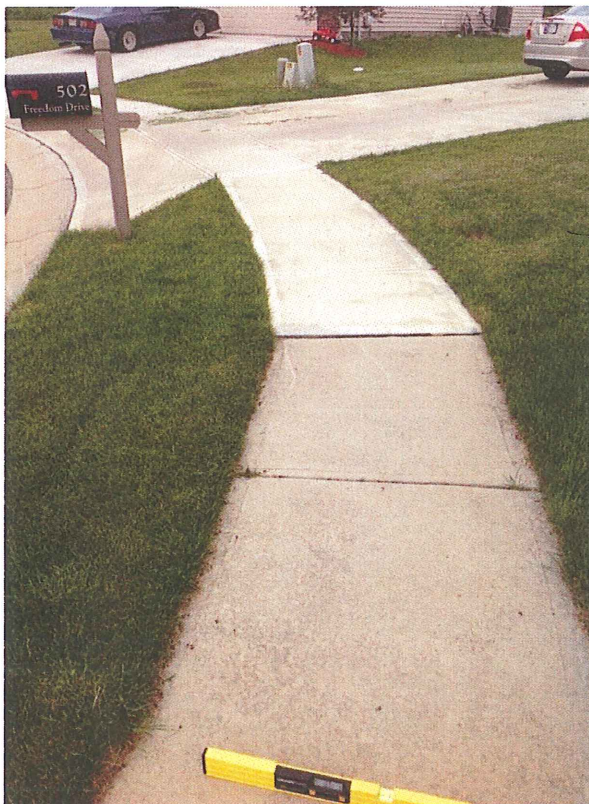
Side	Both
Date	2015-05-20
Surveyor	Jack
Street	Freedom dr / Albermarie Dr

Sidewalk Cross Slope	less than 2%
Sidewalk Running Slope	1.2
Sidewalk Surface Discontinuities	Yes
Sidewalk Width Without Curb Inch	0
Comments	Subdivision with < 50% of lots built on.

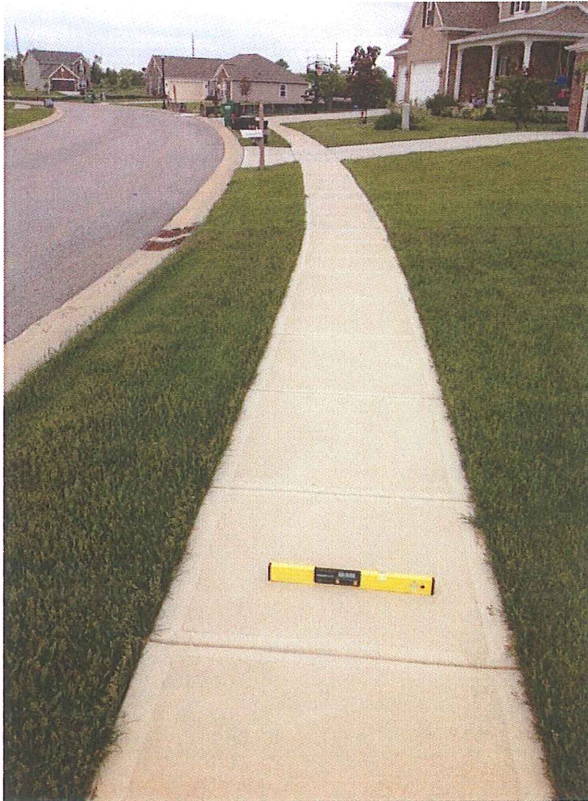
Side	Both
Date	2015-05-20
Surveyor	Jack
Street	Wayles dr

Sidewalk Cross Slope	less than 2%
Sidewalk Running Slope	2
Sidewalk Passing Space	Yes
Sidewalk Surface Discontinuities	Yes
Sidewalk Width Without Curb Feet	4
Sidewalk Width Without Curb Inch	0
Comments	Subdivision with < 50% of lots built on.

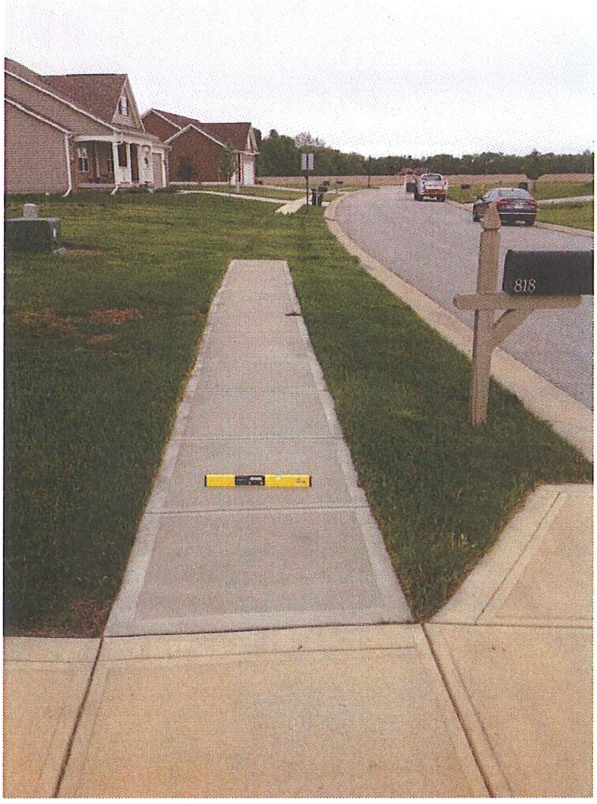
Side	Both
Date	2015-05-20
Surveyor	Jack
Street	Declaration Dr

Sidewalk Cross Slope	less than 2%
Sidewalk Running Slope	1.7
Sidewalk Surface Discontinuities	Yes
Sidewalk Width Without Curb Feet	4
Sidewalk Width Without Curb Inch	0
Comments	Subdivision with < 50% of lots built on.

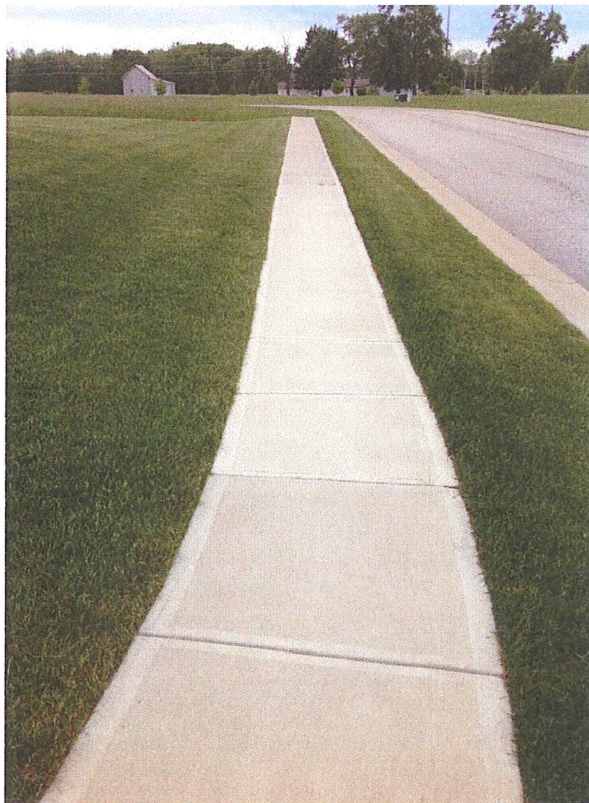
Segment	NW corner of loop
Side	Both
Date	2015-05-20
Surveyor	Jack
Street	Fennel dr

Sidewalk Cross Slope	less than 2%
Sidewalk Running Slope	2.2
Sidewalk Surface Discontinuities	Yes
Sidewalk Width Without Curb Inch	0
Comments	Subdivision with only 4 houses built

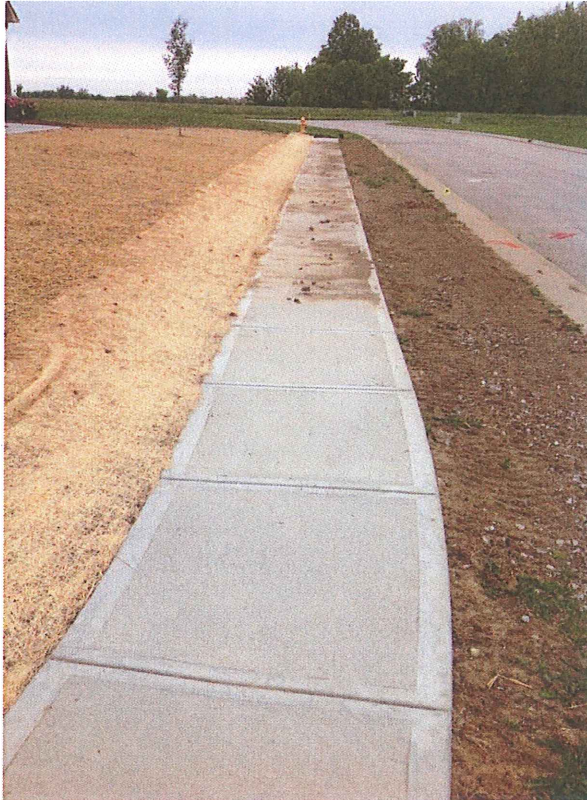
Segment	SE corner of loop
Side	W
Surveyor	Jack

Sidewalk Cross Slope	less than 2%
Sidewalk Running Slope	1.6
Sidewalk Surface Discontinuities	Yes
Sidewalk Width Without Curb Inch	0
Comments	Subdivision with only 4 houses built
